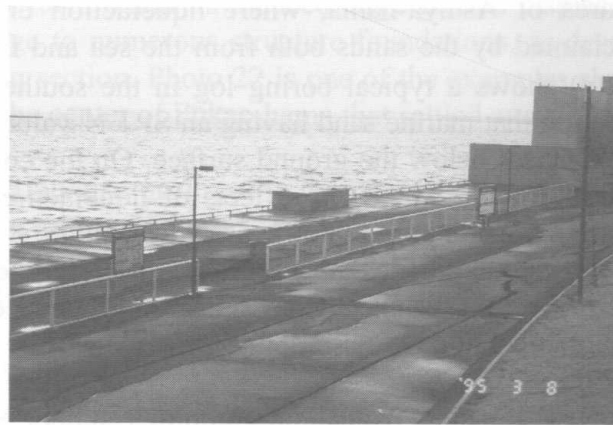
Naruo-hama was reclaimed during 1967-1975, almost in same period as Ashiya-hama, using decomposed granite from Awaji Island. Thickness of the fill ranges 10-14 meters, with ground surface 5 meters above sea level. Greater part of the fill was untreated, nevertheless, liquefaction traces such as sand boils, ground fissures and subsidence were considerably less than those in other reclaimed areas described previously. Photo 27 shows a quaywall of the northeastern end of Naruo-hama, where no major damage was observed. One of the reasons why the liquefaction effects were slight in this area is that the intensity of the ground motion is smaller because of the longer epicentral distance.

Photo 27 Quaywall of Naruo-hama where no major damage was observed (*W* in Figure 4)

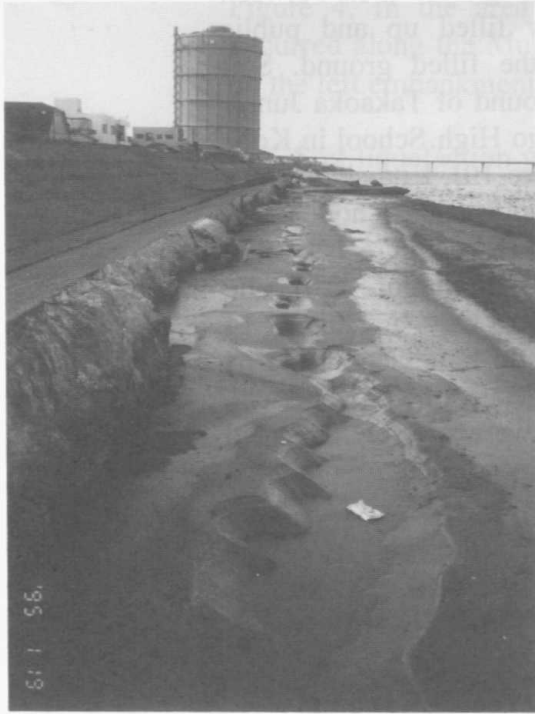
Dikes of the Yodo River were seriously damaged over a total length of 6,590 meters: the concrete parapet of the levees tilted, settled and slid about 8 meters into the river; the embankment cracked and settled maximum of 3 meters¹⁶⁾. Sand erupted from the fissures along the dikes as shown Photo 28.

Photo 28 Sand boils along Torishima Dike of Yodo River
(Courtesy of Mr. R. Isoyama)

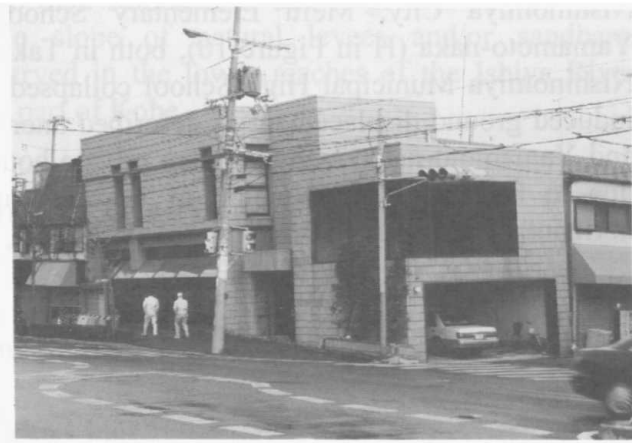
The liquefaction also occurred in the residential areas along the river. Many residence, which were typically 2-story wooden houses with low foundation rigidity, and several low-rise buildings sustained severe settlement and tilting (Photo 29). According to Osaka City Government⁶⁾, damage to houses in Osaka was heavily concentrated in Nishi-yodogawa-ku and Konohana-ku; 47 houses were totally damaged and 912 were partially damaged among a total of 18,840 houses in Nishi-yodogawa-ku, while 115 houses were totally damaged and 620 were partially damaged among 12,248 houses in Konohana-ku. Exact number of houses damaged due to liquefaction were unknown, however the most of the damage to houses is assumed to be related liquefaction since they were located in the liquefied areas.

Photo 29 Liquefaction-induced settlement of stores near Torishima Dike (18)

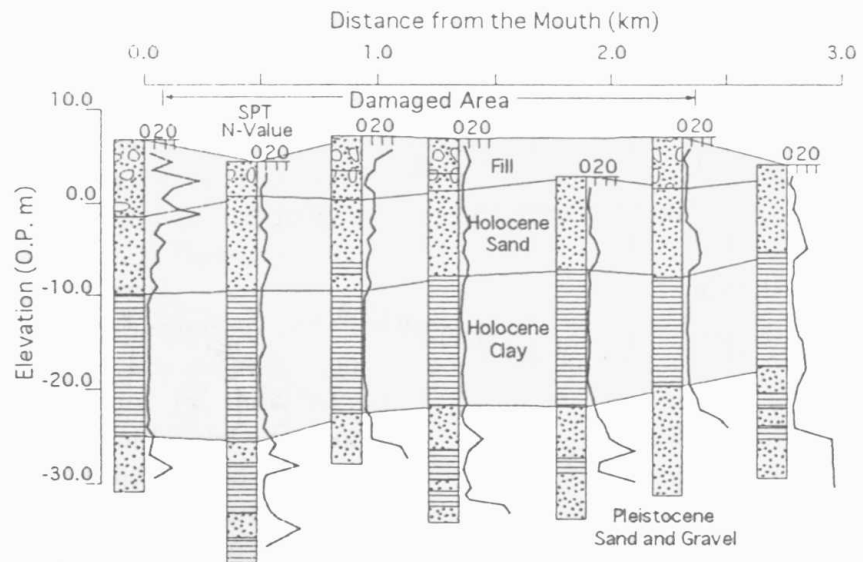
settled 3 meters, located within the abandoned channel of the old Yodo River and had been a swamp until forty years before the earthquake. Figure 9 shows soil profile along the Yodo River. Loose fill and alluvial sand with SPT N-value of 10 or less extend from ground surface to a depth of 15 meters. These alluvial sand and fill beneath the water level are considered to have liquefied.

Figure 9. Soil profiles along the left bank of Yodo River⁽¹⁹⁾
