6. DAMAGE DUE TO LIQUEFACTION AND ITS INDUCED GROUND DISPLACEMENT

6.1 Bridges and embankment

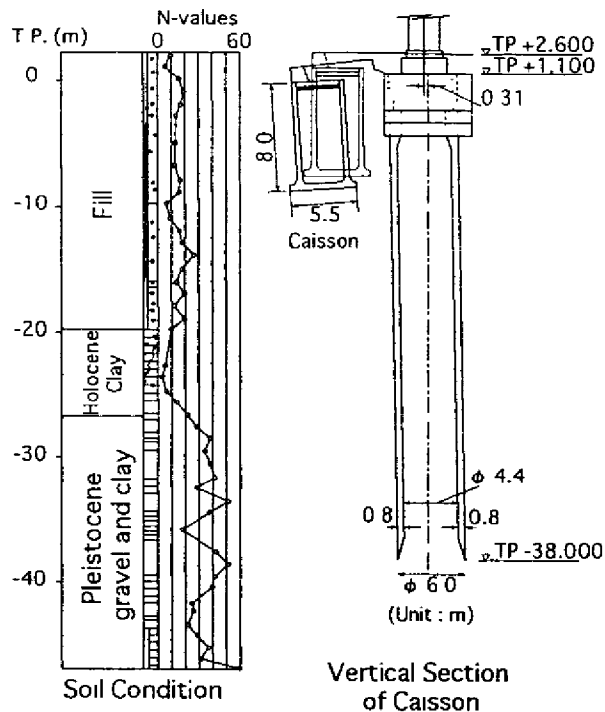
The "Rokko Liner" is a railway, which is connecting J.R. Sumiyoshi St. in mainland and the Rokko Island. It was reported that many foundations of bridges of the railway moved towards the sea several ten centimeters due to liquefaction-induced large ground displacements. Photo 30 shows that a steel girder of the railway dropped due to movement and inclination of its concrete caisson foundation of a diameter of 6.0 meters and a depth of about 40 meters. The surface ground in the neighborhood consists of fill about 20 meters thick, overlying soft Holocene clay of the original seabed sediment as shown in Figure 11. The foundation was penetrated into the Pleistocene gravel layer at a depth of about 40 meters beneath low the ground surface underlying the soft Holocene clay.

Figure 11. Profile of caisson foundation and soil in neighborhood (Rokko Liner) ¹⁹⁾

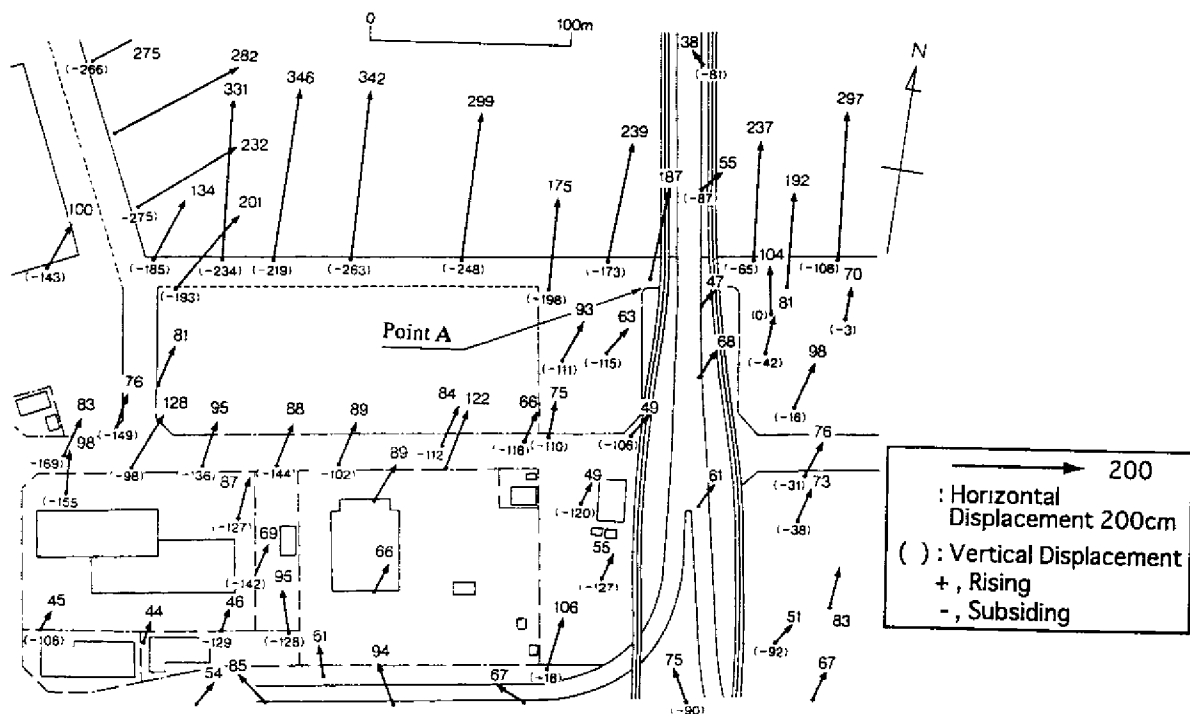
According to an on-ground survey conducted by Kobe City Government the top of the caisson foundation moved about 60 cm towards the sea. As shown in Figure 12, the quaywalls in front of the railway foundation displaced towards the sea, at a maximum about 3.5 meters, and consequently the ground behind the quaywalls widely moved towards the sea. Many ground fissures, about 30-50 cm wide were caused due to the large tensile strain of the ground as shown in Photo 31. The ground in Photo 31 moved towards the sea, from the right to the left, and the ground surface had been originally flat before the earthquake, but largely inclined.

Figure 12. Liquefaction-induced ground displacement on northern part of Rokko Island ¹⁾ (At point A a steel girder of the railway dropped)

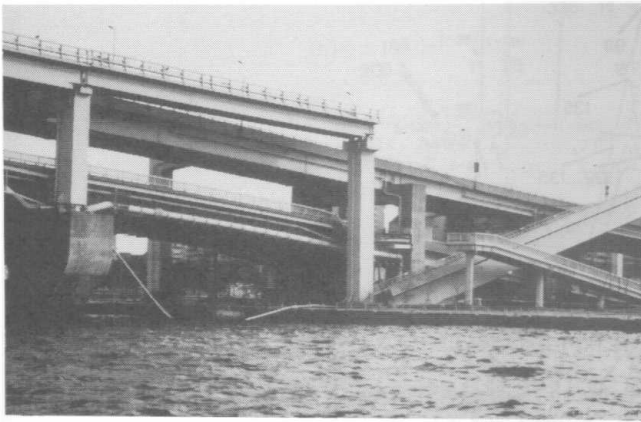
Photo 30 Bridge girder dropped due to ground displacement (A in Figure 12)

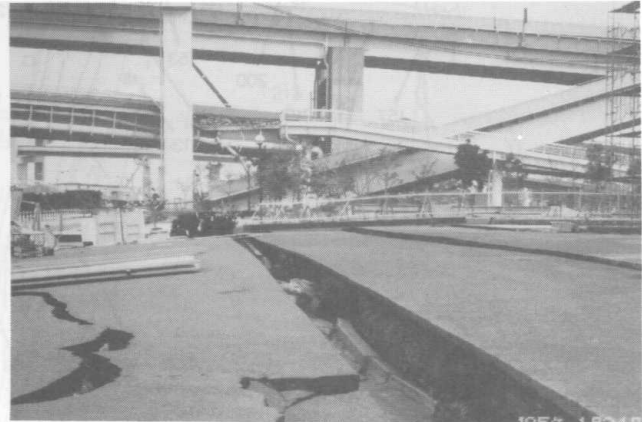
Photo 31 Ground fissure due to ground strain in northern part of Rokko Island

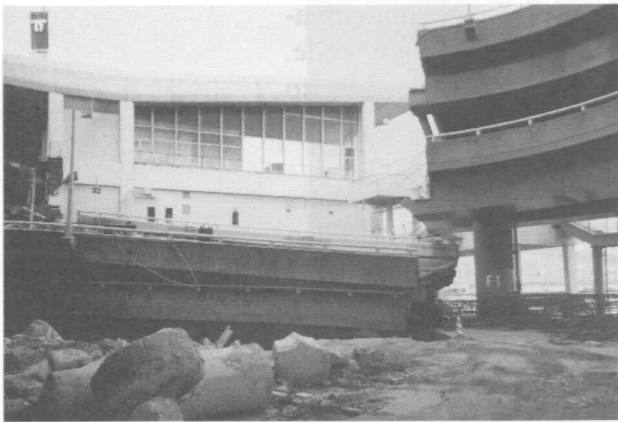
The Kobe Bridge is connecting the Port Island and No. 4 Pier of the Kobe Wharf in the mainland. The damage to the main span of the Kobe Bridge was reportedly slight, but a spiral shaped steel girder with two stories for an approach to the main span dropped as shown in Photo 32. The pier, seen in the photo moved towards the sea (toward the right direction in the photo) about 1 m according to the authors' aerial survey. Figure 13 shows ground displacements in horizontal and vertical directions measured by aerial survey. The ground of the wharf displaced towards the sea 1-3 meters. The wharf was reclaimed from the sea and the depth of the reclamation was about 13 meters.

Photo 32 Bridge girder dropped due to ground displacement (A in Figure 13)

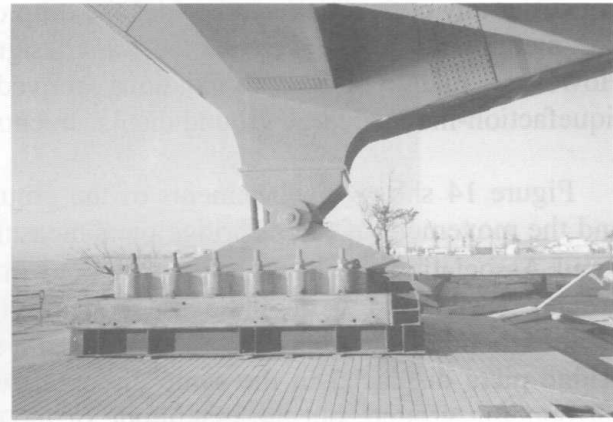
Photo 33 also shows an evidence of horizontal movement and/or inclination of a concrete caisson foundation supports the main span of the Kobe Bridge by a movable-bearing shoe. As shown in the photo, about half meters relative displacement was caused between the top of the concrete caisson and the bearing shoe, due to the movement at the top of the foundation.

Photo 33 Movement of foundation of Kobe Bridge due to ground displacement (B in Figure 13)

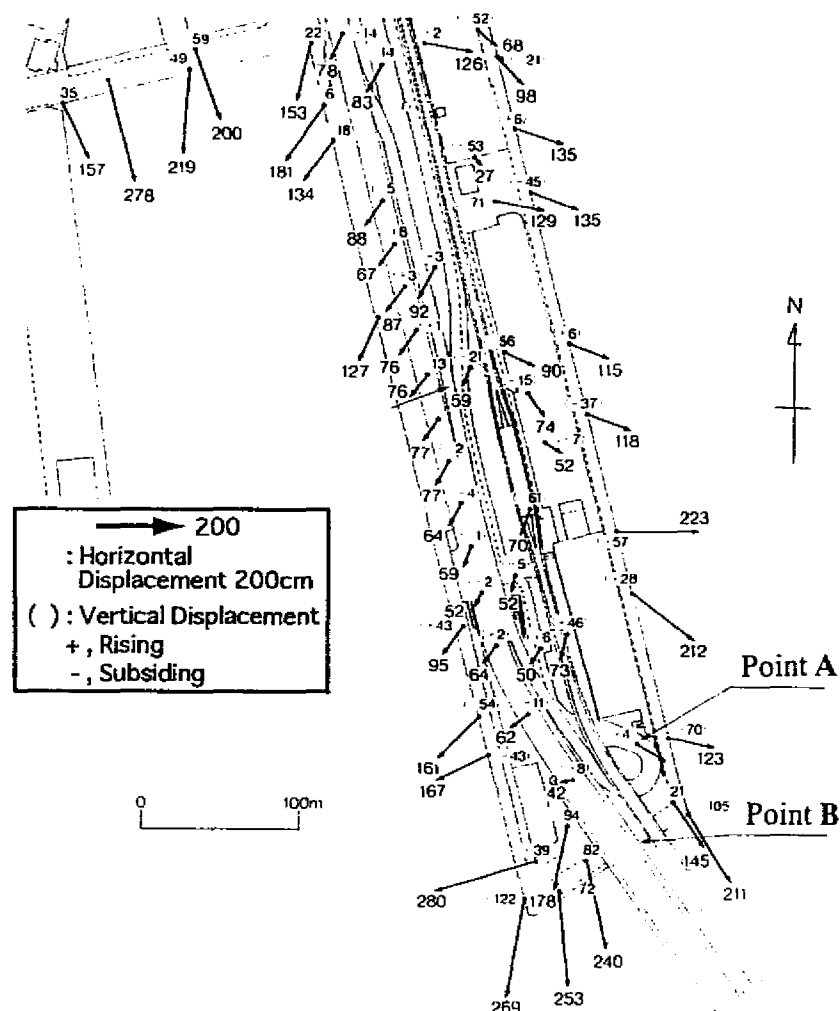
Figure 13. Liquefaction-induced ground displacement at Pier No. 4 of Kobe Wharf⁽¹⁾

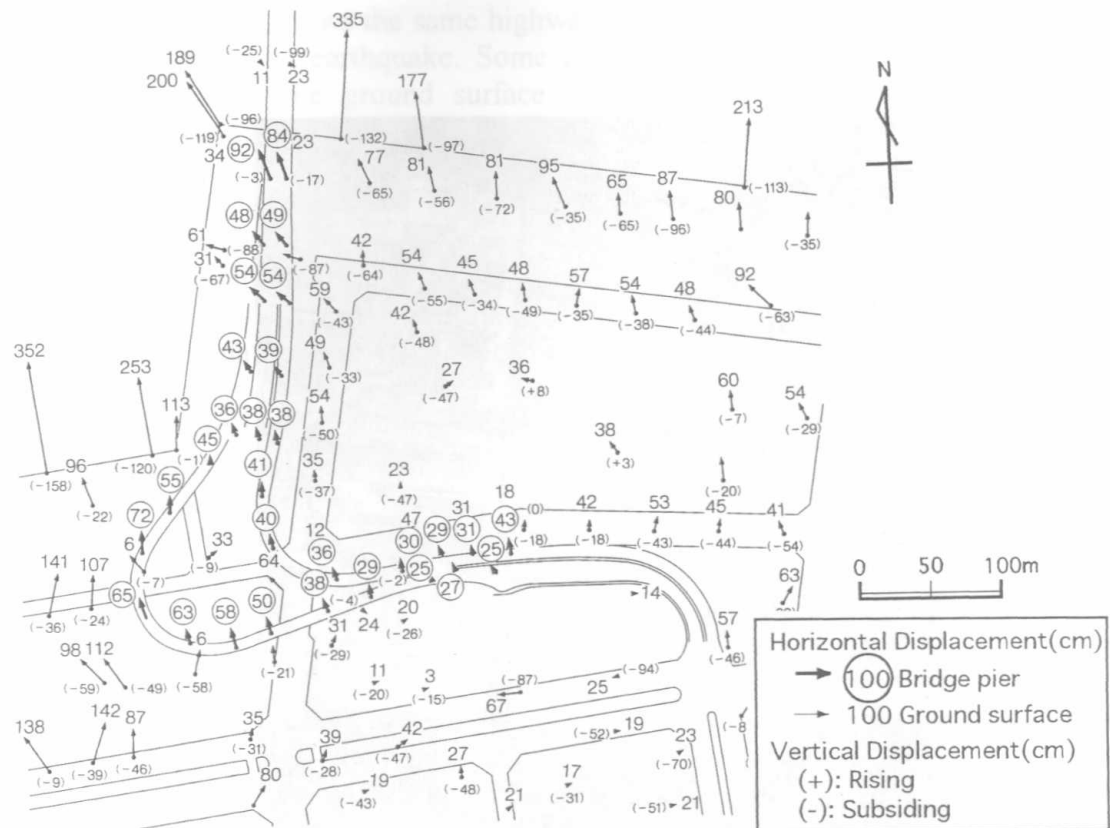
Figure 14 shows displacements of the ground measured by the authors and the movement of top of bridge piers measured by a committee of Japan Road Association²²⁾. The light colored sand in Photo 34 boiled out of the ground surface, and it can be recognized that the ground in the neighborhood of the highway bridge, caused a significant liquefaction. The bridge piers displaced in the same direction with the displacement of the surrounding ground, but the magnitude of the displacement of the piers is smaller than that of the ground. The maximum displacement of the top of the piers was about 90 cm, while the surrounding ground moved about 1-2 meters. These piers have cast-in-place concrete pile.

Figure 14. Displacements at ground surface¹⁾ and at top of bridge piers²⁾ at northern part of Rokko Island

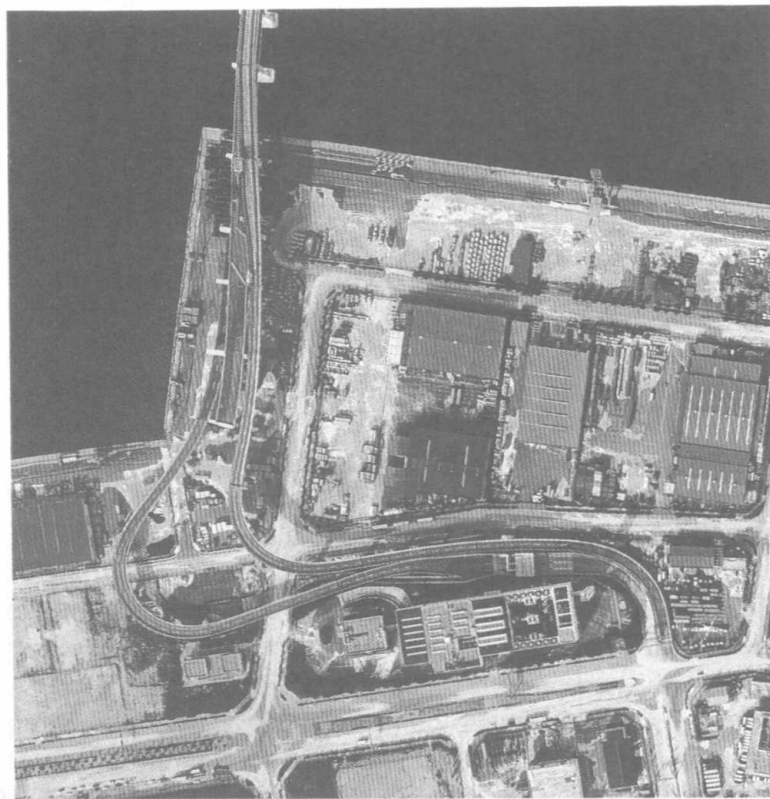
Photo 34 The No. 5 Bay Highway in Rokko Island

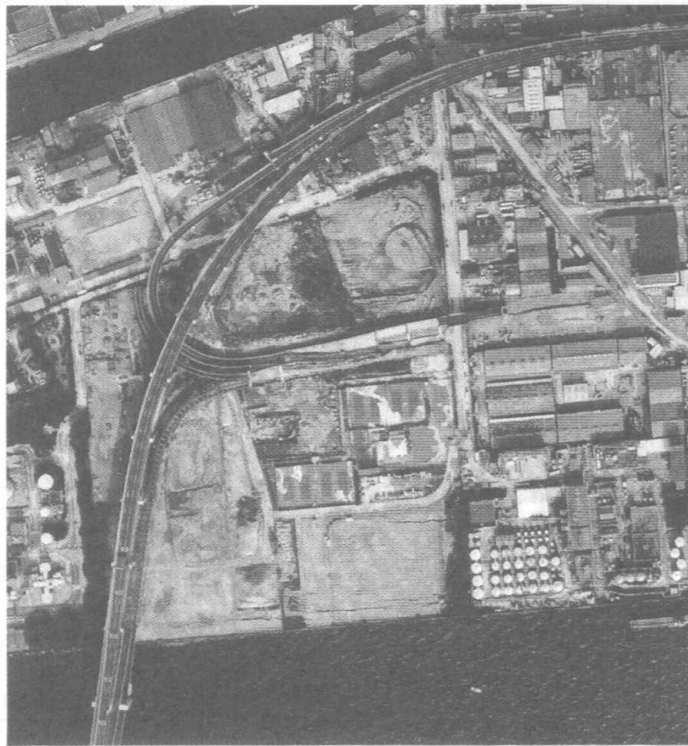
Photo 35 The No. 5 Bay Highway in Uozaki-hama

Photo 35 shows the same highway and its surrounding area in Uozaki-hama after the earthquake. Some amount of sand boil deposit was also observed on the ground surface. The highway bridges reportedly had inground wall foundations. Figure 15 shows the displacements at tops of the bridge piers as well as at the ground surface, which were measured by previously mentioned investigation groups. Compared with the displacement of the bridge piers in Port Island, which had cast-in-place concrete pile foundations, the displacements of the piers with inground wall foundations in Uozaki-hama are much smaller. This suggests that inground wall foundations are more effective to counter the ground displacements.

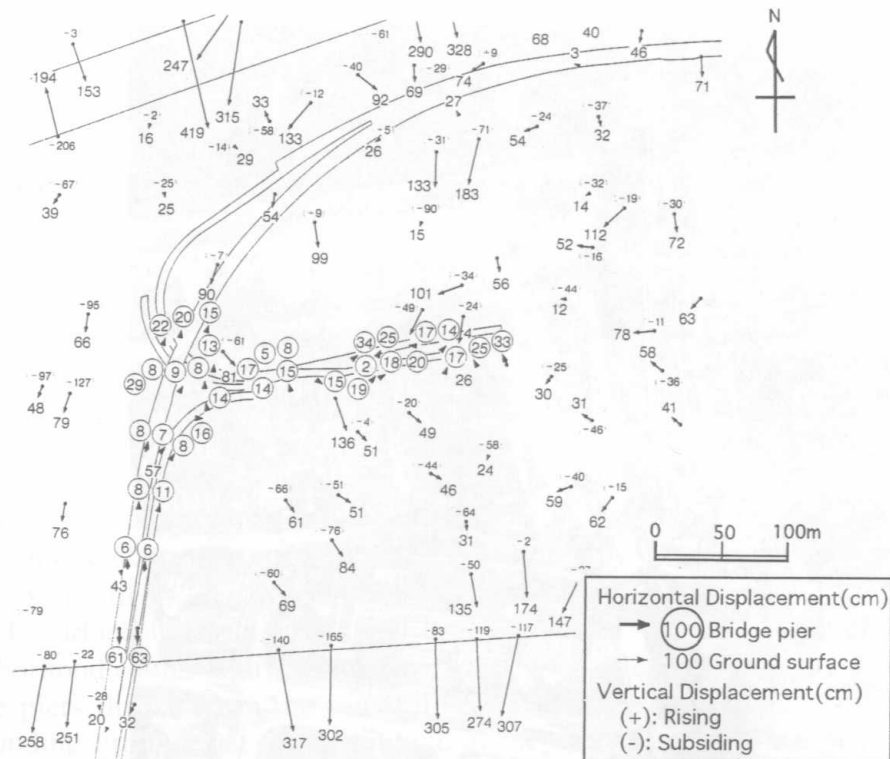
Figure 15. Displacements at ground surface¹⁾ and at top of bridge piers²⁾ at southern part of Uozaki-hama

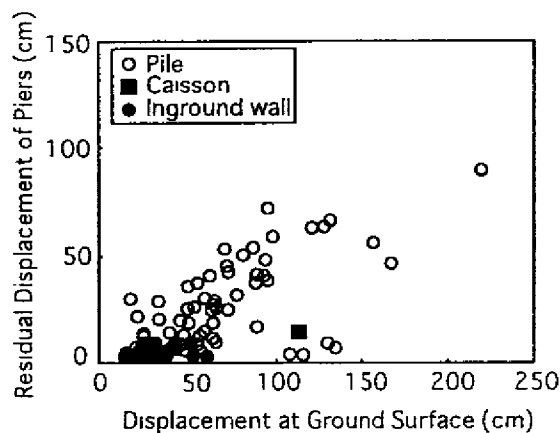
Figure 16 is a relationship between the displacements of the bridge piers and those at the ground surface²⁴⁾. It can be said that with pile foundations. The result in Figure 16 also suggests that inground walls and caissons are more effective for the foundations in the ground with a high potential of liquefaction and its induced ground displacement.

Figure 16. Relationship between the displacements of the bridge piers and those at the ground surface²²⁾

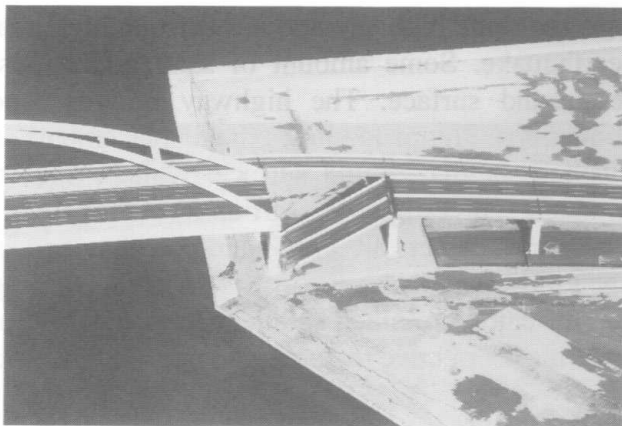
A steel girder of a side span of the Nishinomiya-ko Bridge between Nishinomiya-hama and Koshien-hama dropped from pier as shown in Photo 36. The quaywalls in front of the pier moved towards the sea about 2 meters as shown in Figure 17, and the ground behind the quaywall also moved towards the sea. The ground displacements in the neighborhood of the pier reached above 2 meters. It was reported by a committee of Japan Road Association²²⁾ that a large relative displacement between two neighboring piers, which was combinatorially caused by a permanent displacement of the concrete caisson foundation about 23 meters long due to liquefaction and a dynamic displacement due to the inertia force was the cause of the fall of the girder.

Photo 36 Steel girder of Nishinomiya-ko Bridge dropped due to liquefaction and inertia force (A in Figure 17)

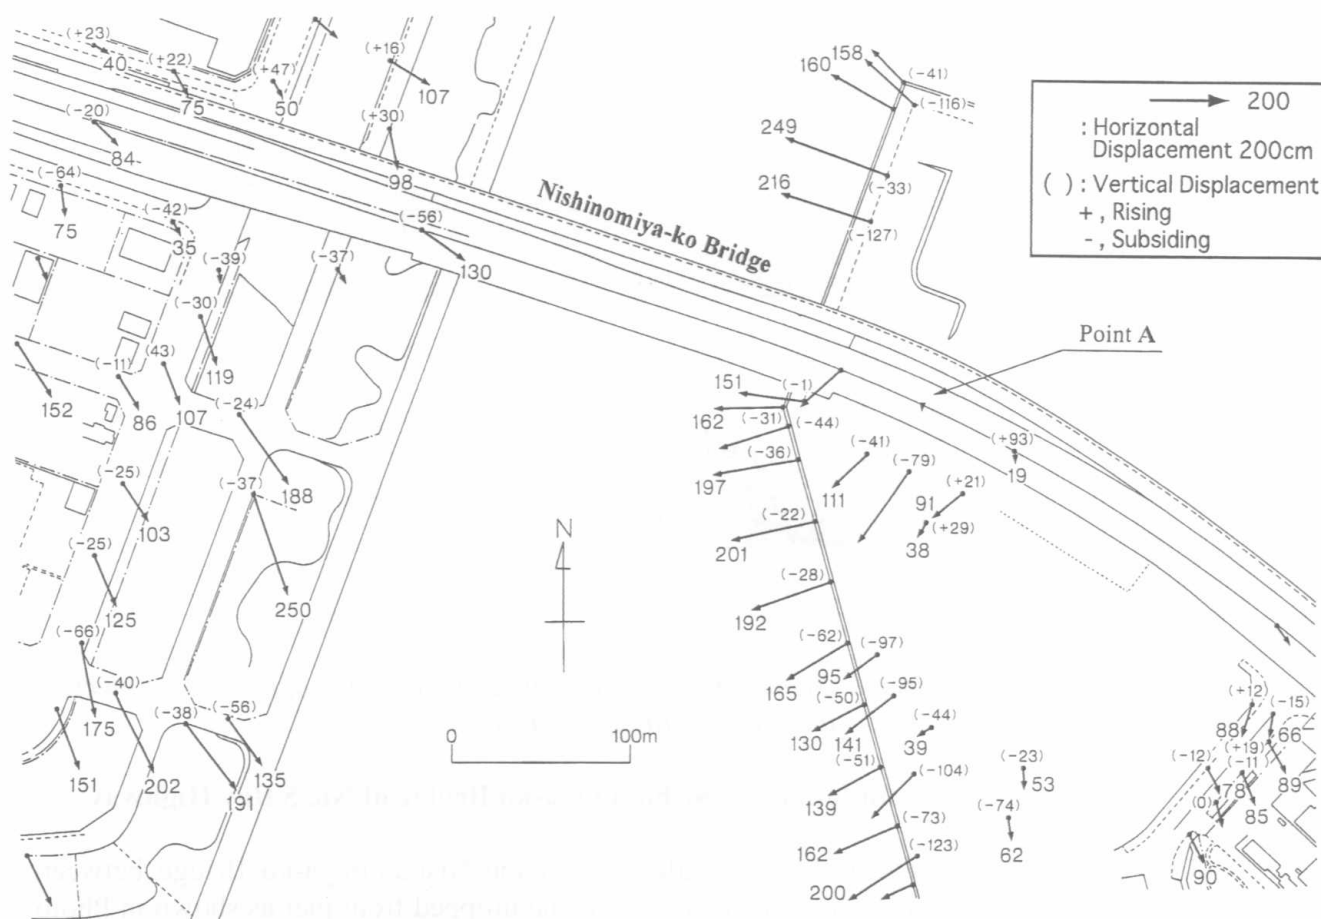
Figure 17. Liquefaction-induced ground displacement at Nishinomiya-ko Bridge¹⁾
