6.2 Lifeline Facilities

(1) Higashi-nada Sewage Treatment Plant

(2) Rupture of welded steel pipe for water trunk line

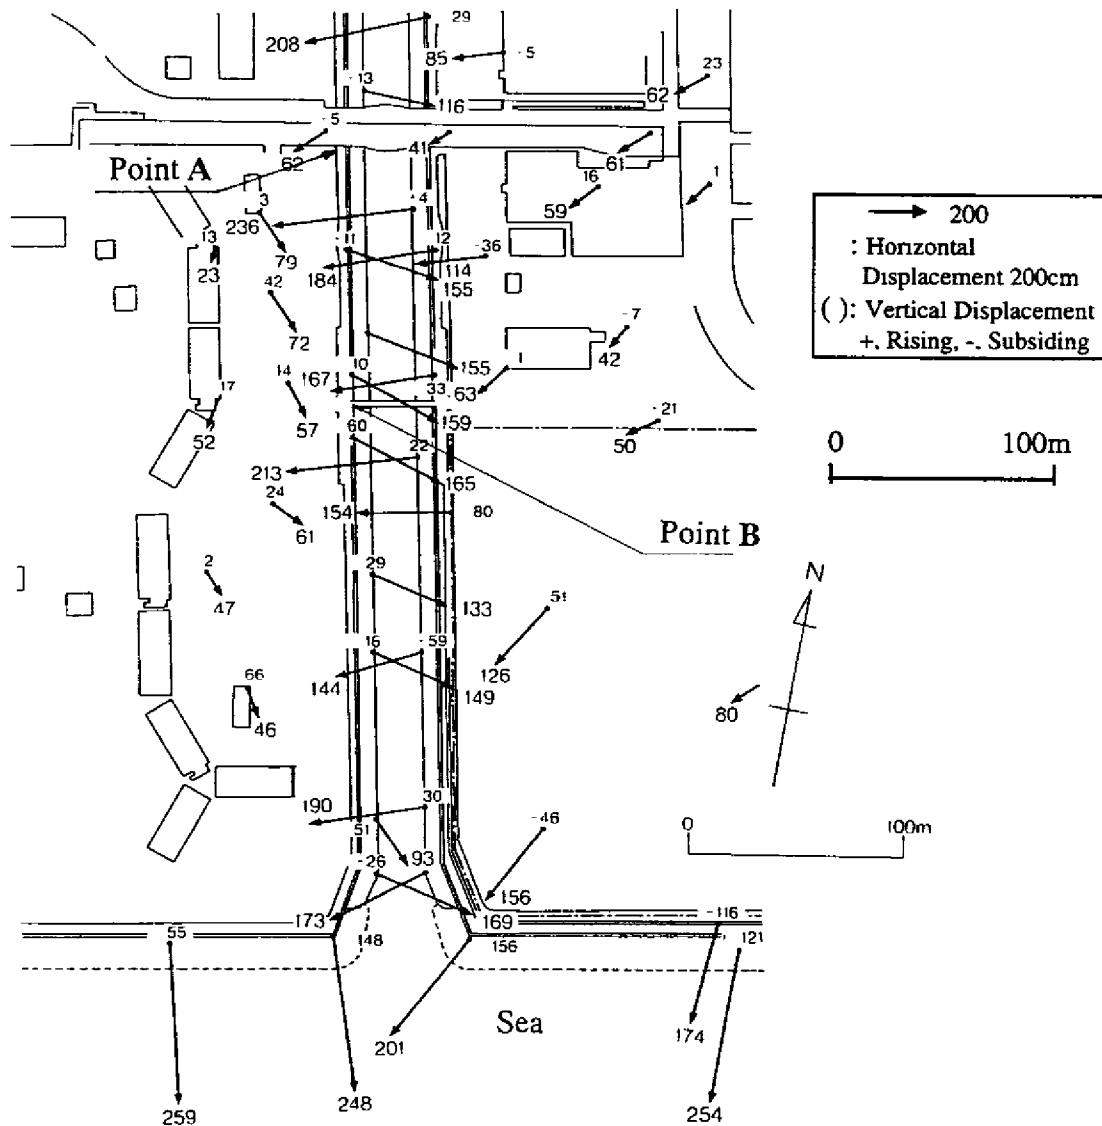
Figure 18. Liquefaction-induced ground displacement at southern end of Ashiya-hama¹⁾

meters. Photo 37 shows the damage to abutment of Miyagawa Bridge at Point B in Figure 18, and Photo 38 shows that a steel girder overlying the road on the river bank at Point B. These suggest that the riverbank moved towards the water. Photo 39 shows the riverbank after the earthquake, and it should be noted that the line of the riverbank was maintained mostly straight and did not collapse even after the large movement of about 2. It can be assumed therefore that the riverbank and non-liquefied ground moved towards the river on the underlying liquefied soil which flowed toward the river.

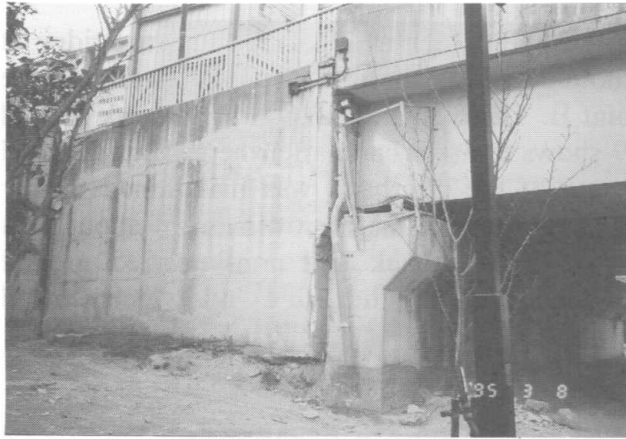
Photo 37 Abutment of Miyagawa Bridge moved and inclined due to ground movement toward the river (left) (A in Figure 18)

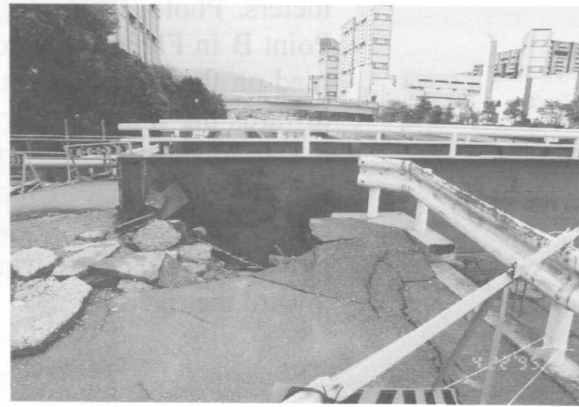
Photo 38 Movement of river bank at Ashiyahama (B in Figure 18)

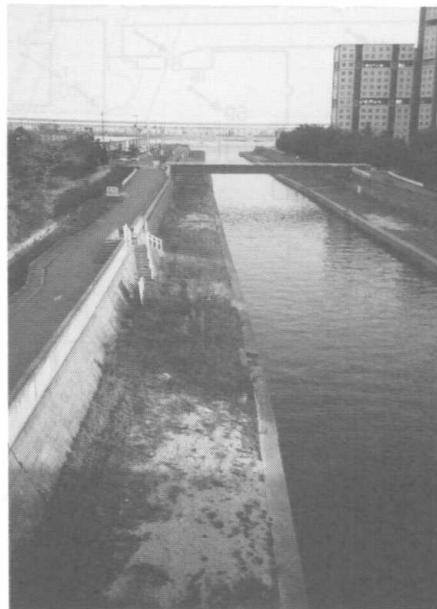
Photo 39 River bank after movement of ground at Ashiyahama

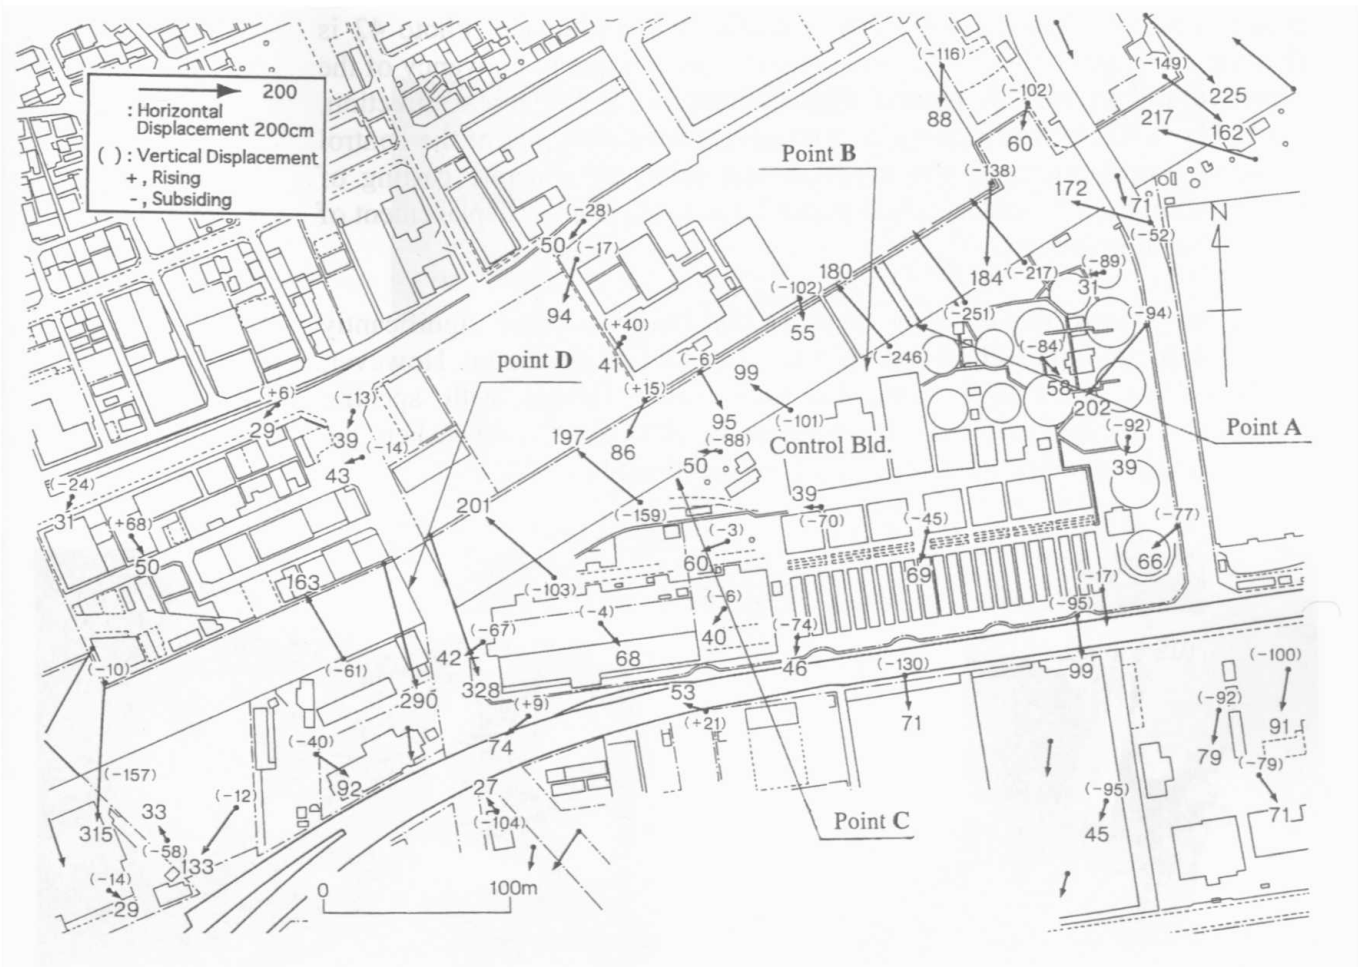
Figure 19. Plan of Higashinada Sewage Treatment Plant and ground displacements¹⁾

The Higashi-nada Sewage Treatment Plant locates in Uozaki-hama which was reclaimed from the sea, and suffered a severe liquefaction. Figure 19 shows the plan of the plant and distribution of ground displacements measured by aerial survey. The ground along a canal moved towards the water at a maximum about 3 meters. Photo 40 shows a concrete pier of a bridge crossing the canal inclined due to displacement of its foundation, where the top of the pier was restrained to move because of the rigidity of the bridge girder. Photo 41 also shows a similar example of evidences of the ground movement toward the canal. A concrete foundation of stairs up to a bridge crossing the canal was separated from the stairs due to ground displacement toward the canal.

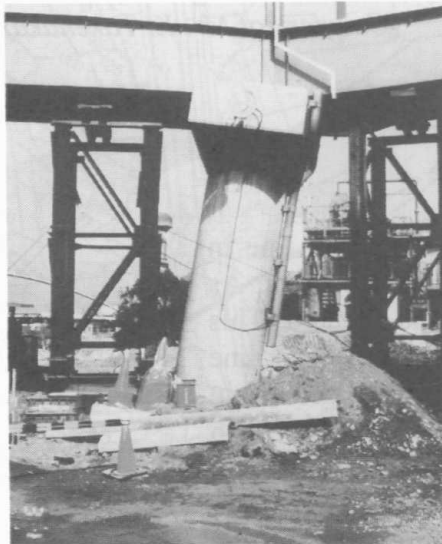
Photo 40 Inclined concrete pier due to ground displacement (A in Figure 19)

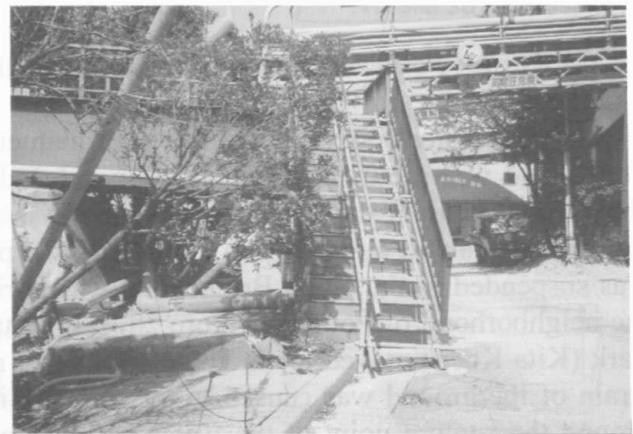
Photo 41 Separation between stairs of over-canal bridge and its concrete foundation due ground displacement toward the canal (left) (B in Figure 19)

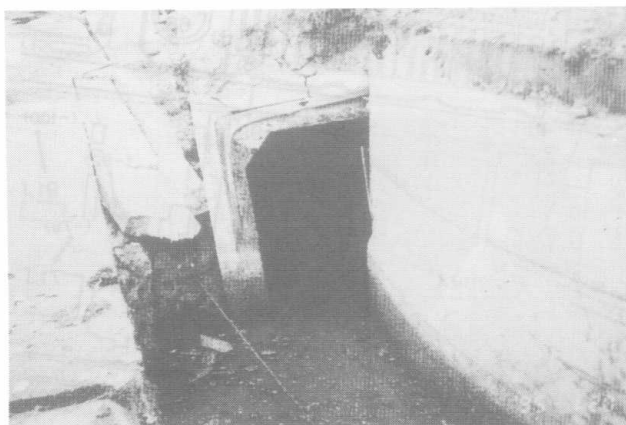
The sewage facilities in the plant suffered severe damage and the function of the plant was perfectly lost after the earthquake. Photo 42 is floating and separation of inground concrete conduit due to buoyancy of the liquefied soil as well as ground displacement in the horizontal direction, while Photo 43 shows breakage of a concrete foundation pile of the control building. Furthermore, it was reported that joints of concrete casting of precipitation basins were largely separated due to horizontal displacement of the surrounding ground.

Photo 42 Floating and separation of concrete conduit due to ground displacement (Courtesy of Mr. K. Takenaka, C in Figure 19)

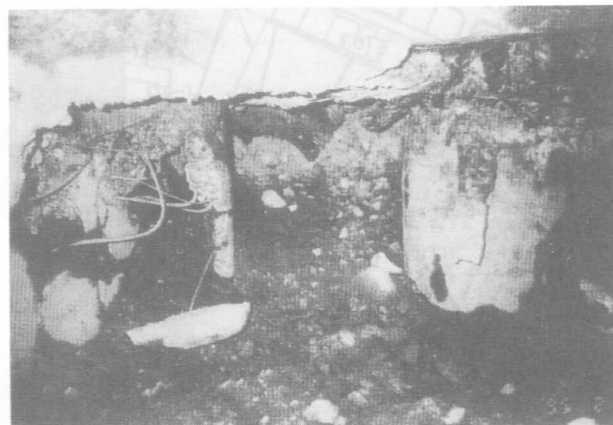
Photo 43 Breakage of foundation pile of the control building (Courtesy of Mr. K. Takenaka)

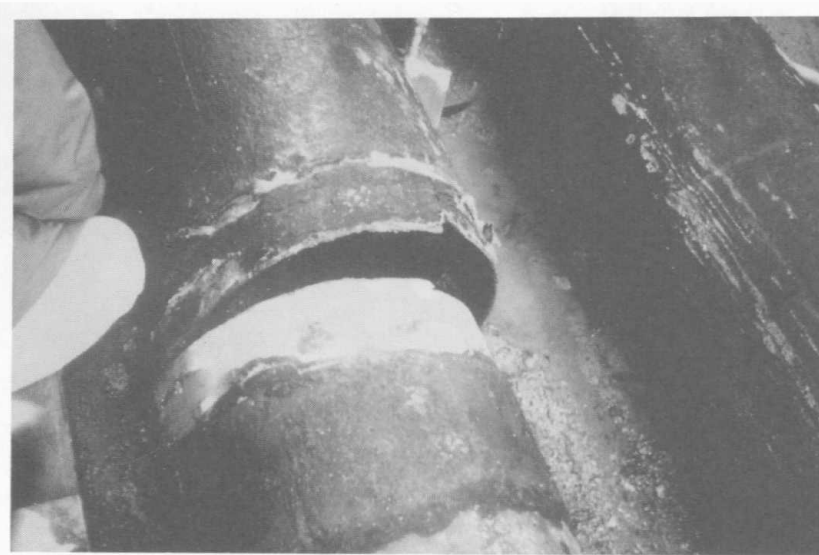
A welded steel pipe 60 centimeter in diameter for water trunk line in Port Island was ruptured by liquefaction-induced ground displacement. As shown in Photo 44, the pipe was horizontally separated and sheared. This rupture was caused at Point A in Figure 20. The pipe of the water trunk line was suspended in the Kobe Bridge, and was buried again in the ground in the neighborhood of Point A. Figure 20 shows that the ground of the North Park (Kita Koen) moved towards the sea over 4 meters, and a large tensile strain of the ground was caused. As shown in Figure 20 the ground strain around the rupture point of the water pipe, which was estimated from the measured ground strain is 2.5 % in tensile. This large ground strain can be considered as a direct cause of the rupture of the pipe.

Photo 44 Rupture of welded steel water pipe (A in Figure 20)
