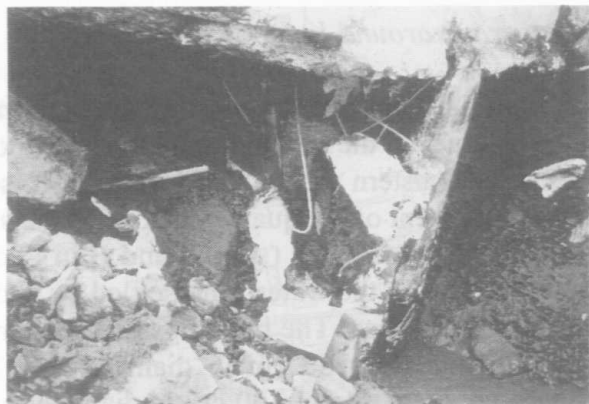
of 40 cm from the head on the opposite side. An integrity sonic test was then carried out for six piles, which indicated that one of the seaside piles was also damaged at a depth of 7-8 meters. The location of the damage is middle part of the fill.

*Photo 49 Failure of pile head due to lateral ground movement*

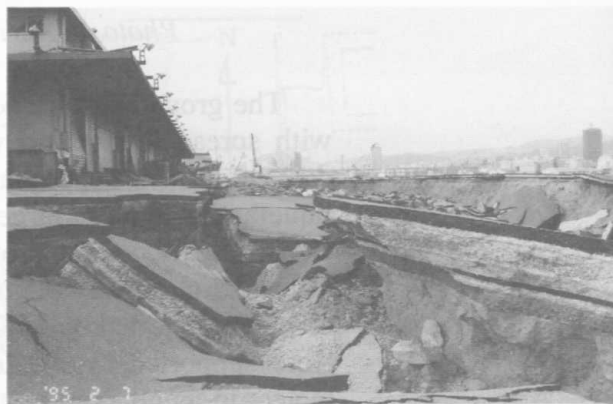
At point C in Figure 20, a warehouse which was supported by precast concrete piles in diameter 60 cm suffered a horizontal separation of 2.5 meters between its basement and the surrounding ground due to ground movement toward the sea. Furthermore, the ground in front of the warehouse subsided as shown in Photo 50. Exposed pile head showed that it had failed vertically as well as horizontally as shown in Photos 51 and 52. In addition, the pile heads separated from the pile caps sand were displaced due to ground movement toward the sea. The quaywalls north of the warehouse moved about 4 meters as shown in Figure 20 and the building slid by 1 meters by the movement. This implies that the primary cause of the damage was lateral ground displacement induced by liquefaction. A building at Point D in Figure 20, the distance of which from quaywall was about 100 meters also suffered damage to its foundation piles due to the ground displacements.

*Photo 50 Large cracks and settlement of the ground behind quaywall due to lateral movement of the ground toward the sea (right)*

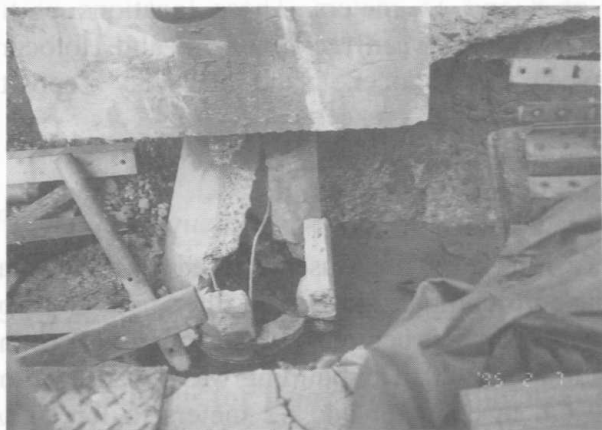
*Photo 51 Failure of pile due to ground displacement (C in Figure 20)*

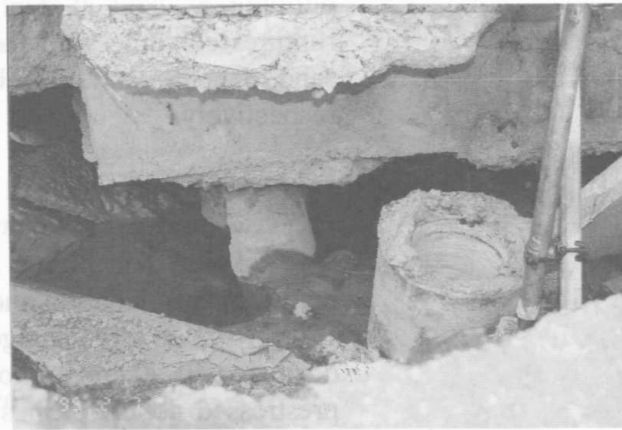
*Photo 52 Separation of pile head due to ground movement (C in Figure 20)*

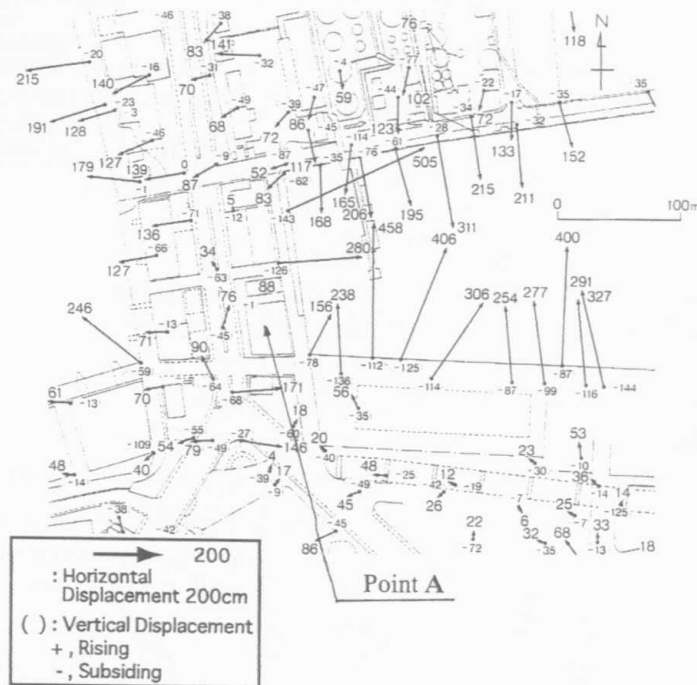
At eastside of the entrance of Maya Wharf, the shoreline was largely curved due to the ground movement toward the sea, as shown in Photo 53. Figure 23 shows the ground displacement of the northern part of Maya Wharf, indicating that the quaywalls displaced eastward at a maximum about five meters. Pile heads of a 3-story building which located at Point A in the figure were exposed after the large ground settlement and found to be failed completely near the heads with slight lean toward the sea (Photo 54). Aerial survey shown in Figure 25 shows that quaywall in front of the building displaced about 3 meters toward the sea.

Figure 23. Liquefaction-induced ground displacement at northern part of Maya Wharf<sup>d)</sup>

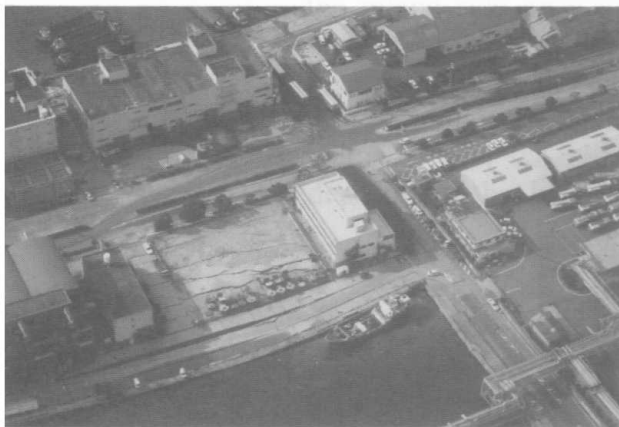
Photo 53 Curved quaywall along due to lateral ground movement toward the sea at road for Maya Wharf

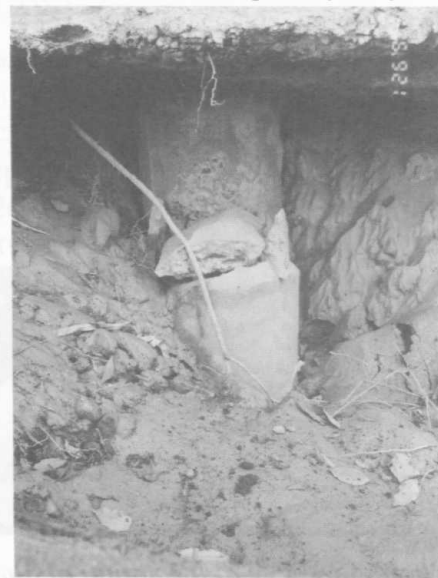
Photo 54 Concrete pile breakage due to ground movement (A in Figure 23)

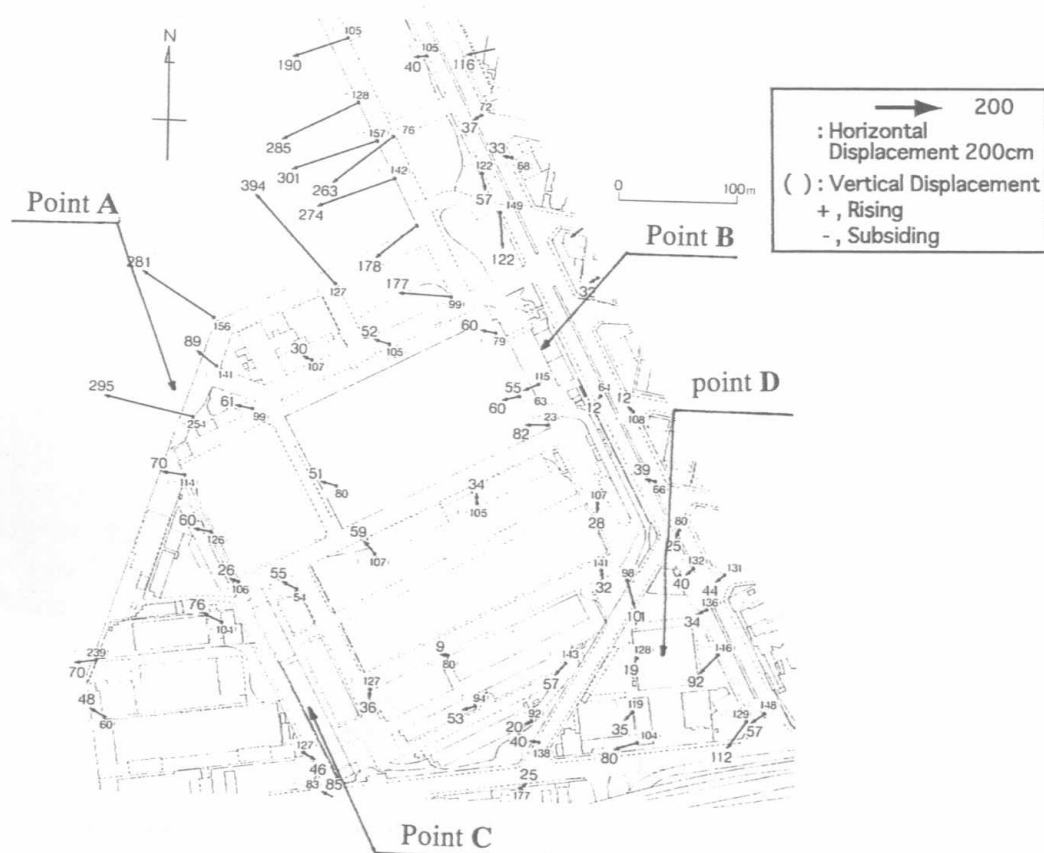
A Kobe city facility locates northwestern part of Fukae-hama, facing to the sea on the north and west sides. Horizontal ground displacement of 3-4 meters occurred toward the sea along the seawalls as shown in Figure 24 and Photo 55. In the site, there existed 35 buildings at the time of the earthquake, which had been gradually constructed since 1969. Fifteen were supported by point bearing steel pipe piles, one by precast concrete pile and the others by spread foundations.

Figure 24. Liquefaction induced ground displacement at northwestern part of Fukae-hama<sup>1)</sup>

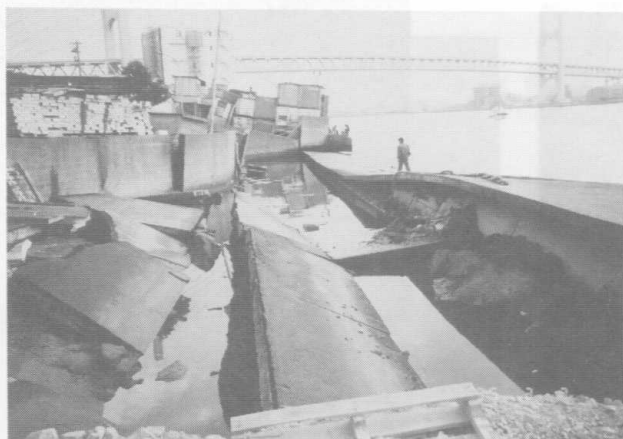
Photo 55 Large deformation of quaywall and ground behind the wall (A in Figure 24)
