(6) Nishinomiya Municipal High School

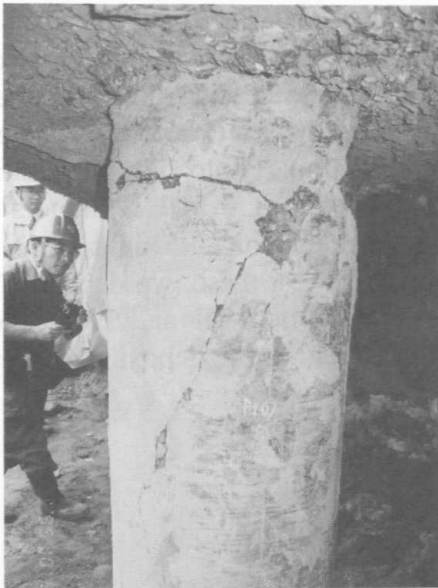
Photo 56 Failure of concrete pile on the sea side (Courtesy of Dr. H. Kiku)

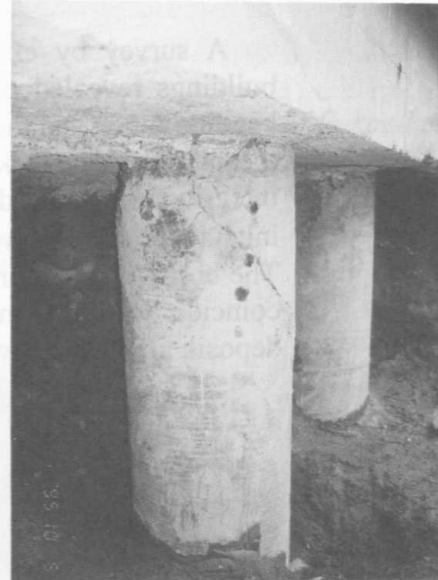
Photo 57 Cracks of concrete pile of the inland side (Courtesy of Dr. H. Kiku)

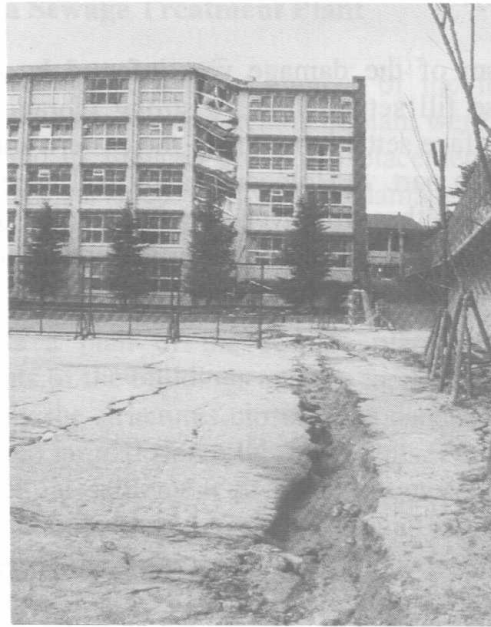
The school is located on a small valley between Pleistocene terrace, 4 km from coastline. Many ground fissures occurred with sand boils in the playground. A large fissure ran with vertical gap slanted to the west, underneath a school building. Consequently, the building, supported by prestressed concrete piles 35 cm in diameter and about 8 meters in length, collapsed at eastern three columns of the ground floor and beams in the eastern third span of all of the floors, as shown Photo 58 and Figure 27. In addition, the western part of the building settled about 10 cm due to ground subsidence.

Photo 58 Collapsed school building due to lateral ground movement

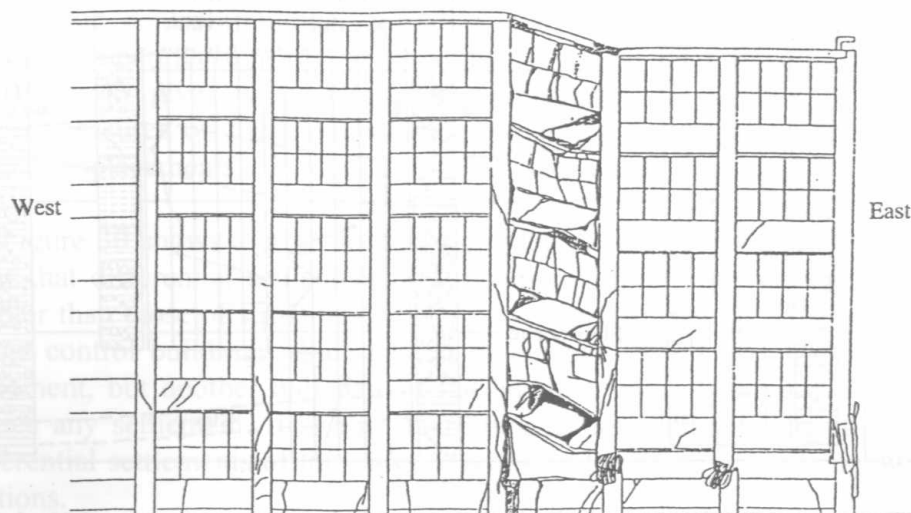
Figure 27. Schematic Figure of damaged buildings²⁵⁾

The mechanism of the damage was inferred by Nishida et al.²⁵⁾ as follows: The loose fill settled first by strong vibration; at this stage, the western ground surface settled more than the eastern surface because the fill is thicker in western part. A Holocene sandy soil beneath the fill liquefied and slid westward together with overlying fill, leading to the cracks of piles. The superstructure also displaced both vertically and horizontally, resulting in the failures of the beam and the columns.

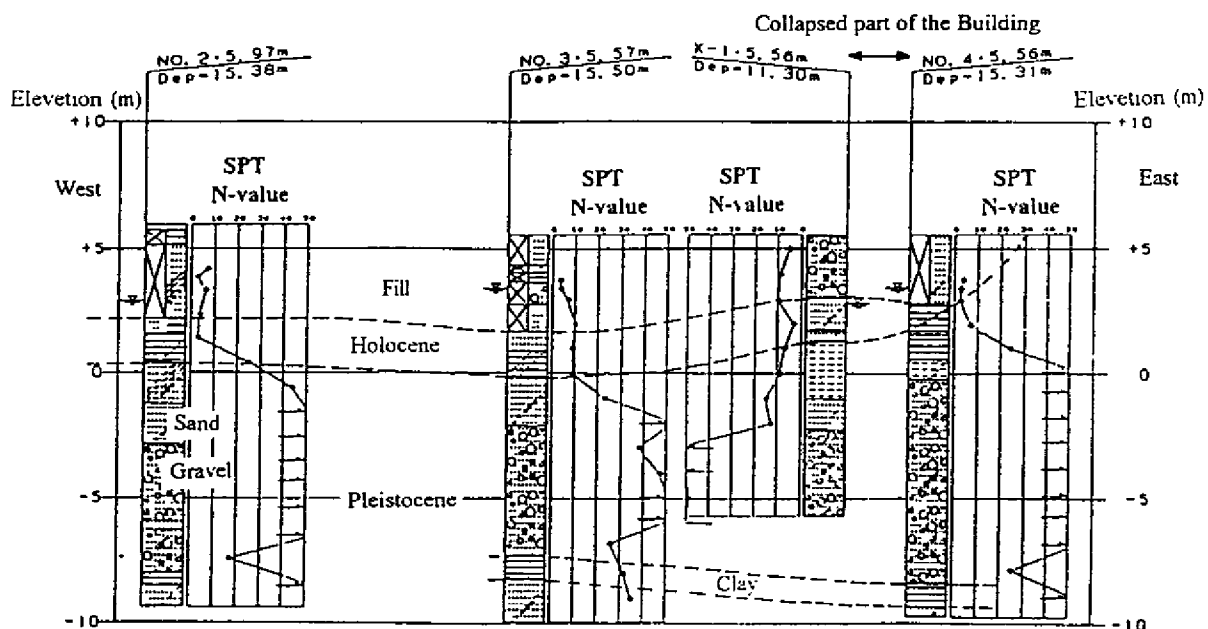
Figure 28. Soil profile at Nishmomiya Municipal High School²⁵⁾

The site had been a pond filled about 30 years ago and the ground surface is gently inclined toward the south (coastline). Figure 28 shows a soil profile along a line in the east-west direction in front of the building. A fill down to depth of 2-3 meters overlies a 1-2 meters thick deposits of the pond bottom and Holocene sandy soils, which, in turn, alternate layers of Pleistocene marine clay and fluvial gravel of Osaka Group. The water table is about 3 meters deep. A survey by excavation of the upper portion of eight piles under collapsed columns revealed that a saturated loose sand layer was found at the depth of about 3 meters from the ground surface²⁵⁾. All of the piles cracked horizontally near the heads and leaned toward the southeast, namely downward. One of them was completely cracked horizontally at a depth of 3.1 meters from the ground surface. An integrity sonic test indicated that cracks also occurred at a depth of 5.7 meters from the ground surface. These depths of the cracks coincide with the interface between Holocene sand and Pleistocene silt, and that between the Pleistocene silt and gravel, respectively.
