7. CASE STUDIES ON EFFECTIVE COUNTERMEASURES OF FOUNDATIONS AGAINST LIQUEFACTION AND LARGE GROUND DISPLACEMENT

7.1 Foundations of Facilities of Sewage Plant

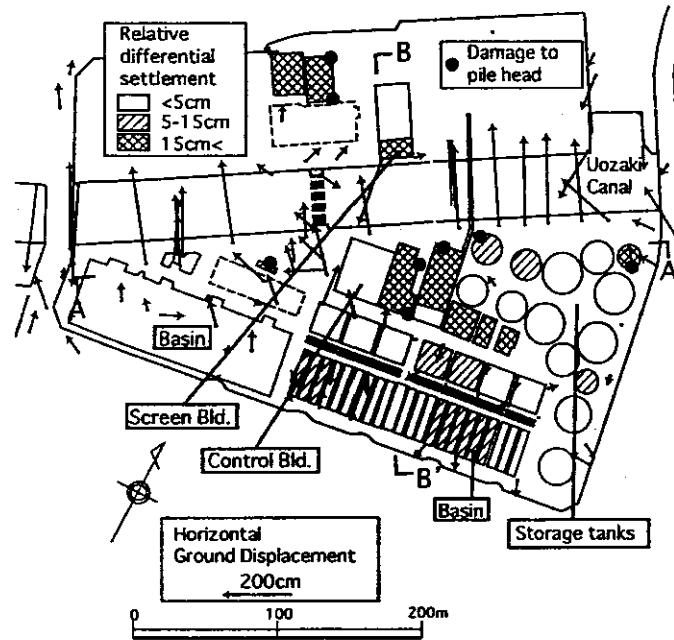
Figure 29 shows a plan of the sewage plant, and three ranks of differential settlements of the buildings and the facilities of the plant. It can be found that not only the structures close to the canal but also those away from the canal suffered large differential settlements. Furthermore, it should be noted that differential settlement of some structures located along the canal is very small, although the surrounding ground largely moved towards the canal. It seems that the distance of a building from the canal did not have a direct influence to the degree of differential settlements. For an example, differential settlement of the storage tanks located in northern-east corner of the plant varies into three ranks. It is also noteworthy that a half part of the control building caused a large differential settlement, but another half part hardly suffered any settlements. The result shown in Figure 30 seems to give us an instructive information to consider effective countermeasures of foundations against liquefaction and its caused large ground displacements.

Figure 29. Plan of Higashinada Sewage Treatment Plant showing ranks of differential settlement and horizontal ground displacement

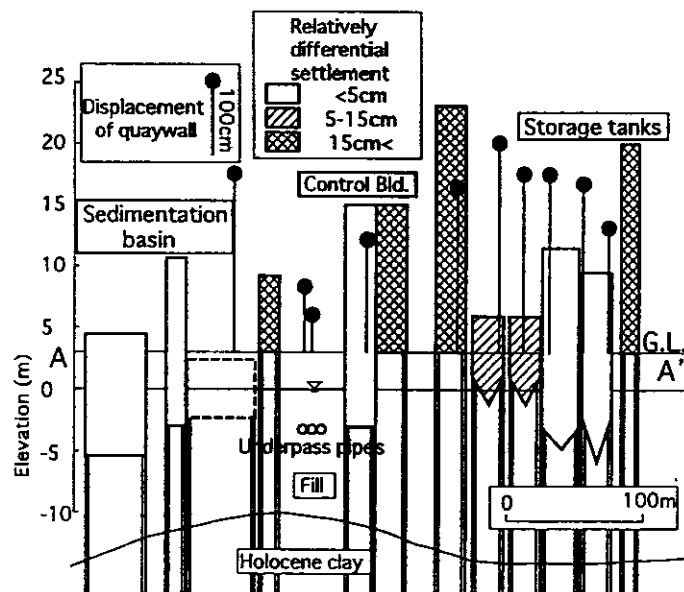
Figure 30 shows a cross section along the A-A' line in Figure 29. It is clear that differential settlement of structures with an inground portion is smaller than those of structures without any inground portion. The half part of the control building, which has no basement suffered large differential settlement, but another half part of the building with a basement did not induce any settlement. It is also interesting to note that the magnitude of differential settlements of the tanks depends on the depth of their inground portions.

Figure 30. Depth of foundations and ranks of differential settlement of structures along A-A' line

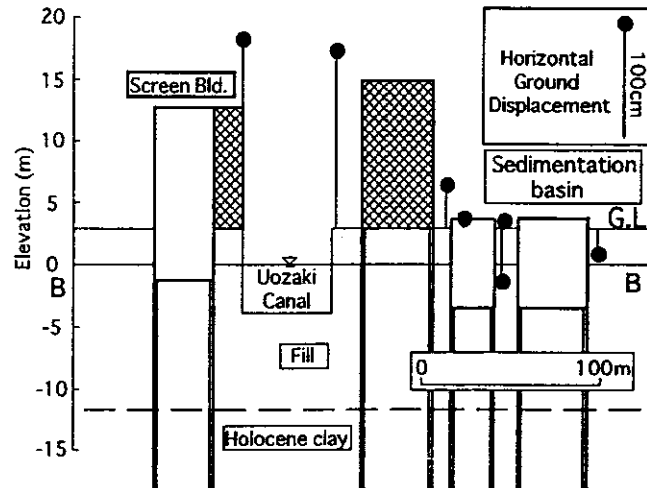
Figure 31 is a cross-section along B-B' line in Figure 29. This figure also shows that the scale of differential settlement is depended on the depth of inground portion of structures. A building (Screen Building in Figure 31) along the canal consists of two parts. A large differential settlement above 15 cm was observed in a part without any basement, while no differential settlement was found in another part with a basement.

Figure 31. Depth of foundations and ranks of differential settlement of structures along B-B' line

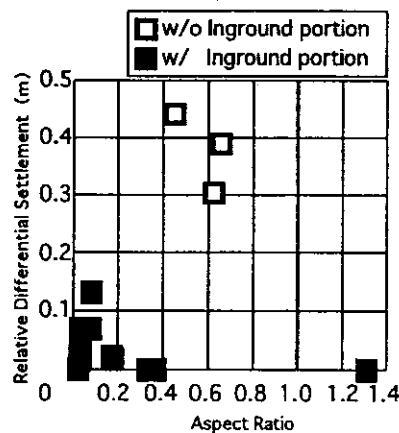
where, A and h are area of foundation and height of structure, respectively. The result in Figure 32 also clearly illustrates that the existence of the inground portion has a great influence to reduce differential settlements of the structures.

Figure 32. Relationship between differential settlement of structure and aspect ratio

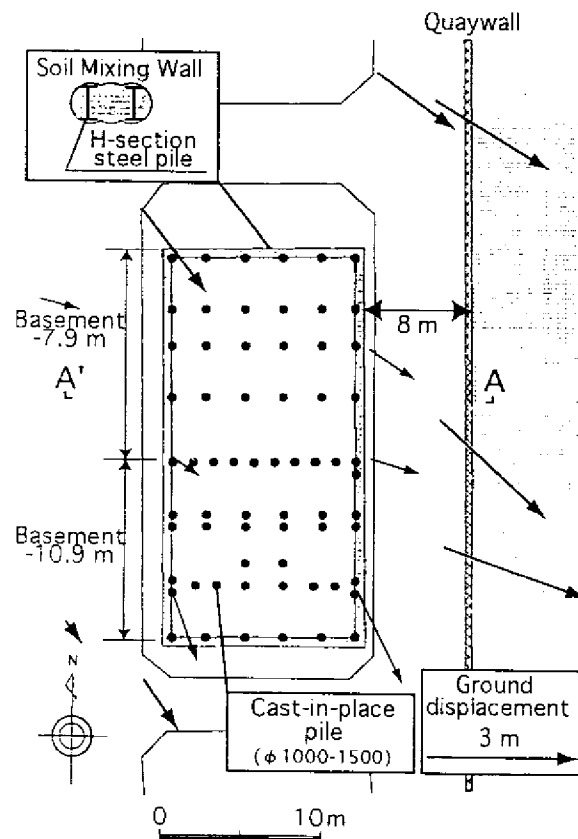
The Shimagami pumping station located along a shoreline at Nagata ward in Kobe City. The distance of the building from the quaywall is only 8 meters. As shown in Figure 33 the quaywall moved towards the sea at a maximum about 3 meters, and consequently the ground behind the quaywall displaced toward the sea. However, the building of the pumping station with a height of about 16 m hardly suffered any damage, besides the surrounding ground subsided more than 1.0 meter. This building has a basement about 8 m deep for northern half of the building and about 11 m for southern half, and is supported by cast-in-place concrete piles of diameters of 1.0-1.5 meters as shown in Figure 34. An inground wall, named as SMW (Soil Mixing Wall), with a width of 45 cm, was built for the excavation of the basement. This inground wall remained after the construction of the building and surrounded the concrete piles. It can be guessed that the existence of the inground wall had a great influence to prevent damage to the foundation piles, in addition to the existence of the basement.

Figure 33. Plan of Shimagami Pumping Station and liquefaction-induced ground displacement

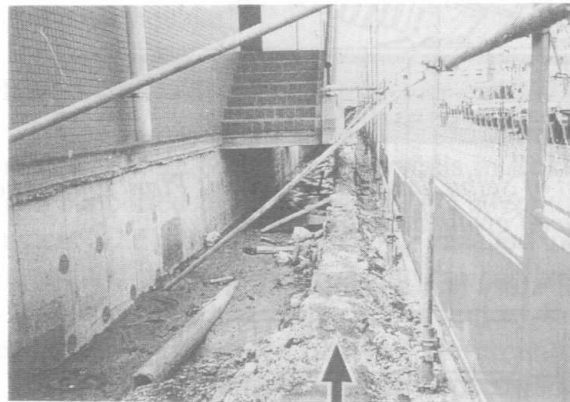
The liquefaction around the building caused a large settlement of the ground surface. Photo 59 shows ground subsidence and top of the inground wall, which appeared after the earthquake.

Photo 59 Inground wall of Shimagami Pumping Station, which appeared after the earthquake due to ground subsidence

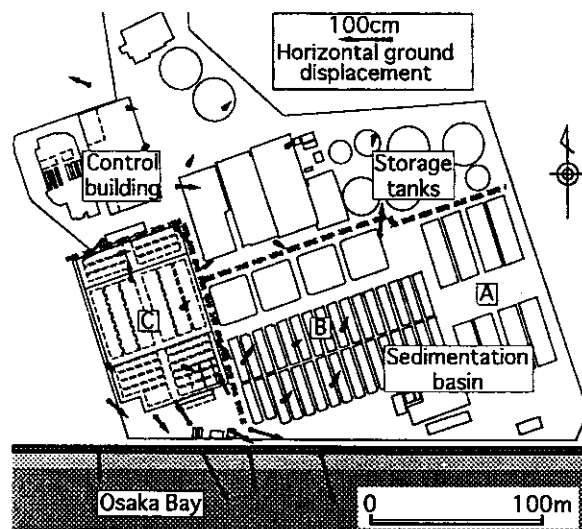
The Seibu Sewage Treatment Plant locates at Nagata Port in Kobe City. Figure 35 shows a plan of the plant, which was constructed on a ground reclaimed from the sea and the depth of the reclamation is about 10 meters. The plant has three sedimentation basins as shown in Figure 35. In two among them (A and B in the figure) large separations were observed at concrete casting joints after the earthquake, but any damage could not be found in another basin (C). This basin was constructed closely to quaywalls, and the quaywalls moved toward the sea about 2 meters during the earthquake.

Figure 35. Plan of Seibu Sewage Treatment Plant and liquefaction induced ground displacement

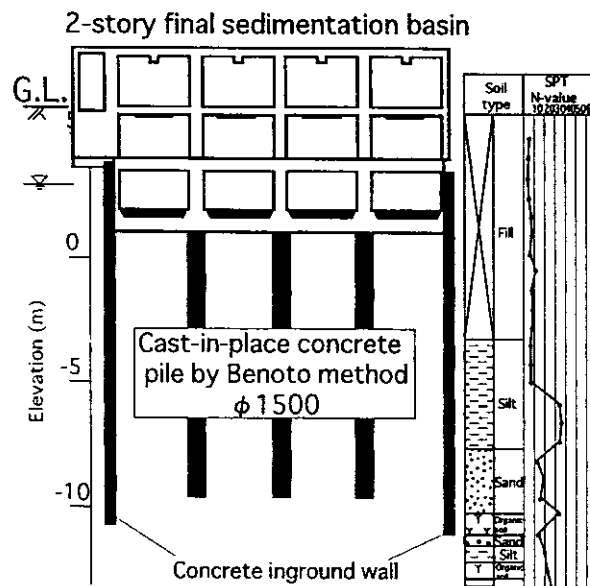
As shown in Figure 36, the above ground portion of the structure is used for an office floor, and the basement has two stories, about 6 meters deep, much deeper than that of another two basins. Furthermore, a concrete inground wall, originally built for the excavation of the basin, had remained after the construction and had been used for a part of the foundation of the basin, in addition to cast-in-place concrete piles with a diameter of 1.5 meters. The soil for the reclamation is very soft, N-value of which below 10, and is assumed to have liquefied during the earthquake.

Figure 36. Structure of foundation of sedimentation basin (c)

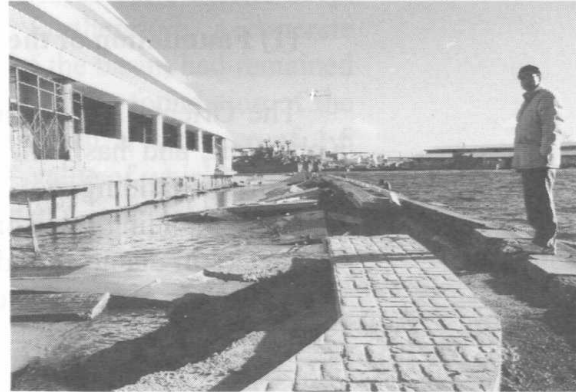
The Oriental Hotel shown in Photo 60 located on the Central Pier of Kobe Port, and has 60m height above ground surface. The quaywalls in front of the building moved towards the sea and subsided shown Photo 61. The hotel building was constructed on cast-in-place concrete piles of about 1.0 meters in diameter and about 30 meters in length. The thickness of the reclamation is about 12 meters and the foundation piles reached into a firm Pleistocene gravel layer.

Photo 61 Ground in front of the hotel moved towards the sea and subsided

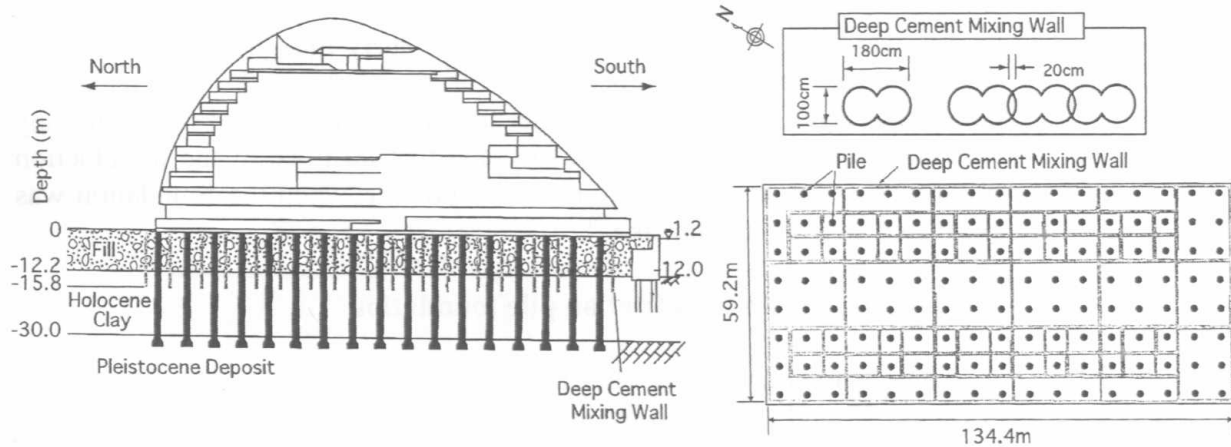
It was reported that at the stage of the structural design of this building, lateral flow of the liquefiable soil beneath the building towards the sea was considered to seriously affect the stability of the building²⁶⁾. Therefore, inground walls was designed and constructed to avoid the lateral flow of foundation ground. As shown in Figure 37, the inground walls, consisted of continuous cast-in-place piles of 1.0 meters in diameter and 12-19 meters in length, were constructed by mixing cement slurry into the ground, and the wall reached into non-liquefiable soil layer through the reclaimed liquefiable layer. It was reported that this hotel building did not suffer any structural damage and any settlement, and that no trace of the liquefaction was found on ground surface under the building, when the foundation was excavated after the earthquake²⁶⁾.

Figure 37. Section and plan of foundation of Oriental Hotel

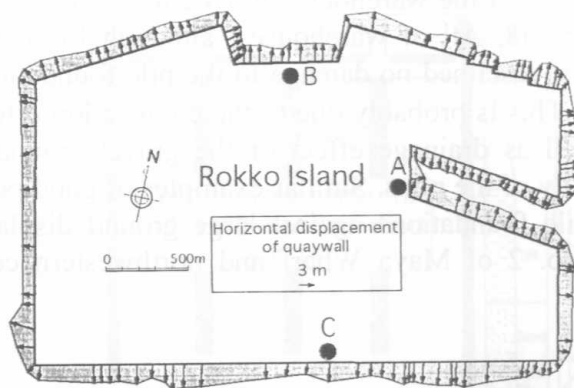
Three warehouses were built near quaywalls in Rokko Island as shown in Figure 38 and supported by prestressed high strength concrete piles 40-50 cm in diameters. The piles 12 meters long installed into drilled holes and bounded to the ground by casting gravel into the gap between the piles and the drilled holes. The piles had many nodes and as shown in Figure 39, which induced large friction force between the ground (so-called nodular friction pile). During the earthquake sand boils occurred nearby ground and the quaywalls in front of the warehouses moved horizontally by 3-4 meters as shown in Figure 38. All of warehouses, although located about 30 m from the quaywalls, sustained no damage to the pile foundations as well as super structures²⁷⁾. This is probably due to the compaction effect during the pile driving as well as drainage effect of the gravel around the piles in addition to flexibility of the piles. Similar examples of good performance of nodular friction pile foundations against large ground displacement were reported at Pier No. 2 of Maya Wharf and northwestern corner of Port Island²⁷⁾.

Figure 38. Map of Rokko Island showing displacement of quaywalls and locations of the warehouses
