# **SEISMIC CAPACITY OF REINFORCED CONCRETE BUILDINGS DAMAGED BY 1995 HYOGOKEN-NAMBU EARTHQUAKE**

## **1. INTRODUCTION**

## **2. INVESTIGATED BUILDINGS AND THEIR DAMAGE LEVELS**

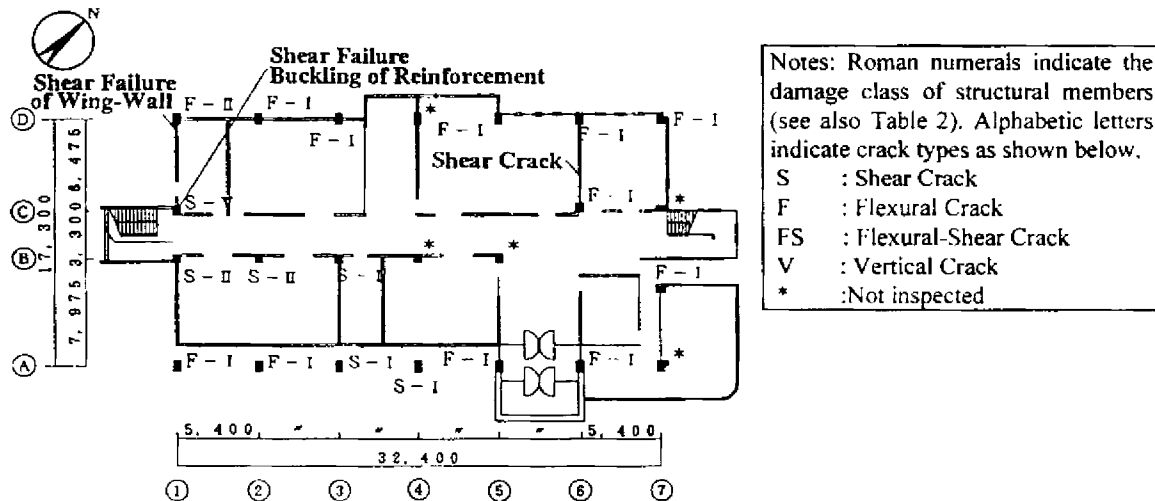
Figure 2.1. Midori-cho Civic Center (First Story)

Damage in the first story is shown in Figure 2.1. This building was a three story reinforced concrete building constructed in 1977. The structure consisted of reinforced concrete frames and a few shear walls in the longitudinal and transverse direction. This building had a reinforced concrete pile foundation.

Remarkable damage was observed in frame 1 in the first story and the staircase connected with frame 1. A column at C-1 sustained severe shear failure with exposed and buckled reinforcement and was categorized in Class V. A wing-wall provided between frames C and D showed shear failure with concrete crush and exposed reinforcement. Slight flexural-shear failures categorized in Class I were observed in many columns of the first story. The damage level of the entire building defined by D-index was "moderate". It should be noted, however, that judging from the field survey the damage level should be identified "light", because the severe damage to the building was localized.

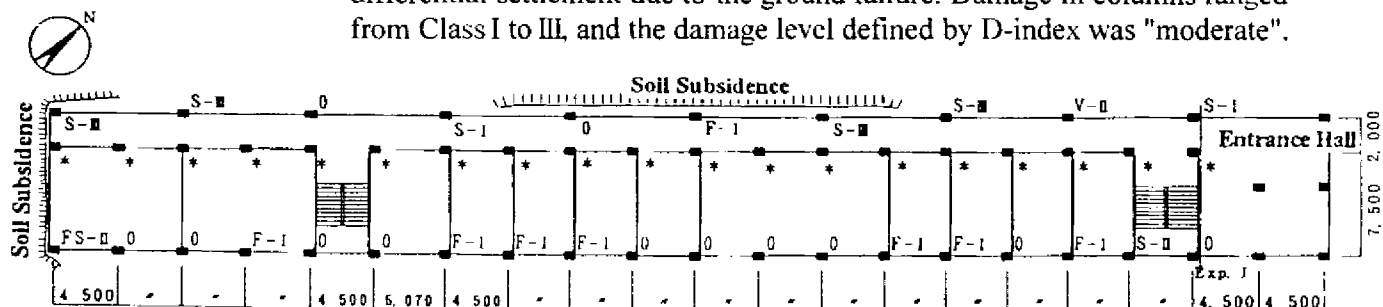
Figure 2.2. Hokudanhigashi Middle School (First Story)

Damage in the first story is shown in Figure 2.2. The building was a four story reinforced concrete building constructed in 1963. Shear walls were provided only in the transverse direction.

Ground failure was observed around the school. Spandrel walls and columns of the north-west frame sustained cracks that might be caused by differential settlement due to the ground failure. Damage in columns ranged from Class I to III, and the damage level defined by D-index was "moderate".

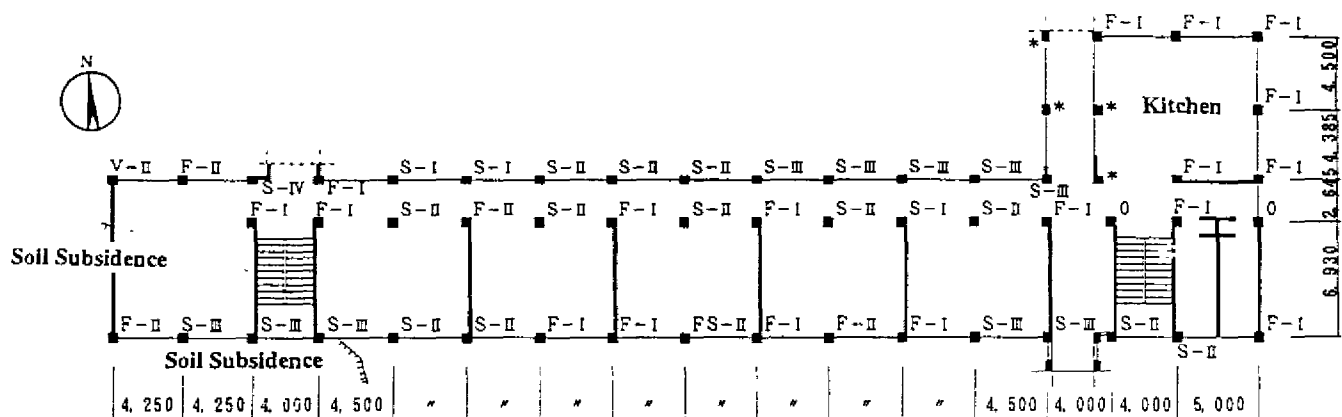
Figure 2.3. Higashiura Middle School (First Story of Building-B)

Damage in the first story is shown in Figures 2.3 and 2.4. The school consisted of three buildings referred to as Building-A, -B and -C. These three buildings were three story reinforced concrete buildings constructed in 1967 and located in parallel on a hill. Each building had shear walls in the transverse direction. Building-B and -C were partially placed on the refilled soil above the slope and more severely damaged while building-A had few damage. The outline of damage to Building-B and -C is as follows.

- 1) Building-B: Differential settlement caused by soil damage was observed in four spans of the west zone located on the refilled soil. Columns in the first and second story had many shear cracks due to differential settlement, and the damage level defined by D-index was "moderate".
- 2) Building-C: Soil subsidence was observed in the south-west zone of the building. One span of the west frame tilted about 1 to 2 degrees. Remarkable damage was generally observed in columns of the first story. Many columns in the south and north frame were shaken and failed in shear and resulted in Damage Class V. The damage level defined by D-index was "collapse".

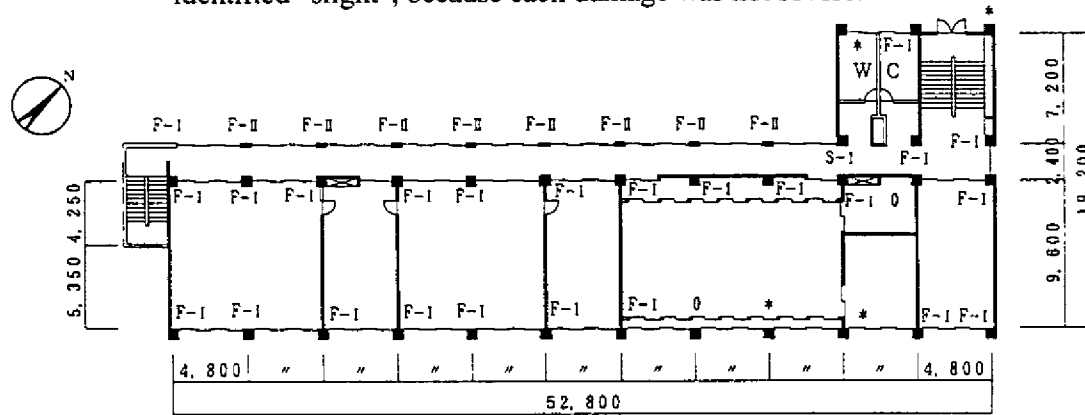
Figure 2.5. Awaji Agriculture High School (Third Story of Farm Management Building)

Damage in the third story is shown in Figure 2.5. This building was a three story reinforced concrete building constructed in 1984. Shear walls were provided mainly in the transverse direction.

Minor damage to the building was observed in columns of each story. The damage level defined by D-index was "moderate". It should be noted, however, that judging from the field survey the damage level should be identified "slight", because each damage was not severe.

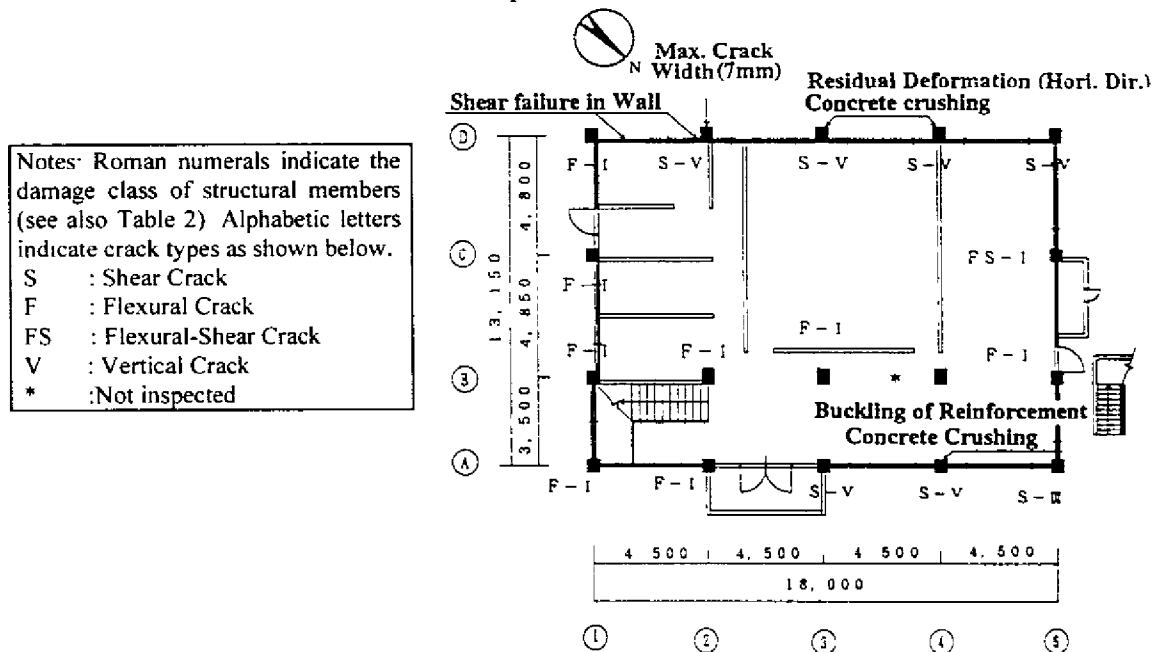
Figure 2.6. Ichinomiya-cho Civic Center (First Story)

Damage in the first story is shown in Figure 2.6. This building was a three story reinforced concrete building constructed in 1969. Shear walls were provided in the transverse and longitudinal direction. This building had a reinforced concrete pile foundation.

Major damage to this building was generally observed in the first story, and many columns in the first story sustained severe shear failures or shear cracks. In particular, six columns in the exterior frames without shear walls failed in shear and were categorized in Class V. Columns at D-3 and D-4 had severe shear failures and the residual horizontal deformation was observed. The column at A-3 suffered from shear failure, concrete crushed and reinforcement was exposed. The damage level defined by D-index was "collapse".

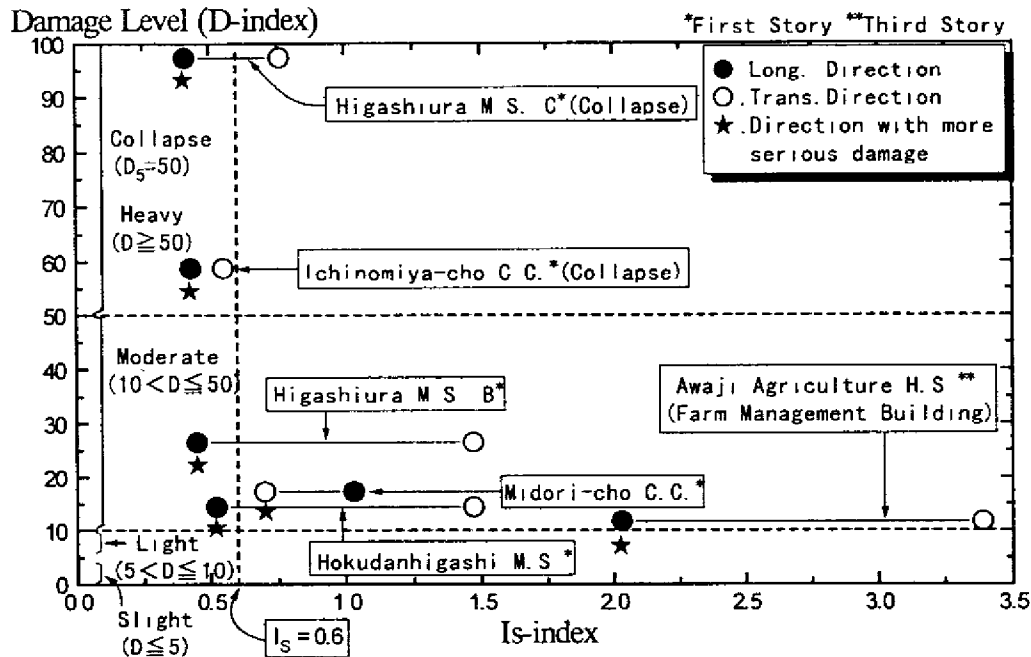
Figure 3. Correlation between Is-index and Damage Level

The correlation between Is-index and the damage level (D-index) is shown in Figure 3. Figure 4 shows the correlation between D-index and the construction year of six buildings described in this paper, together with other surveyed buildings in Awaji-Island. From the figures, the following findings can be obtained.

- 1) Excluding Midori-cho Civic Center which had a few shear walls in the longitudinal direction, the seismic capacity in the transverse direction is significantly higher than that in the longitudinal direction, because shear walls in the transverse direction were more provided than in the longitudinal direction (Figure 3).

- 2) Judging from the correlation between the seismic capacity index and the damage level, buildings with higher seismic capacity had less damage. If the damage levels of Midori-cho Civic Center and Awaji Agriculture High School (Farm Management Building) identified by the authors were taken into account, the boundary to avoid serious damage during this event in this district may be around 0.6 in terms of Is-index (Figure 3).

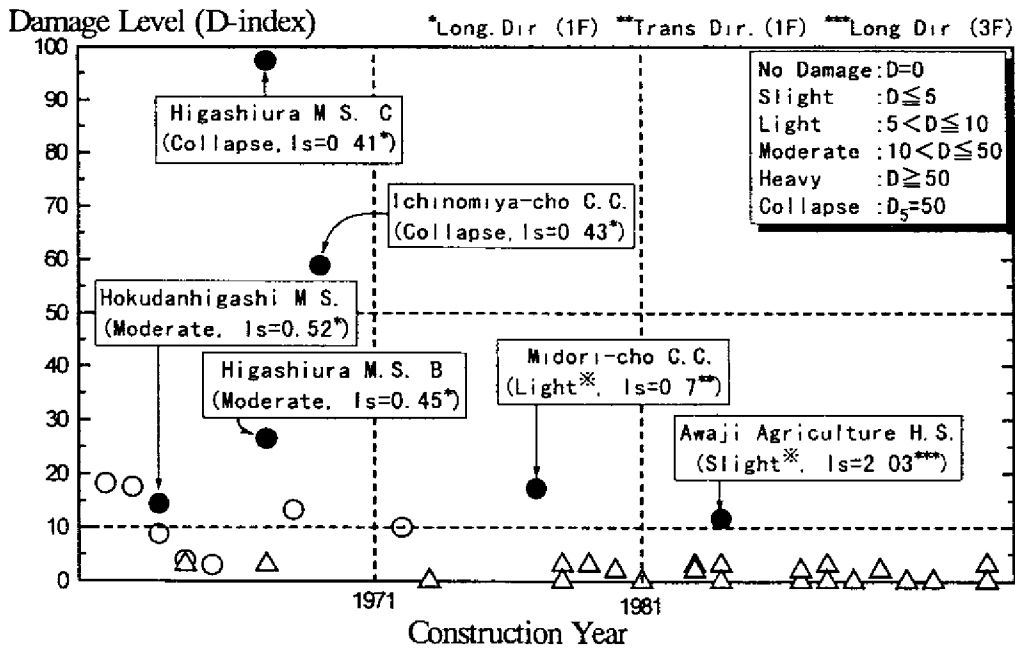
Figure 4. Correlation between Damage Level and Construction Year (Awaji-Island)

- 3) Is-indices of buildings constructed before 1971 were significantly lower and sustained more serious damage than those constructed after 1971. This result can be attributed to the improvement of the shear design due to the code revision in 1971 (Figure 4).
