#### Industrial Structures

#### Gujarat Cyclone

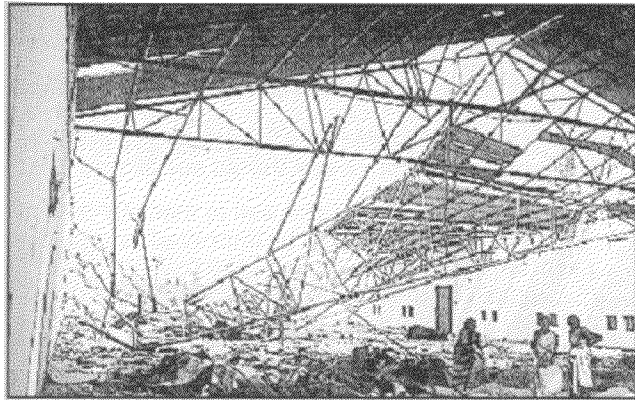
Fig 4 : Damage to a Storage Godown

these openings into the "near empty" godowns has given rise to the build-up of uplift and high unprecedented internal pressure, which caused the collapse of the gable end wall including its RCC columns and roof truss system including its cladding (Fig. 4). Openings in the wall, allowing the gusty wind to enter, insufficient cover to reinforcement in the columns of the gable wall, main rods in the columns placed in the normal to wind direction and lapping of more than 50 per cent of rods at the same point are some of the reasons for the failure of the building.

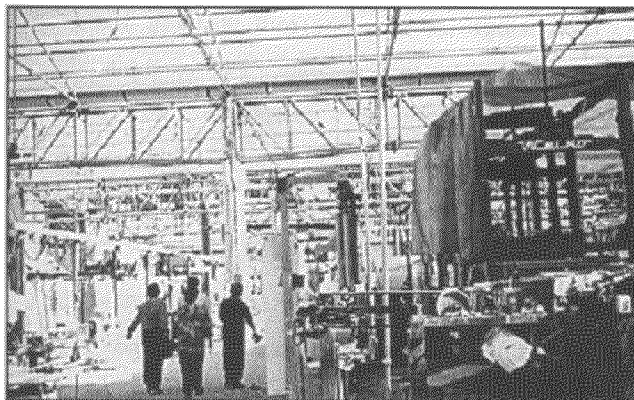
Most of the Industrial structures are provided with A.C sheet roofing and also failure of such roofs are very common during cyclones, due to their inadequate strength to resist uplift force and to debris attack, poor connection details and also due to their low fatigue strength owing to their material brittleness. The complete A.C. Sheet roof cladding of a big industry shed of size 80m x 160m had failed due to the debris impact on north light glass, thus leading to increased internal pressure, and hence failure of total roof system (Fig. 5).

Fig 5 : Damage to an Industrial Structure

**It is recommended to provide toughened glass to the north light covering to resist the debris impact and to provide 'U' bolts (4 Nos. for each sheet) in place of 'J' bolts, to have better connection system and number of support points to resist cyclonic forces.**

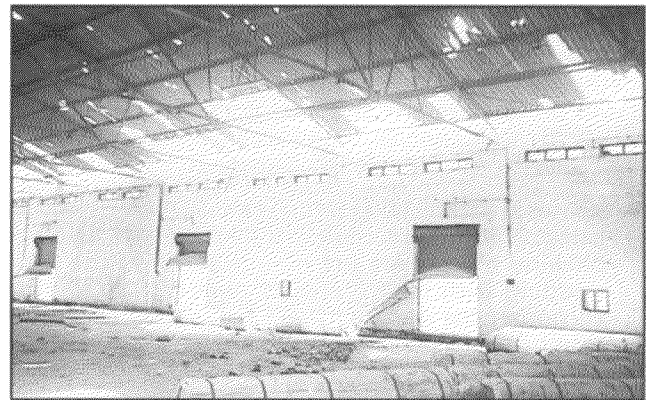
Fig 6 : Failure to Rolling Shutters and A.C. Sheet Roofing

Being one of the major national ports for handling both solid and liquid cargo, the surroundings of the Kandla Port area, there were number of storage godowns. The storage godowns have been typical with number of rolling shutters and AC sheet roofing on steel trusses of 15 to 30m span. **The failure initiation has been due to twisting and tearing of rolling shutters due to sudden impact of the storm surge on rolling shutters and besides direct wind force, wind gushing through these openings cause increased internal pressure leading to the roofing damage (Fig. 6).** Further 11 storage godowns inside the Kandla Port with sizes vary from 60m to 192m length and with span of 22.5m have been damaged either to the failure of A/C sheet roofing or to the truss system. In some of the sheds, the supporting columns have failed at the ground level.

**As observed by SERC, many of the AC sheet roofing failures at 'J' bolts were due to dynamic action of wind, flattening of the 'J' bolt and thus ineffectiveness of the connections.**

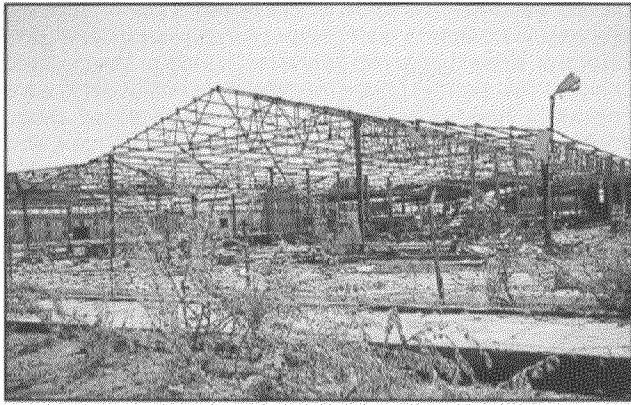
Since Kutch area is the major salt producing place in India, there is lots of industrial structures for salt industry. Invariably almost all the industries have their roof trusses with tubular members, roof with asbestos sheets and they were connected by means of 'J' bolts to the purlin. As

Fig 7 · Roof Cladding damage of an Industrial Structure

the common failure during cyclones, all the asbestos sheet roofing had failed either completely or partially (Fig. 7).

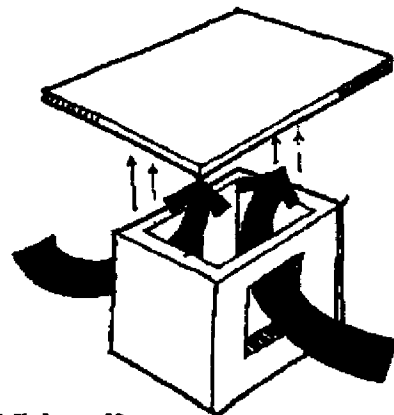
**Anchorage and Bracing primarily Influence structural integrity.**
