**PART THREE**

# **HARVEY CEDARS, NEW JERSEY, FIELD EVALUATION IN RESPONSE TO THE DECEMBER 11-12, 1992 NORTHEASTER: PILOT STUDY ON THE EFFECTIVENESS OF NFIP CONSTRUCTION STANDARDS IN REDUCING COASTAL FLOOD DAMAGE**

# **EROSION HAZARDS AND COASTAL CONSTRUCTION DEFICIENCIES OBSERVED ON KAUAI AFTER HURRICANE INIKI**

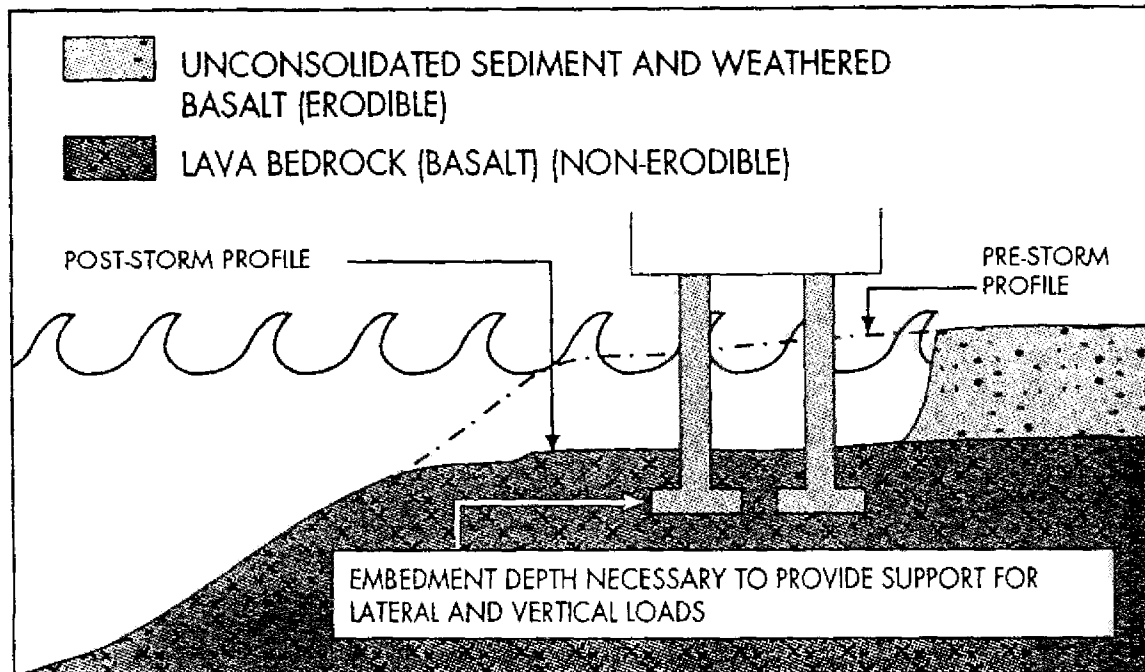
*Figure 1. Recommended foundation embedment, Type 1.*

In the case of Type 1, if the unconsolidated sediment is of insufficient thickness to support a building during severe wind and water loading conditions, the foundation must be keyed or drilled into the lava bedrock and grouted. Figure 1 shows one example of a bedrock-anchored foundation, although alternative designs have been suggested (FEMA, 1993). While anchoring into bedrock is a more expensive proposition, in this case it is the only design that can withstand storm-induced erosion and meet NFIP performance standards for coastal high hazard areas.

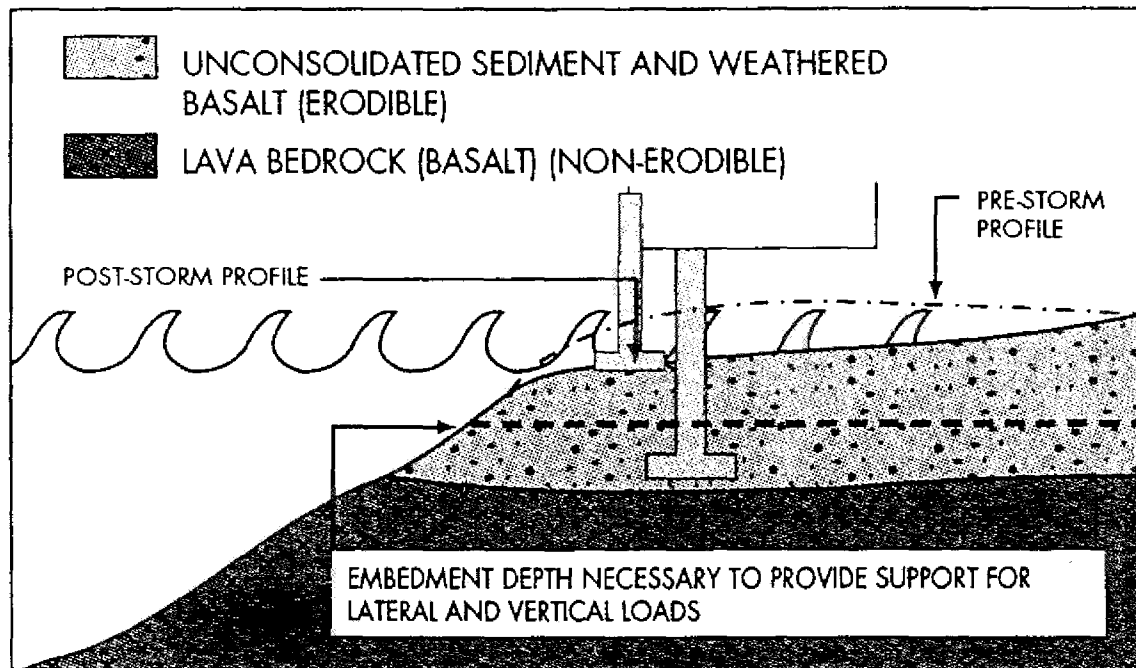
*Figure 2. Recommended foundation embedment, Type 2.*

In the case of Type 2, if the unconsolidated sediments are of sufficient thickness that a foundation can be driven or excavated below the maximum vertical scour zone, then the embedment design shown in Figure 2 is applicable.

This design should allow for supporting a building under simultaneous wind and water loading during a 100-year flood. The fundamental factor is an accurate estimate of the potential storm-induced vertical scour. Given that our current understanding of geomorphic processes is lacking and geologic conditions are highly variable at different sites, an accurate and confident measurement of storm-induced erosion is tenuous. Thus, a foundation embedment depth that is conservative or includes a safety factor is imperative.
