# **PERFORMANCE OF MANUFACTURED HOMES DURING HURRICANE EMILY**

**Albert Romano and Christopher Hanson  
Greenhorne & O'Mara, Inc.**

**Cecelia Rosenberg  
Federal Emergency Management Agency**

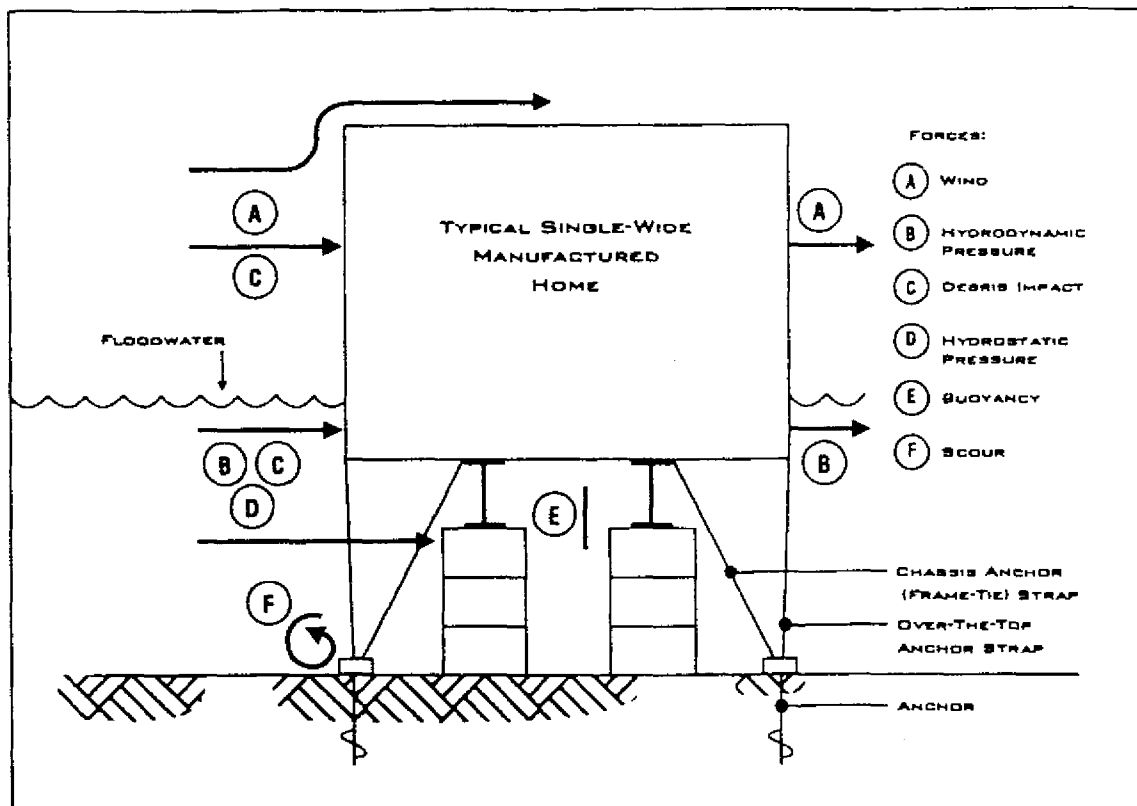
*Figure 1. Typical forces acting on a manufactured home in a floodplain.*

shims were typically not "fastened" to each other or to either the chassis or pier. They were held in position by the weight of the MH unit and the additional force of friction caused by tensioning of the galvanized straps. In effect, the strapping provided a clamping force for all the parts: the piers, the plates, the shims, and the MH.

In general, when the strapping is loosened (for whatever reason) the entire system becomes unstable. In many cases, the MH is acted upon by lateral forces (e.g., floodwater acting above the first floor line in combination with wind) that exceed the horizontal frictional forces from the weight of the MH alone, and therefore movement of the MH occurs. Also, the piers tilt in the direction of the lateral forces. This tilting may then cause rotation at the top of each pier away from the base of the chassis because the chassis remains rigidly fixed to, and at right angles to, the floor of the MH. The effect of the resulting loss of any contact friction between the chassis and the plates/shims greatly reduces the lateral force resistance of the foundation system. Since buoyancy and/or wind uplift forces may be present, they compound the problem by causing the entire separation of the contact surfaces.
