Terms of Reference

September 18th, 1995

**TO STUDY THE EFFECTS OF HURRICANE LUIS
ON THE BUILDINGS AND OTHER STRUCTURES
OF THE ELECTRICITY SECTION OF APUA**

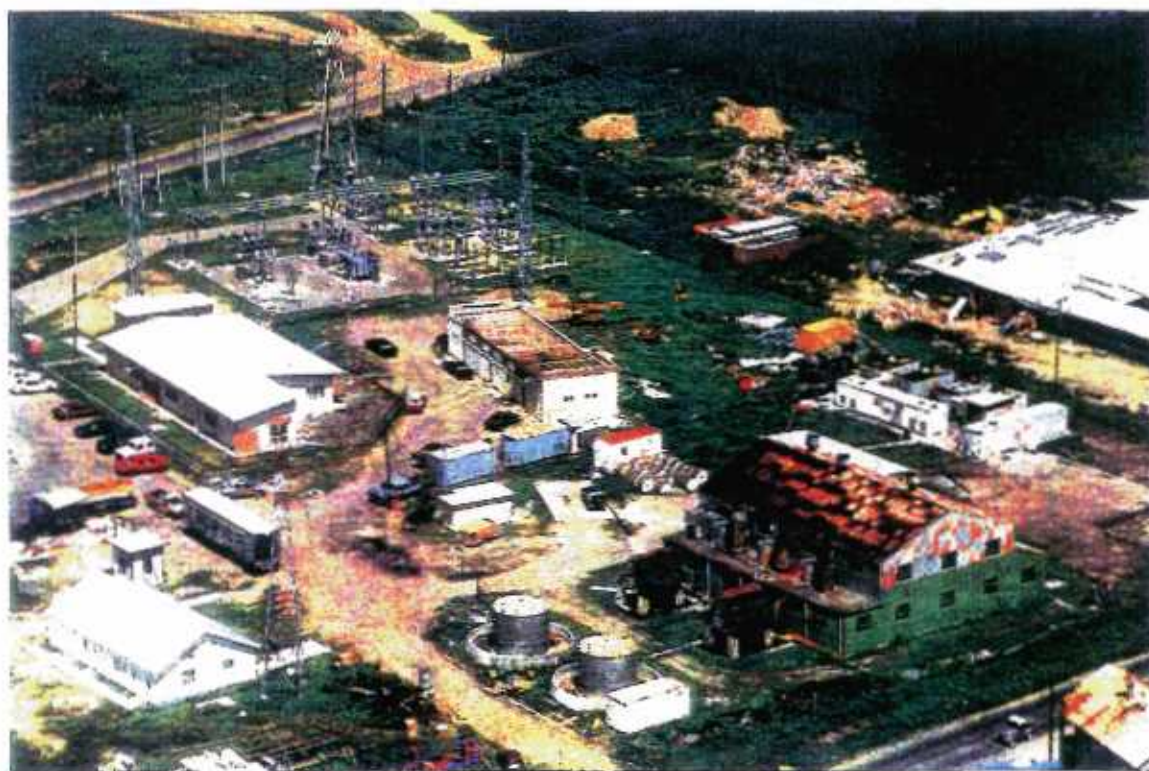
2 Cassada Gardens Complex - Note the badly rusted but undamaged Old Power Station and the destroyed Canteen/Workshop.

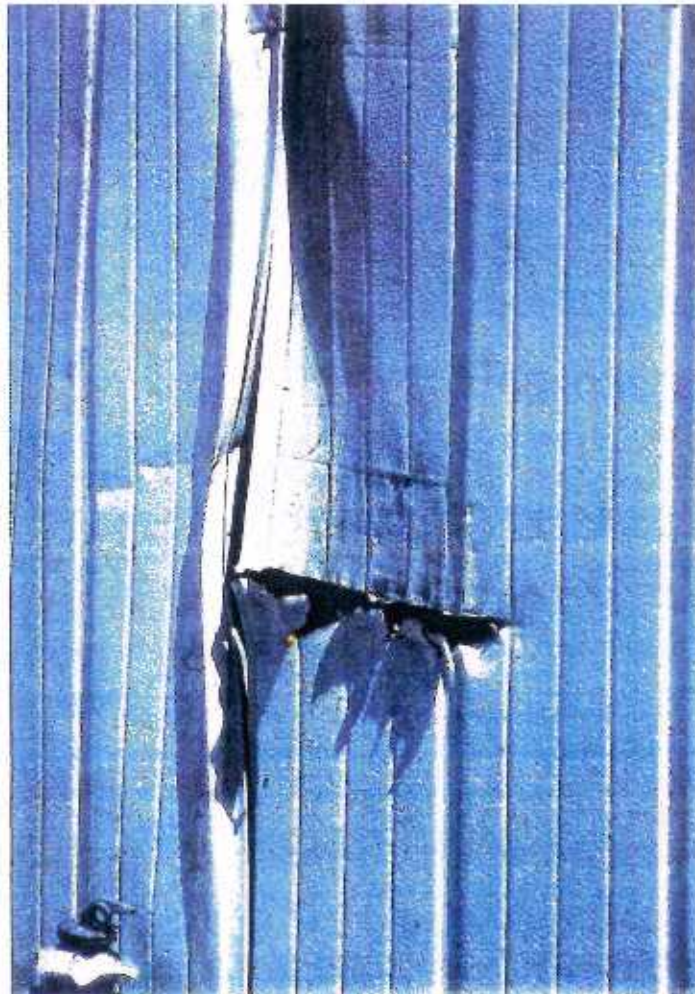
4 Cassada Gardens Stores Building - impact damage to the siding

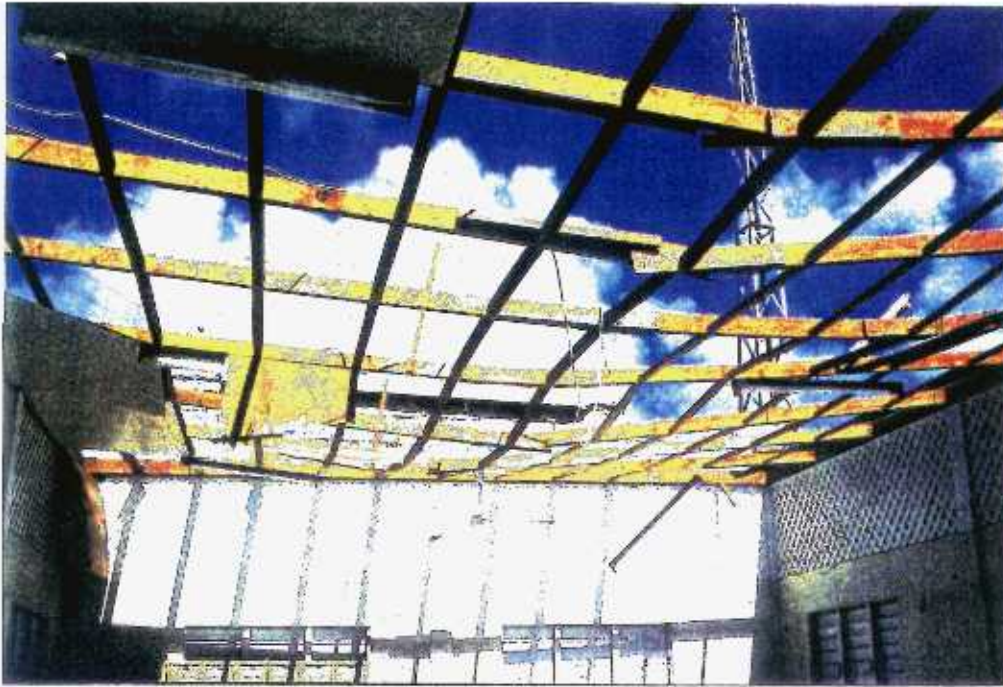
5 Cassada Gardens Canteen - roof structure completely removed; ceiling structure badly damaged, but in place.

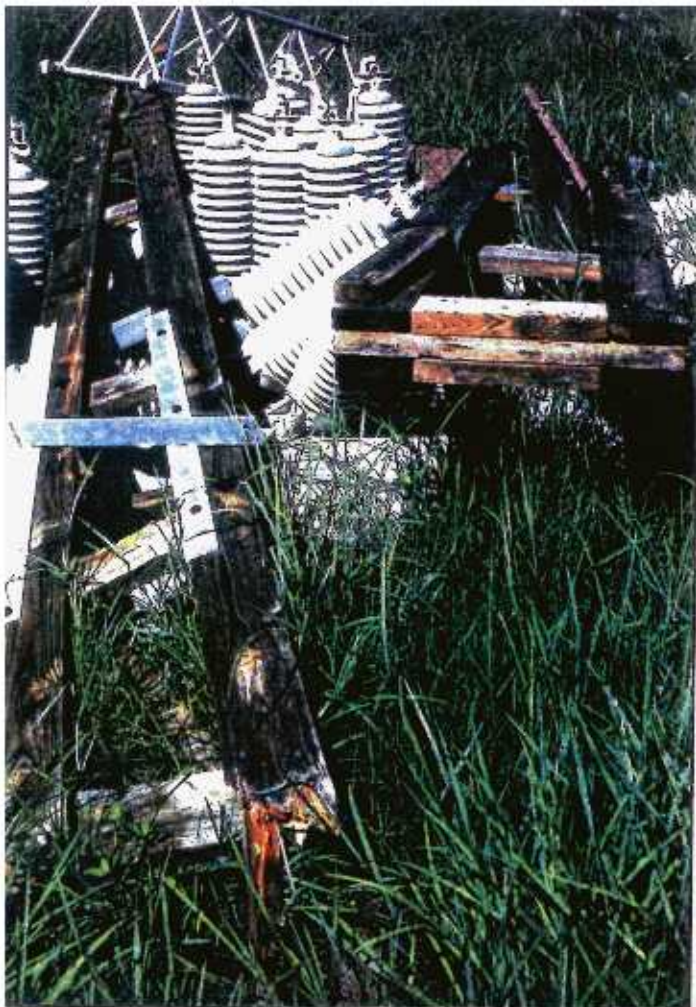
6 Cassada Gardens Canteen - removed roof trusses on the ground

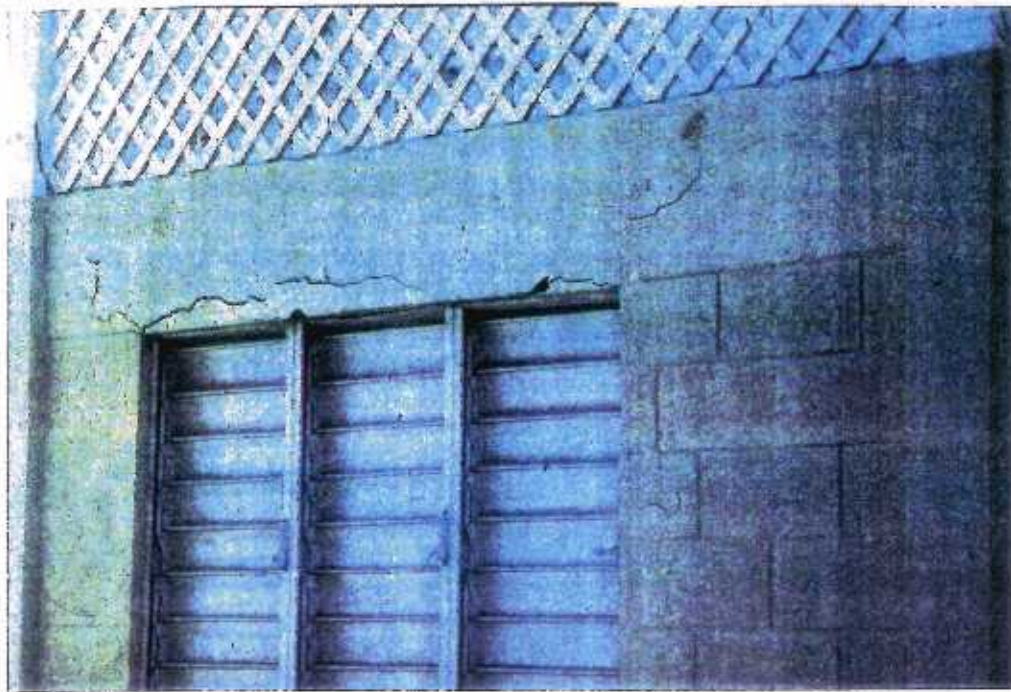
7 Cassada Gardens Canteen - cracked walls

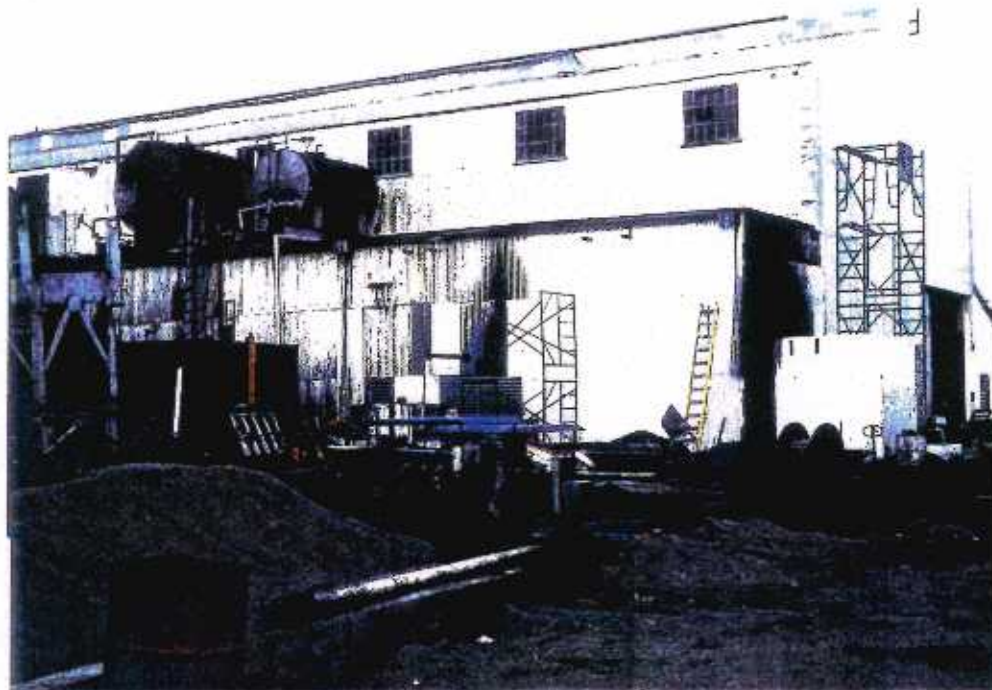
8 Friars Hill Power Station
- the south gable-end cladding has been replaced since the hurricane.

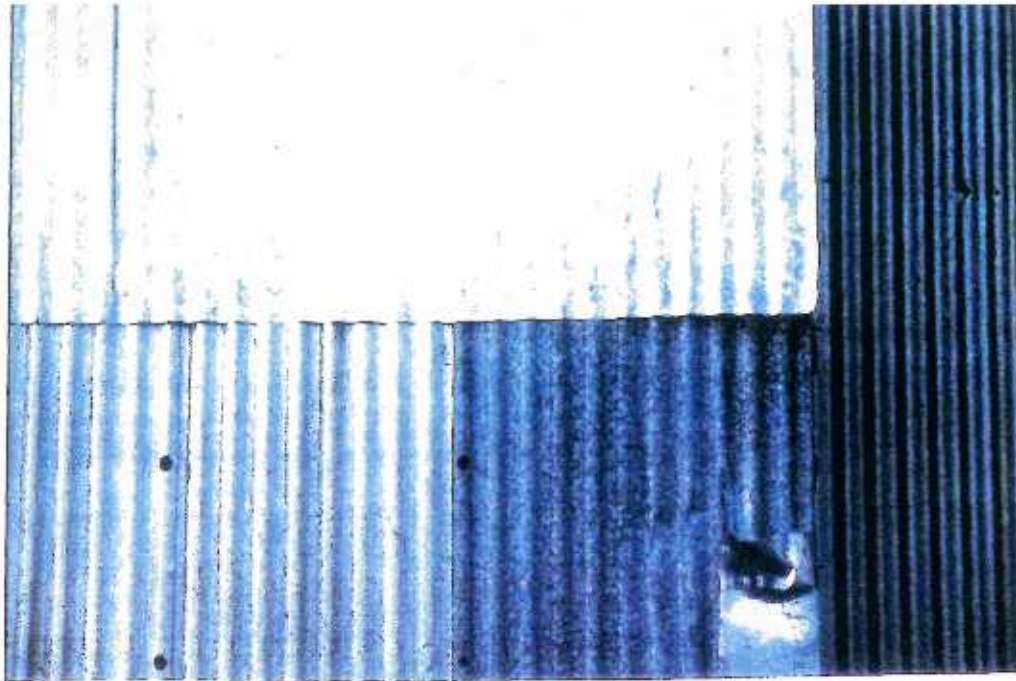
- 9 Friars Hill Power Station - the south gable-end cladding showing repairs after Hugo (1989) and Luis (1995) - note that the latest repairs are not even as well secured as those which failed in Luis.

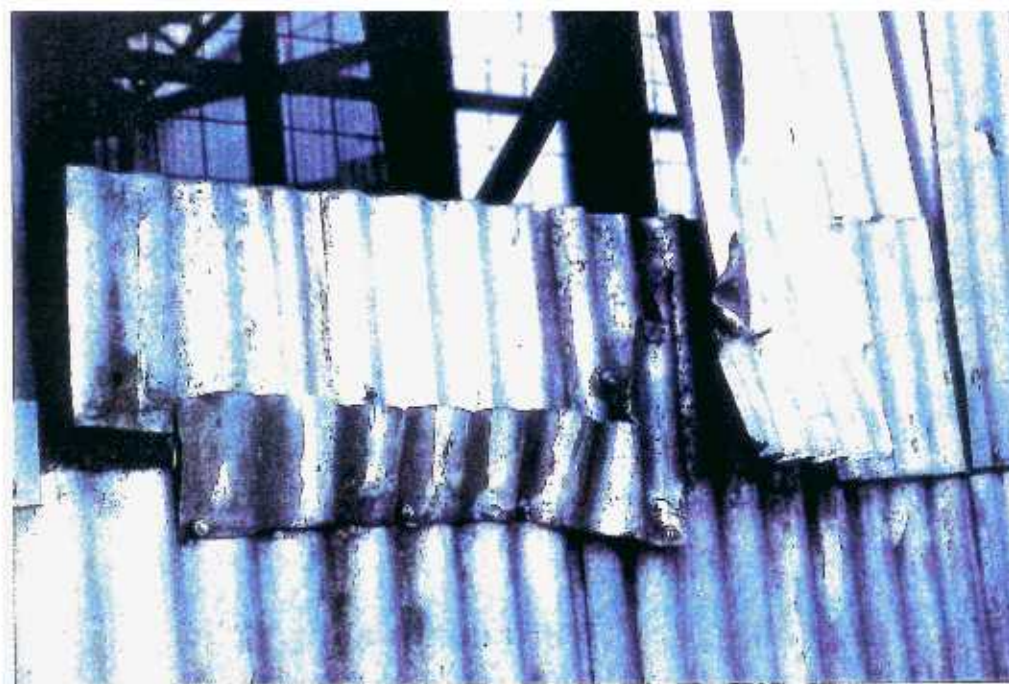
14 Friars Hill Workshop - note the torn corrugated steel sheets
