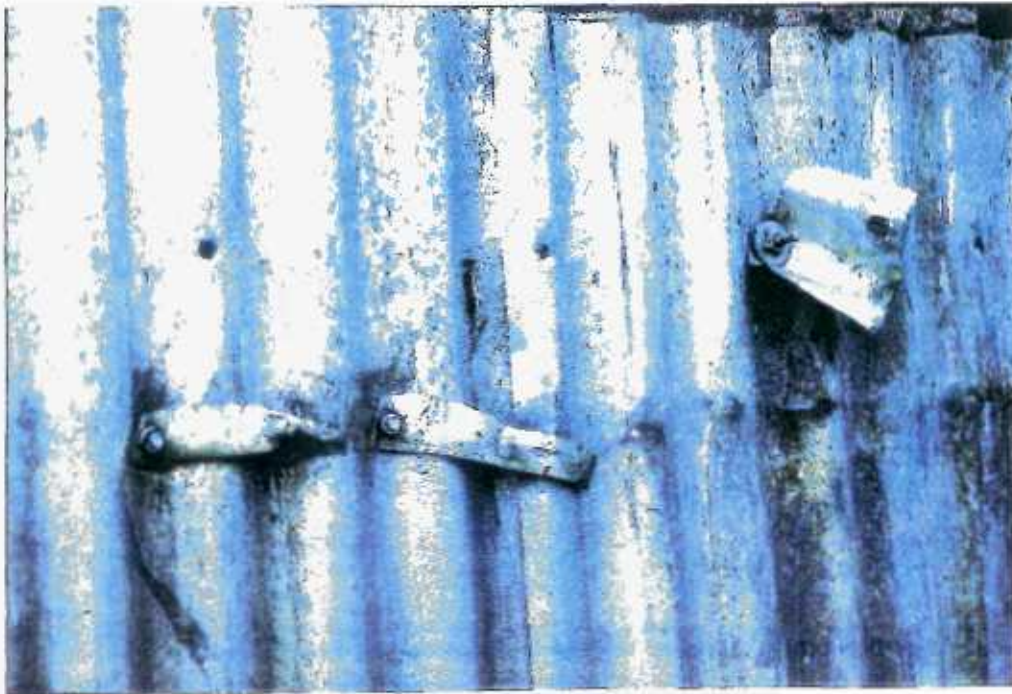
15 Friars Hill Workshop  
Surprisingly, the sheeting failed away from the fixing locations.

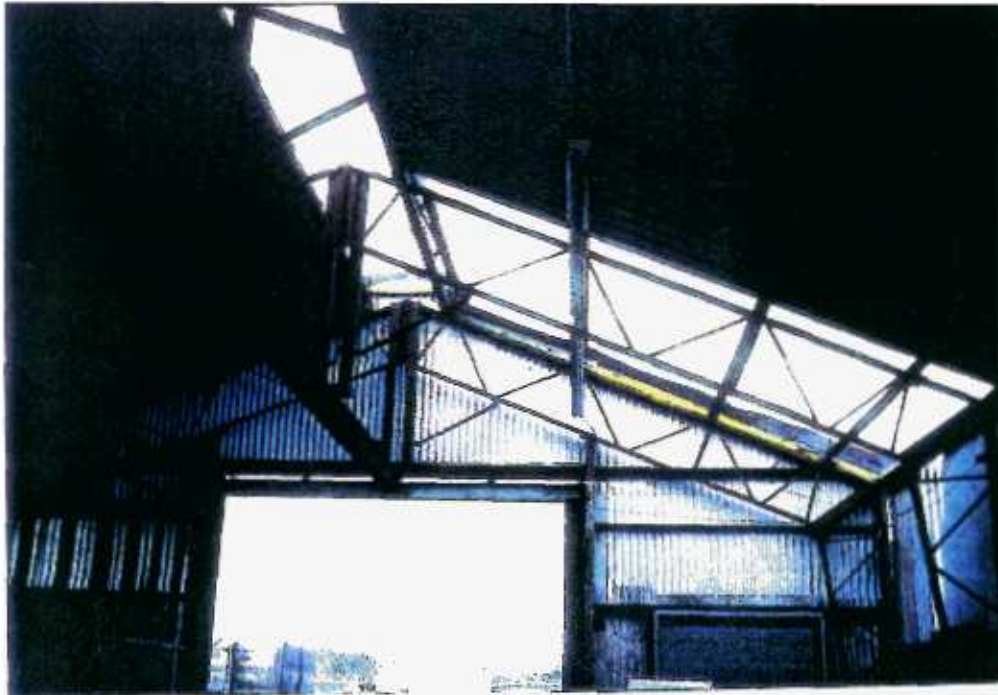
16 Friars Hill Workshop - view from inside showing loss of gable-end and ridge sheeting

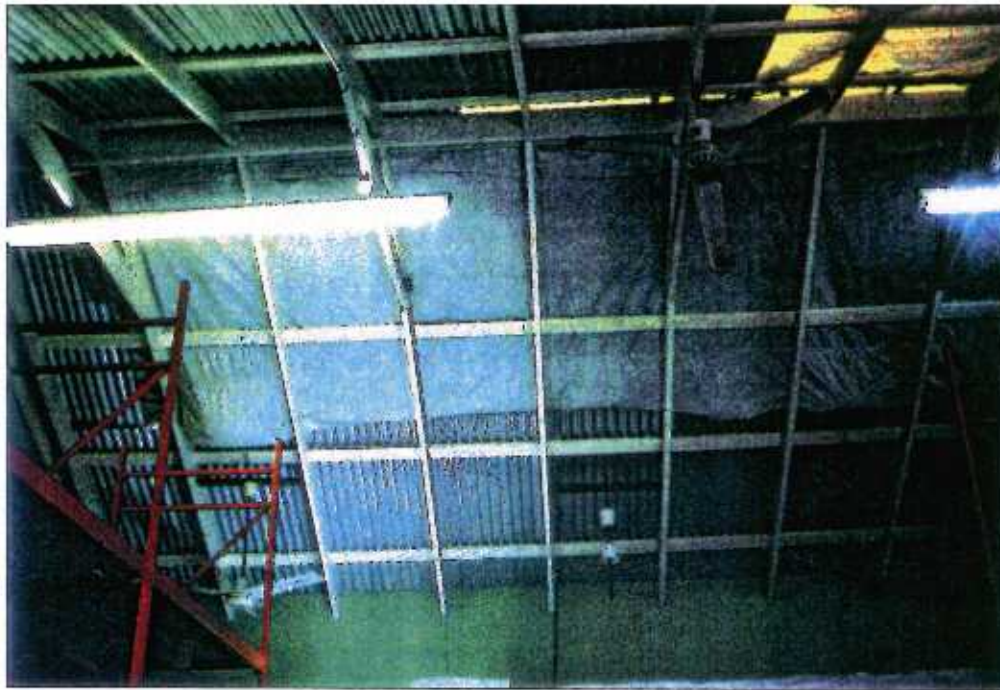
17 Friars Hill Stores - loss of roof sheeting

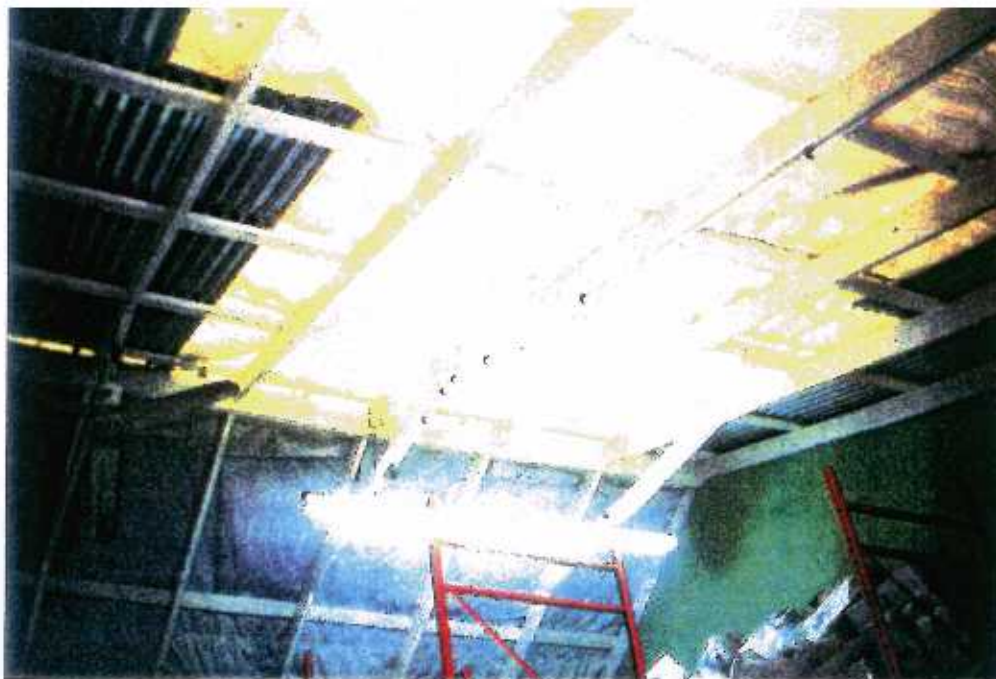
18 Friar's Hill Office Building - loss of roof sheeting

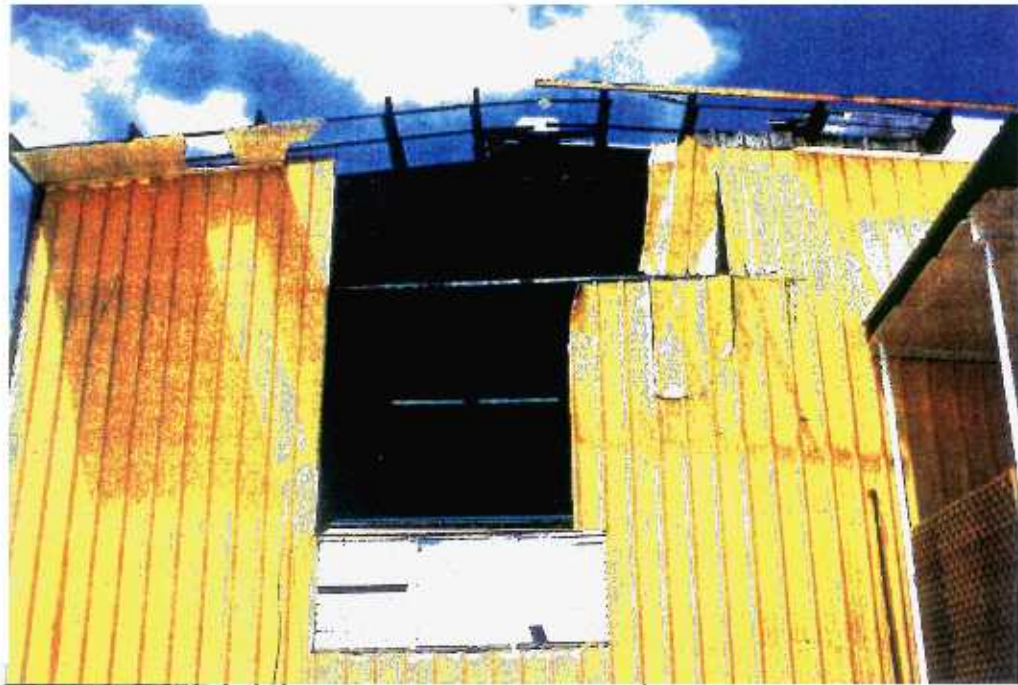
19 Crabbs Diesel Power Station - damage to gable-end sheeting

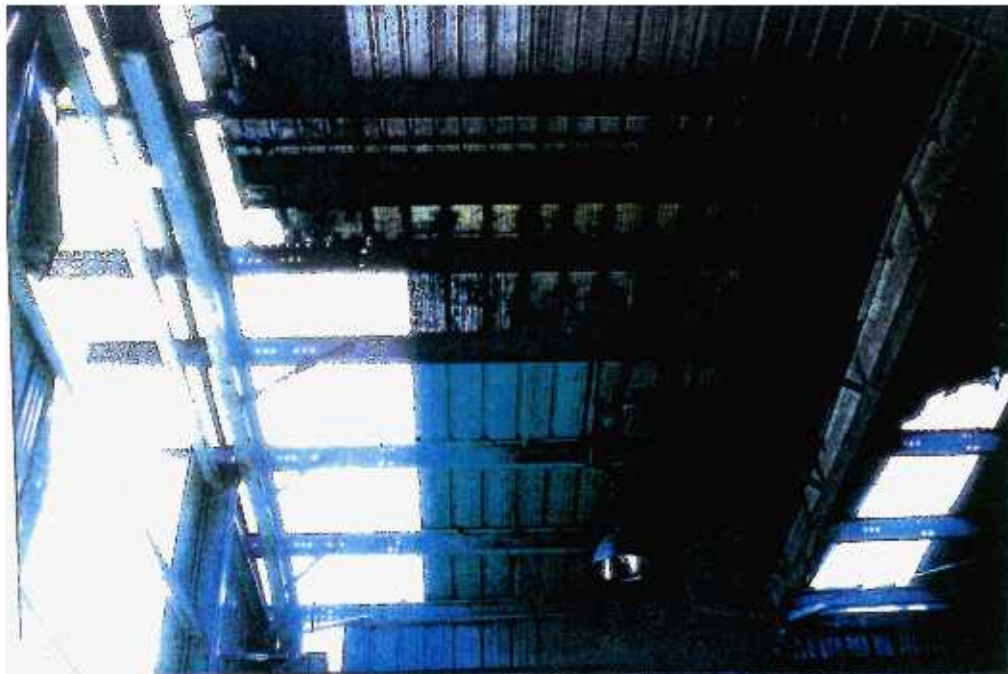
20 Crabbs Diesel Power Station - damage to gable-end wall and roof sheeting

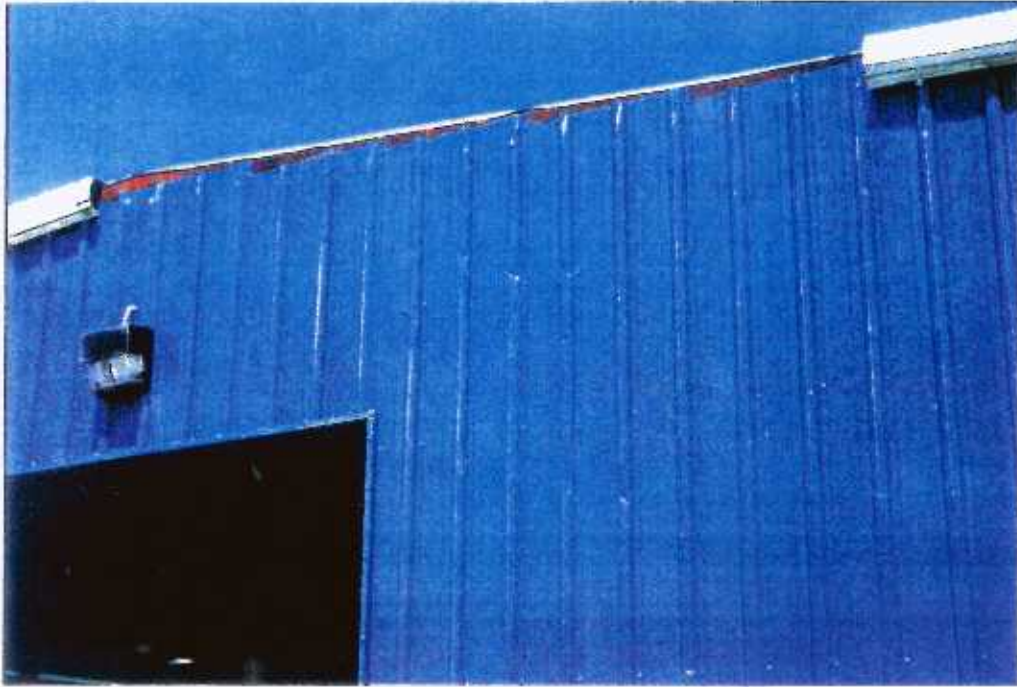
21 Crabbs Reverse Osmosis Plant Building - loss of gable flashing

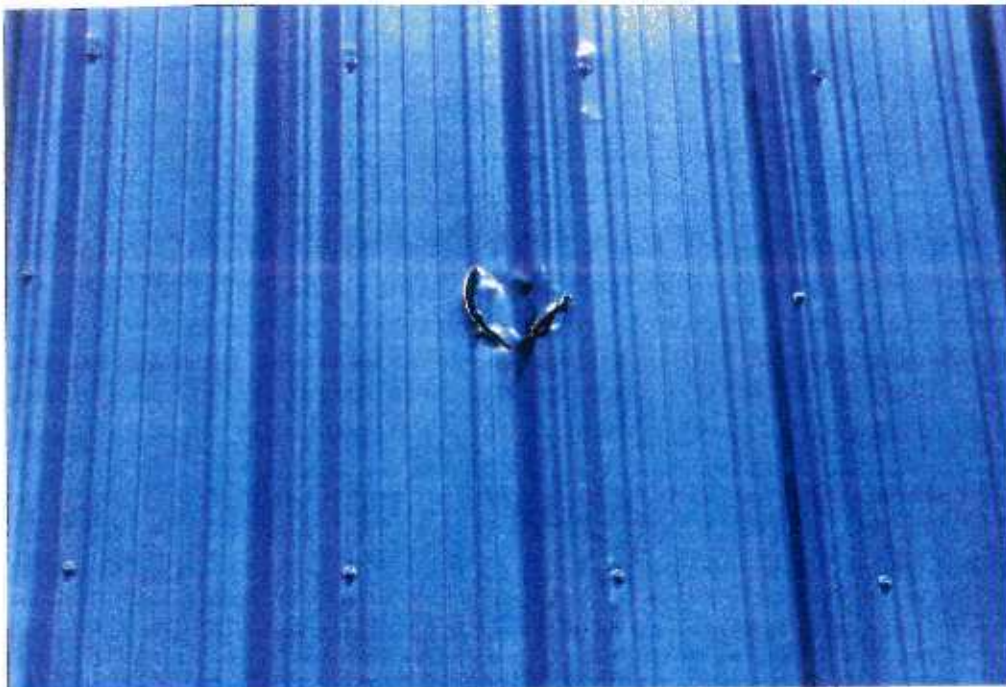
22 Crabbs Reverse Osmosis Plant Building - impact damage probably from a flying pipe

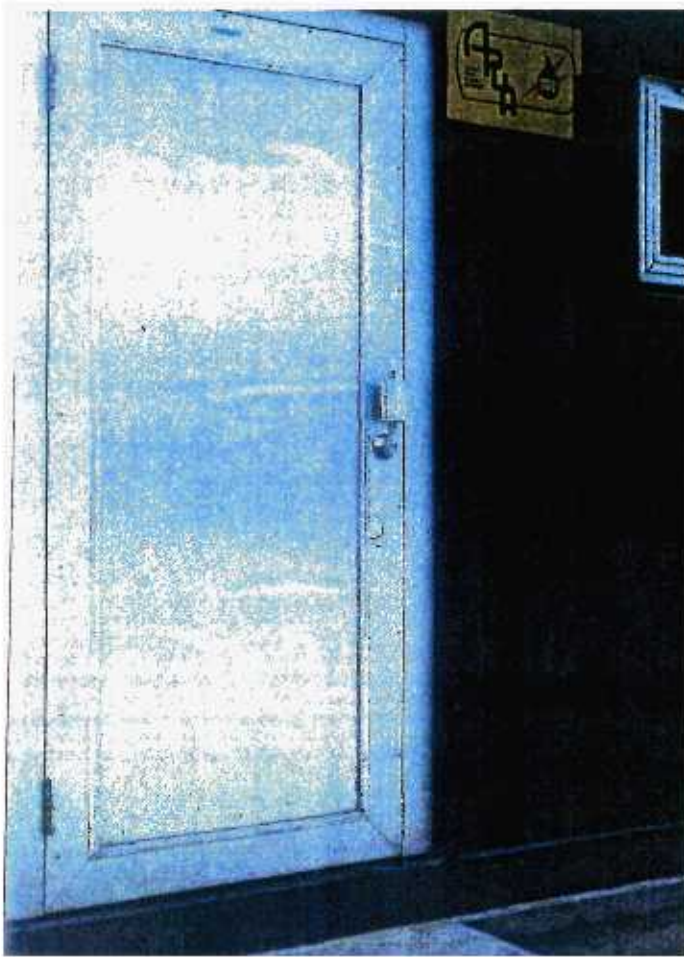
23 Typical container-type Substation Control Room showing door and window openings

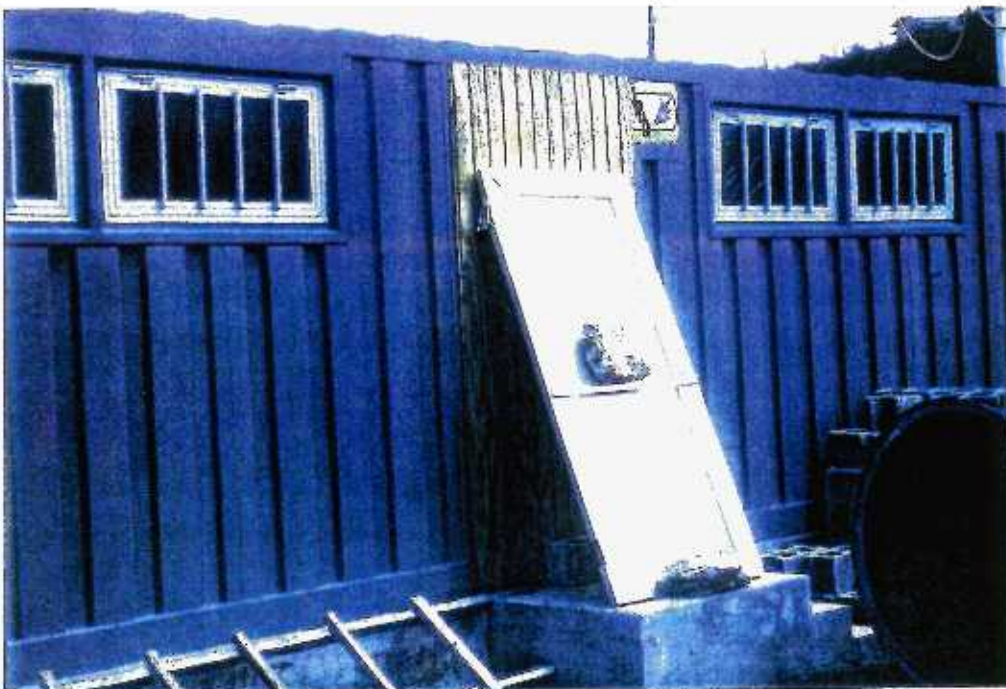
24 Typical container-type Substation Control Room showing door removed by the wind

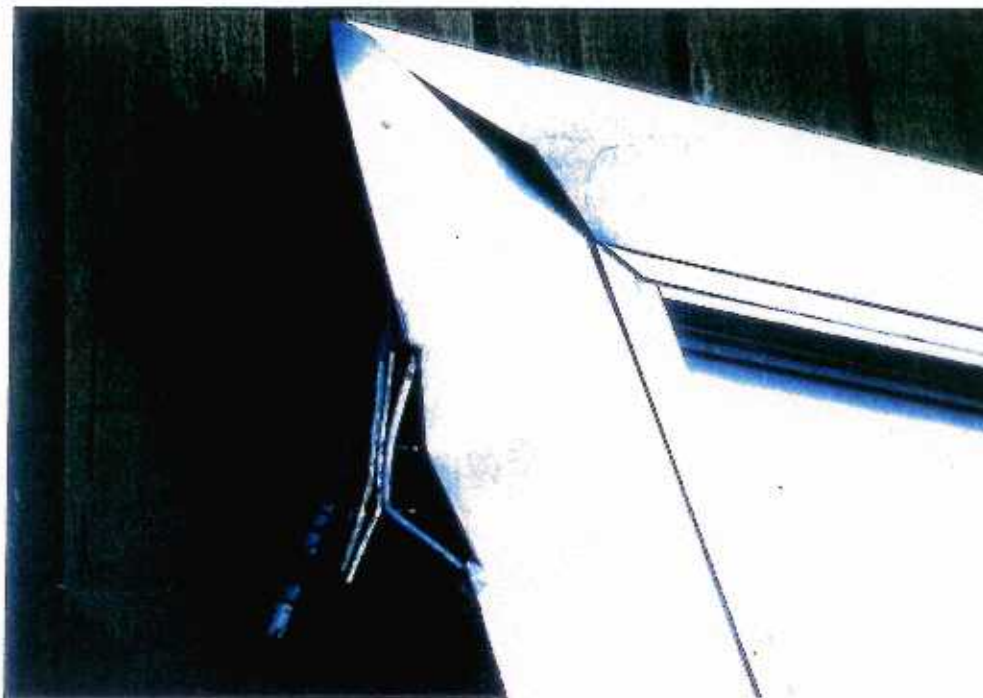
25 Close-up of damaged hinge of the door in No 24

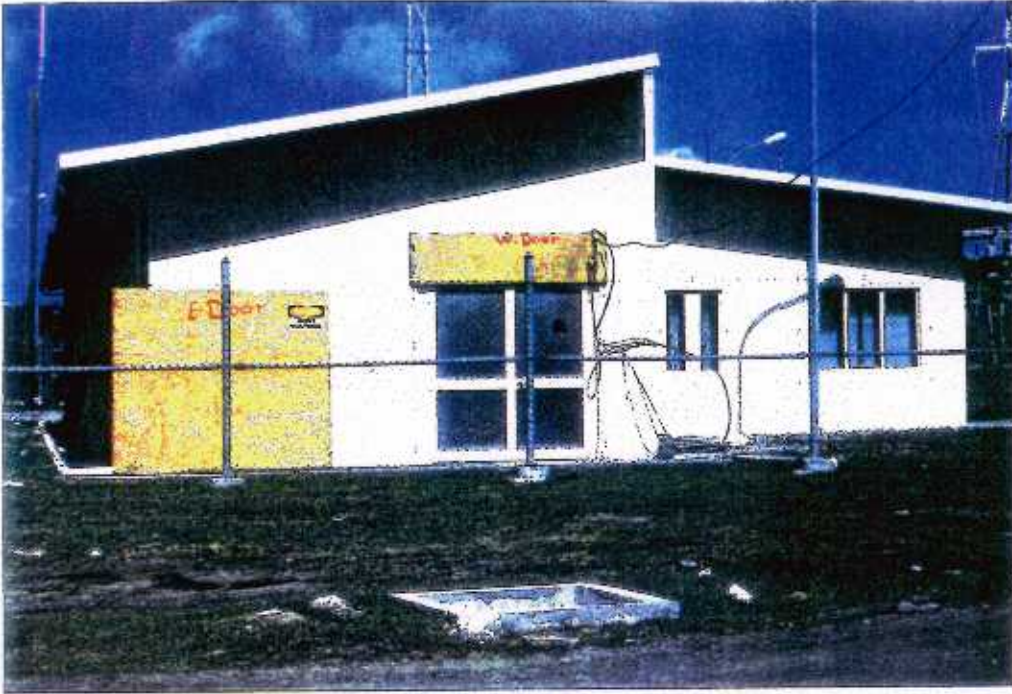
27 Cassada Gardens Complex - hurricane shutters were in place during Luis

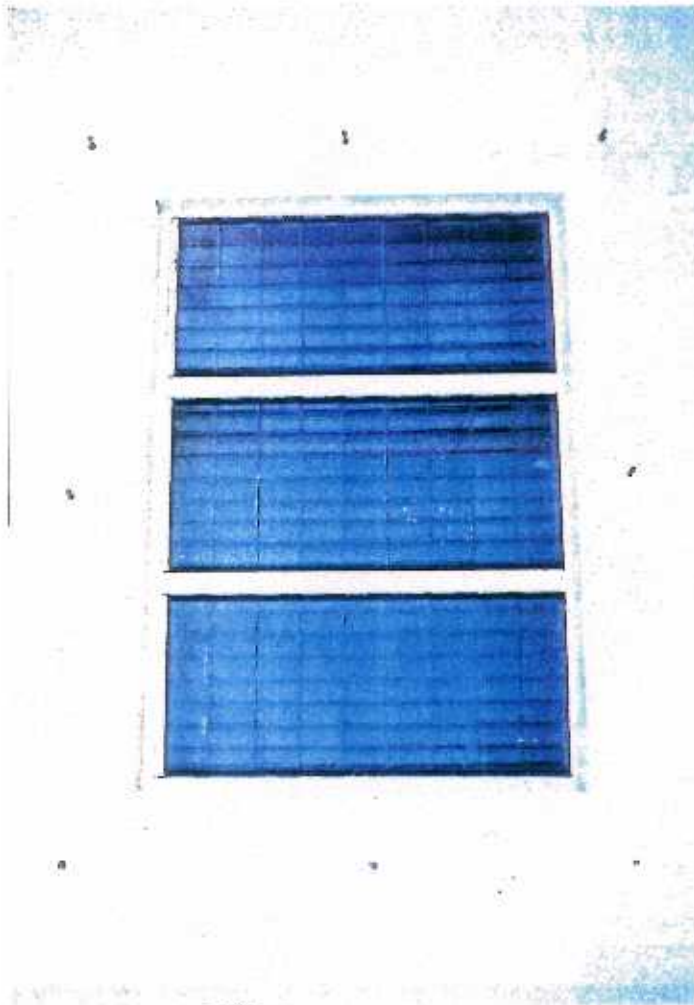
28 Cassada Gardens Complex  
- bolts for fixing hurricane  
shutters

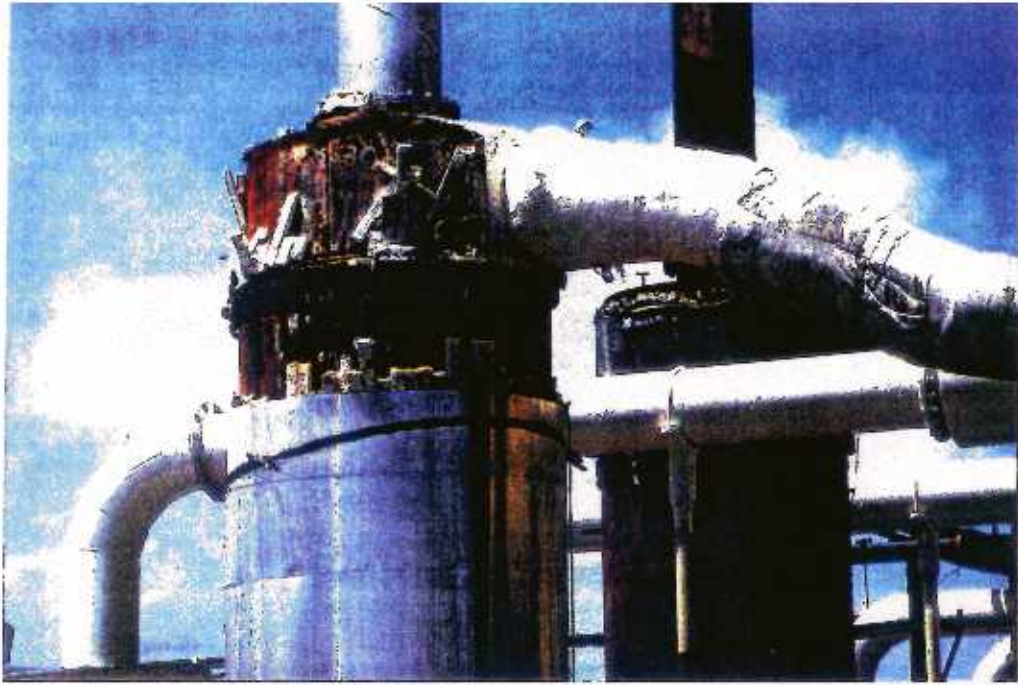
29 Crabbs Complex - damage to insulation of Fairbanks Morse stack

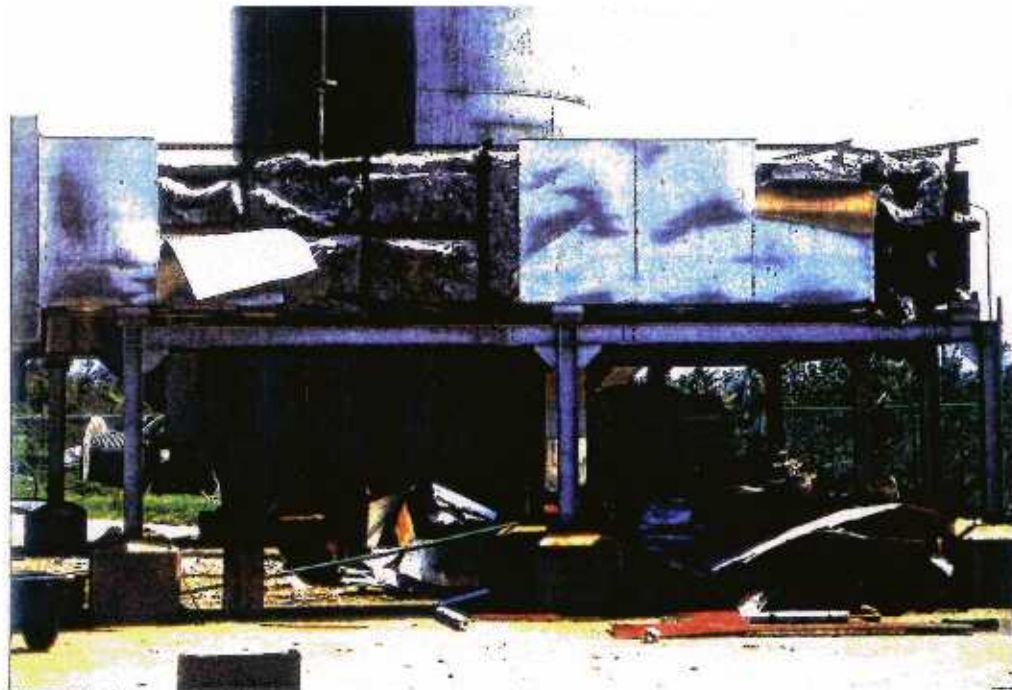
30 Crabbs Complex - damage to cladding and insulation around intake duct of Cogeneration Plant

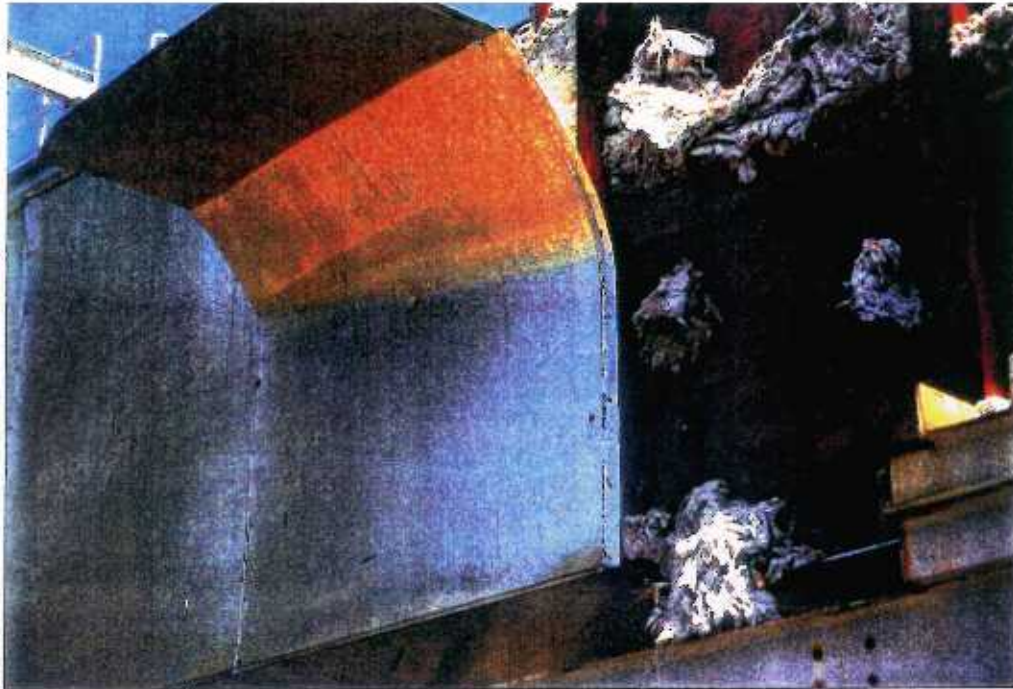
31 Crabbs Complex - close-up of damage to cladding and insulation in No 30

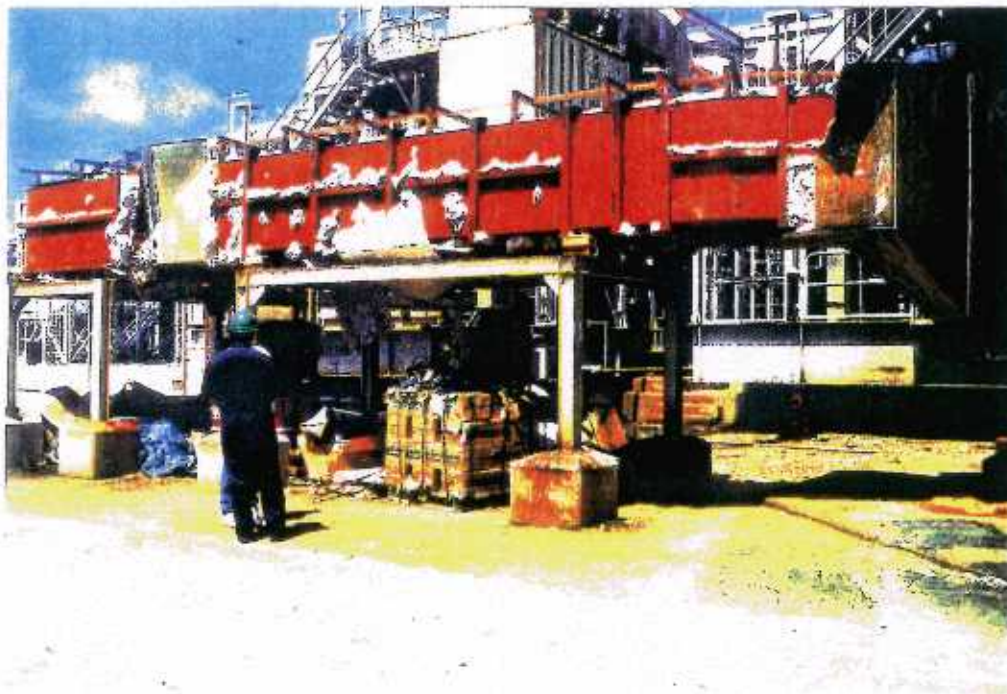
32 Crabbs Complex - damage to cladding and insulation around intake duct of Cogeneration Plant

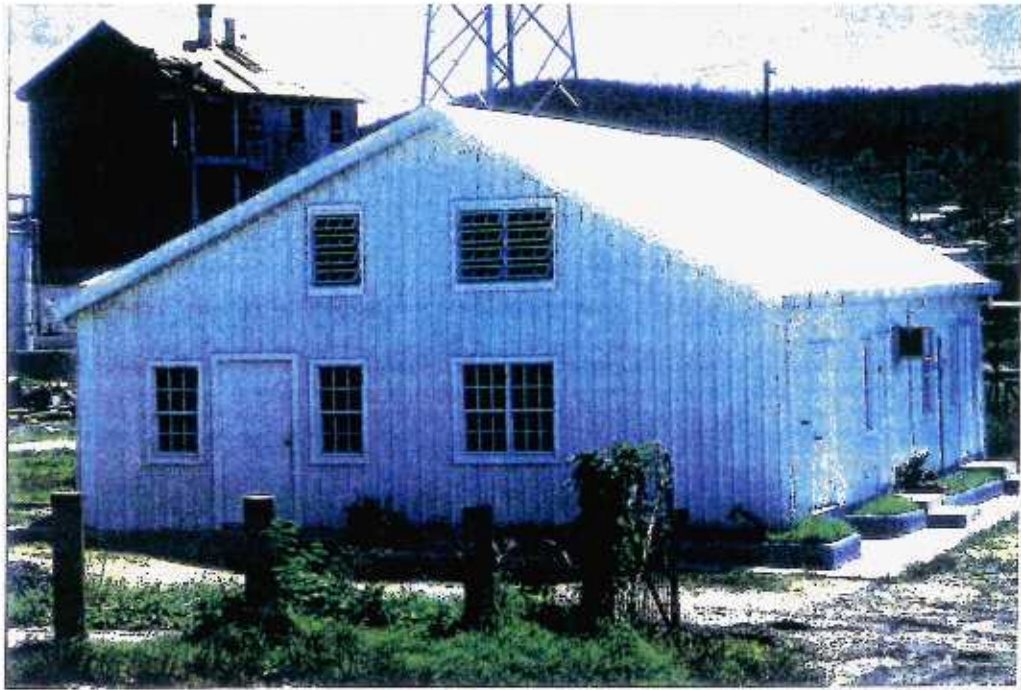
33 Cassada Gardens Complex - building with no damage whatsoever, proving that success is possible

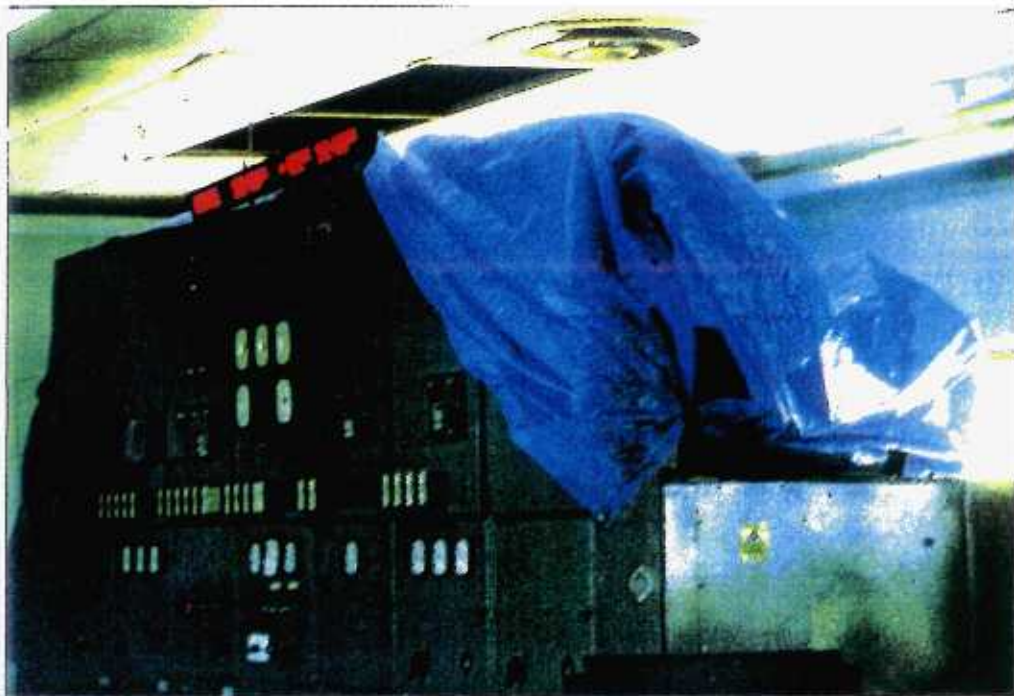
34 Crabbs Diesel Power Station - control panels were protected by tarpaulin during Luis

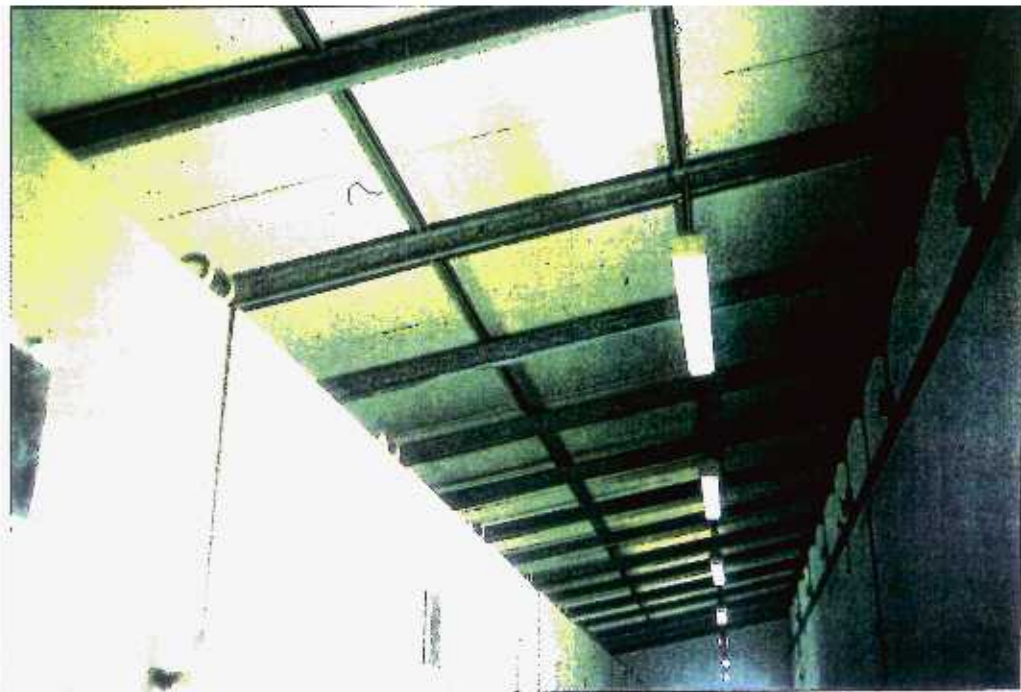
35 Cassada Gardens Complex  
- control panels did not need additional protection during Luis

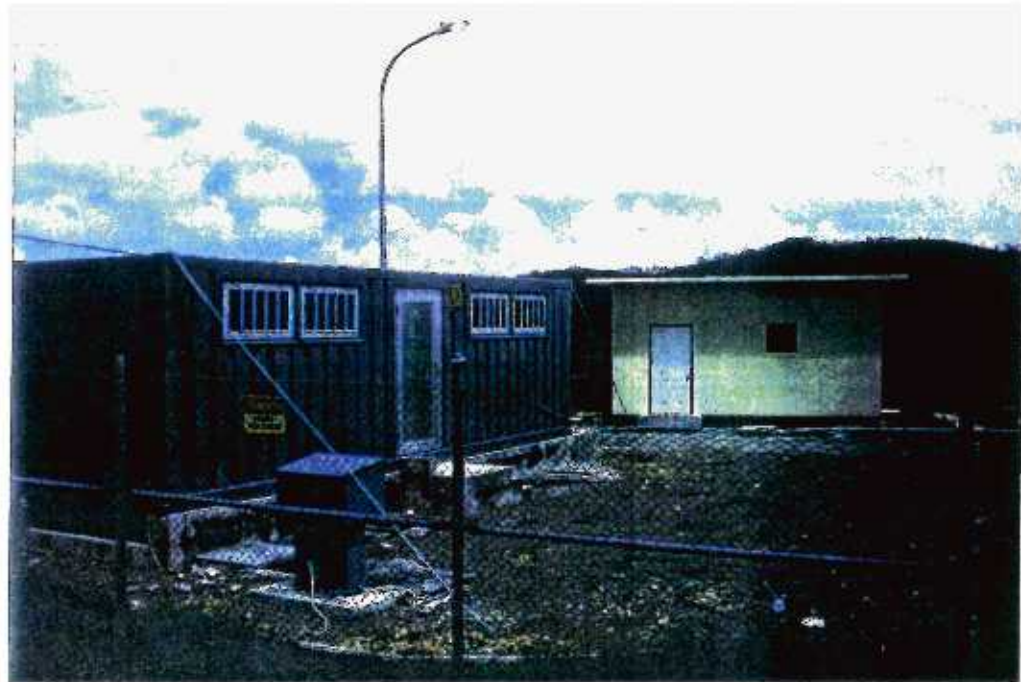
36 Belmont Substation - showing old and new types of Control Rooms

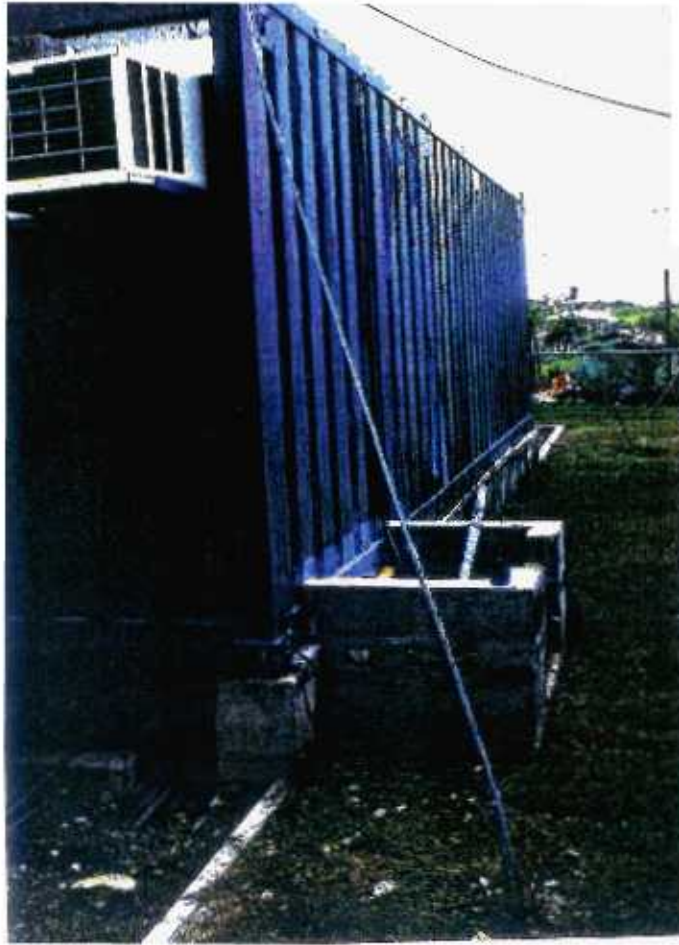
37 Swetes Substation - tie-downs were installed in advance of Luis to prevent toppling of the containers

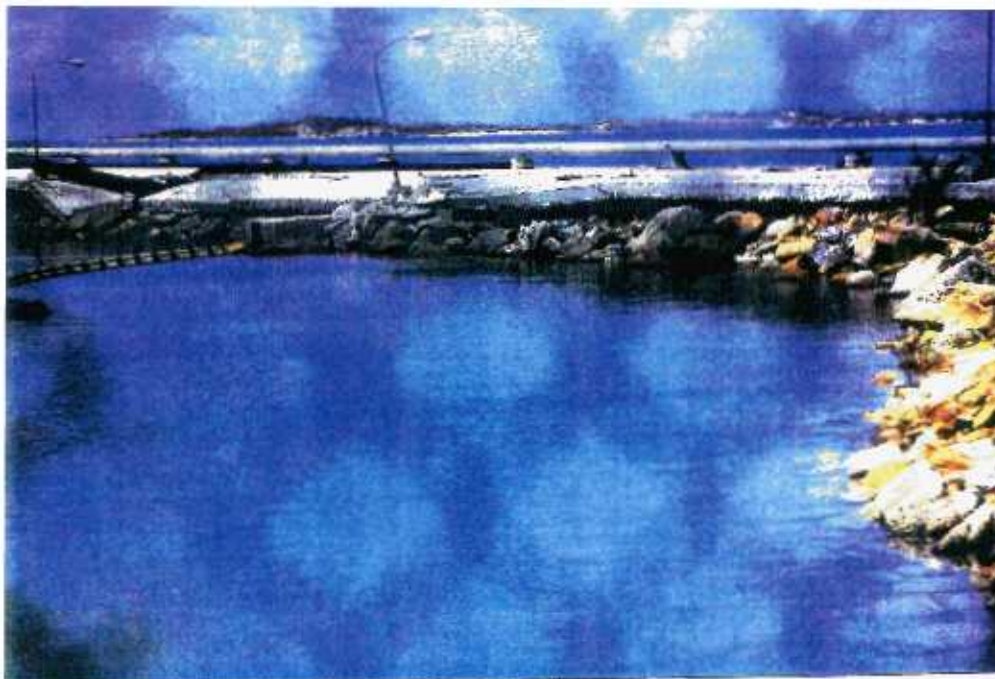
38 Crabbs Complex - destruction of marine facility at the root of the Jetty due to wave action
