Appendix 5

Barry Pinnock's Report

**CEP Survey of
Antigua Public Utilities Authority (APUA)
Power Generating Facilities**

CARIBBEAN DISASTER MITIGATION PROJECT

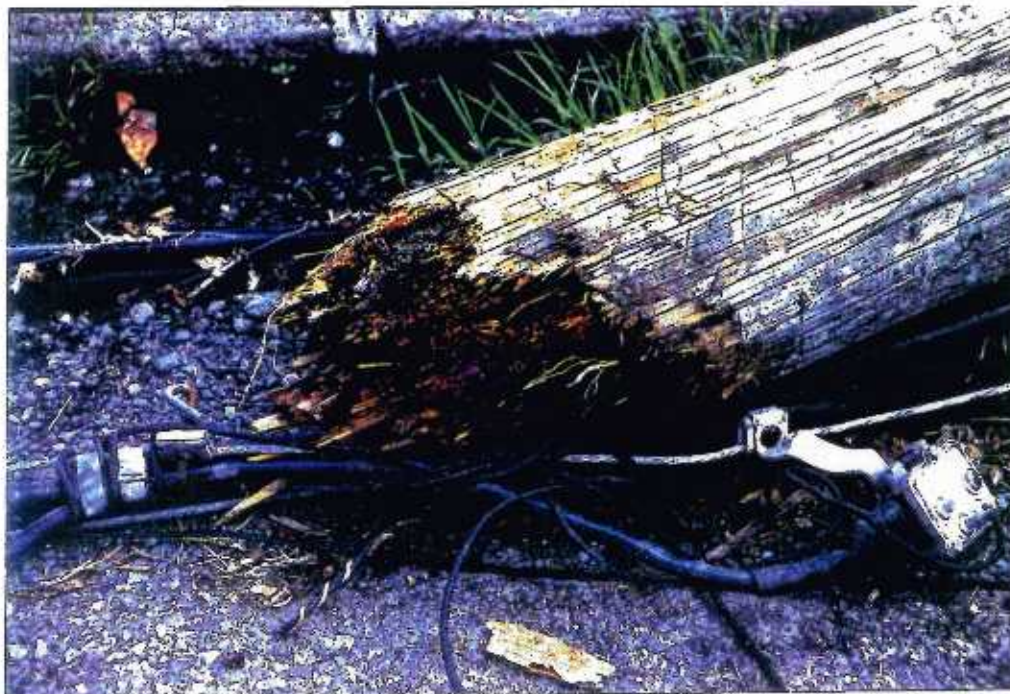
43 Failure of southern-yellow-pine pole (Mental Hospital Road)
due to rotting at the soil line

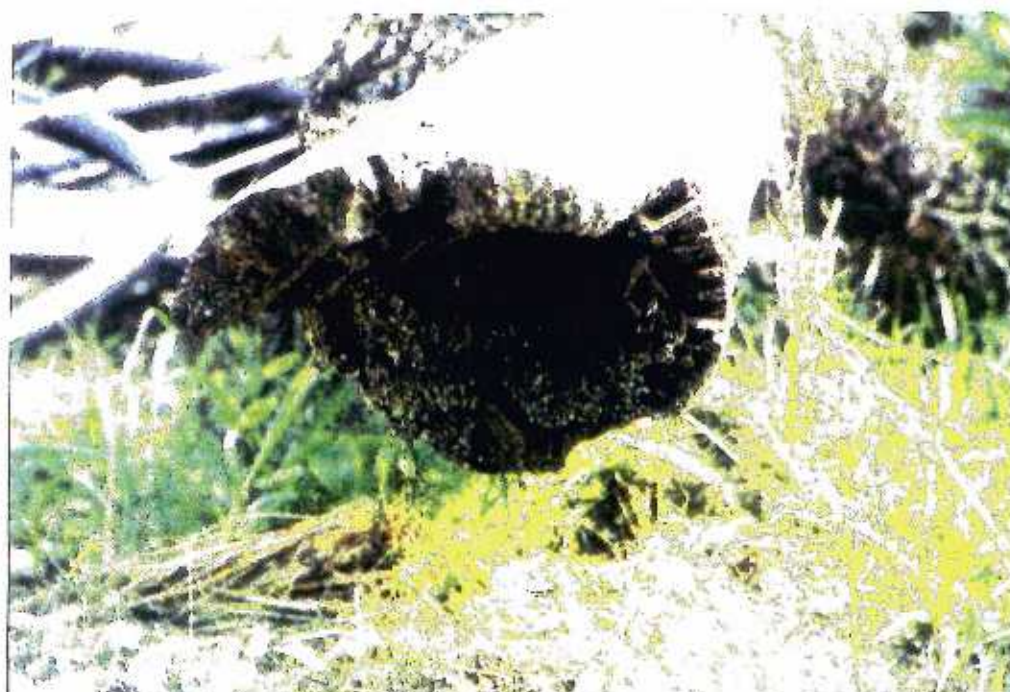
44 White rot causes deterioration of wallaba poles starting from the inside

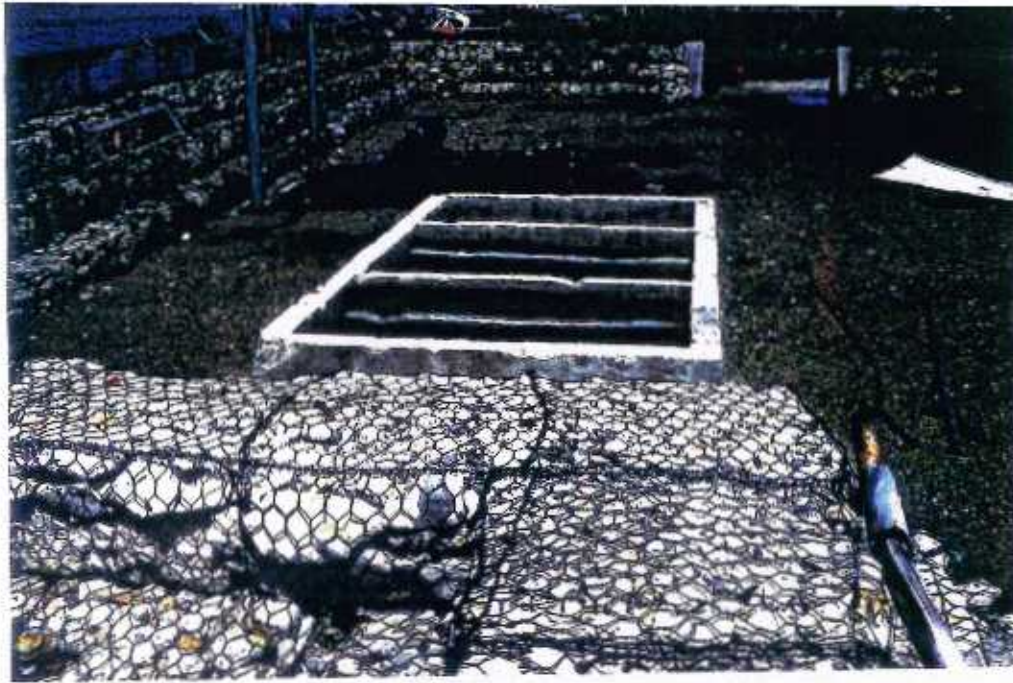
41 Crabbs Complex - gabion cofferdam protecting equipment pit outside of Diesel Power Station (note gap in the wall)

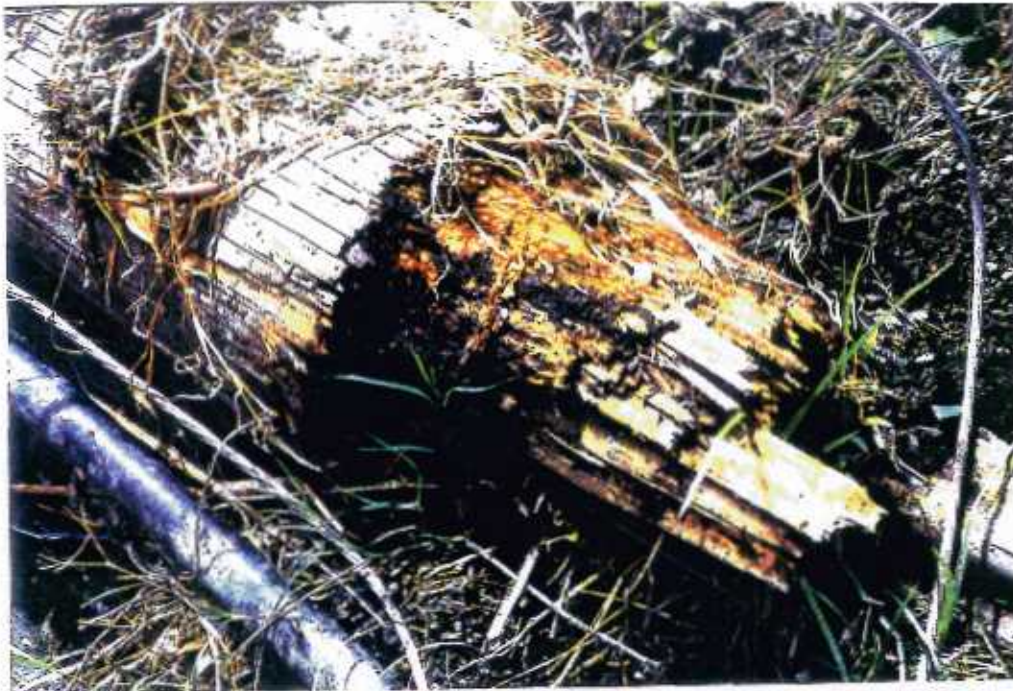
42 Failure of southern-yellow-pine pole due to rotting at the soil line

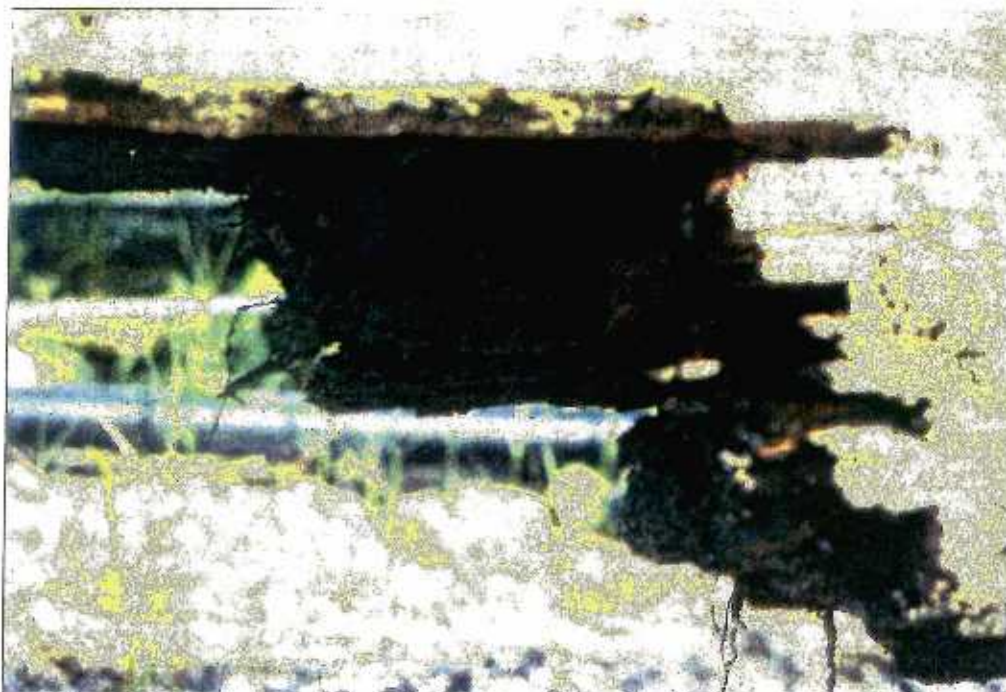
45 Close-up of failed wallaba pole (Jonas Road) due to white rot

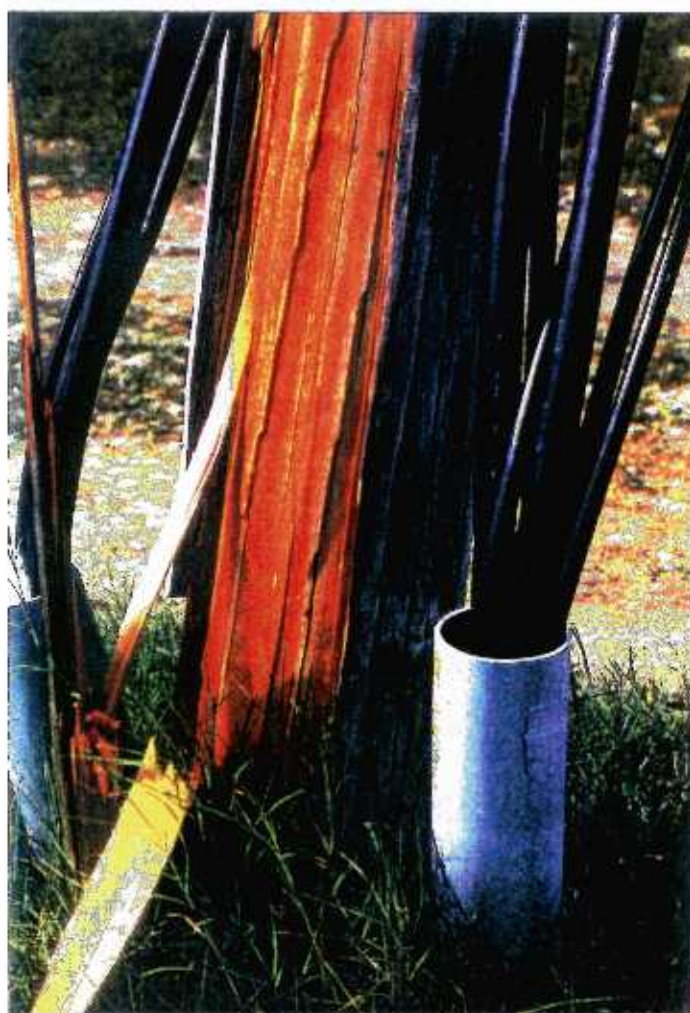
46 Failure of southern-yellow-pine pole due to overstress

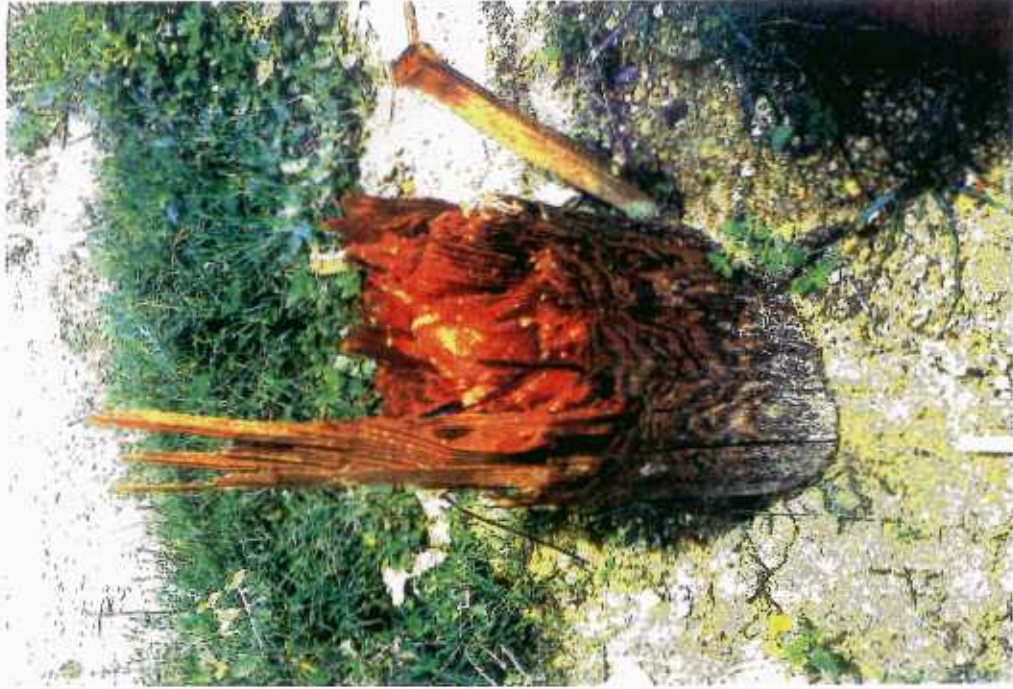
47 Failure of new southern-yellow-pine pole due to overstress

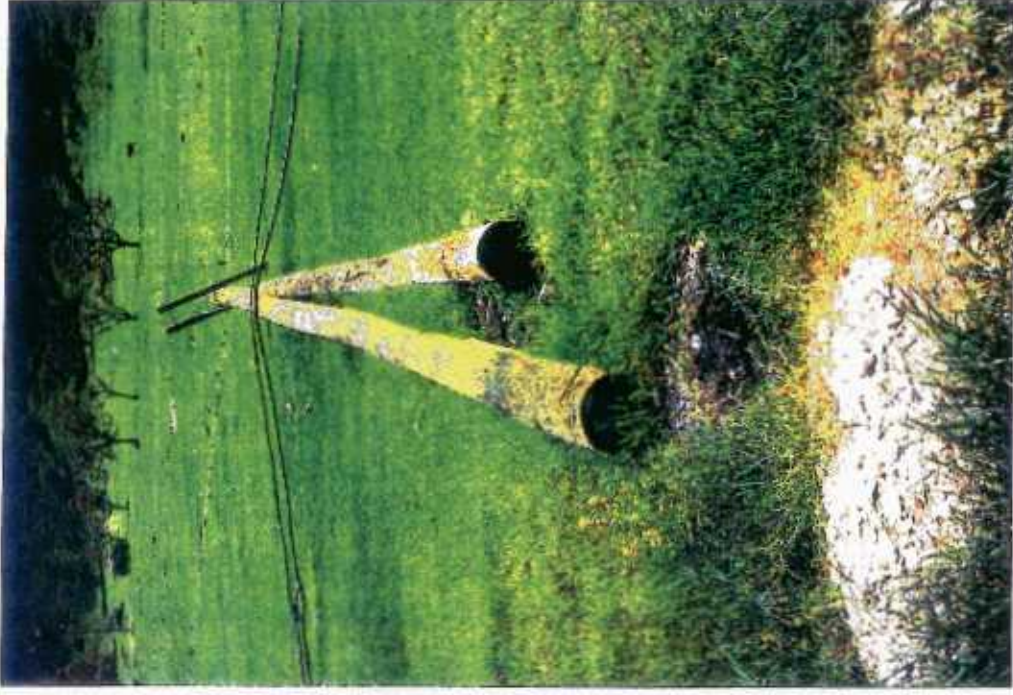
48 Failure of braced-pole assembly by uprooting (Jolly Harbour location)

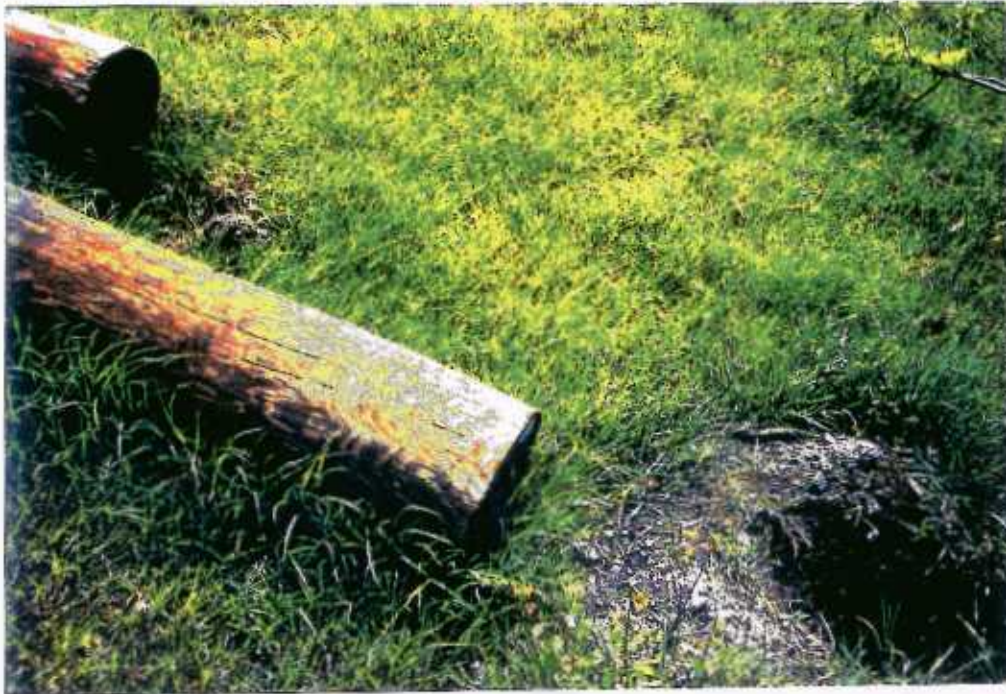
49 Close-up of the failure in No 48

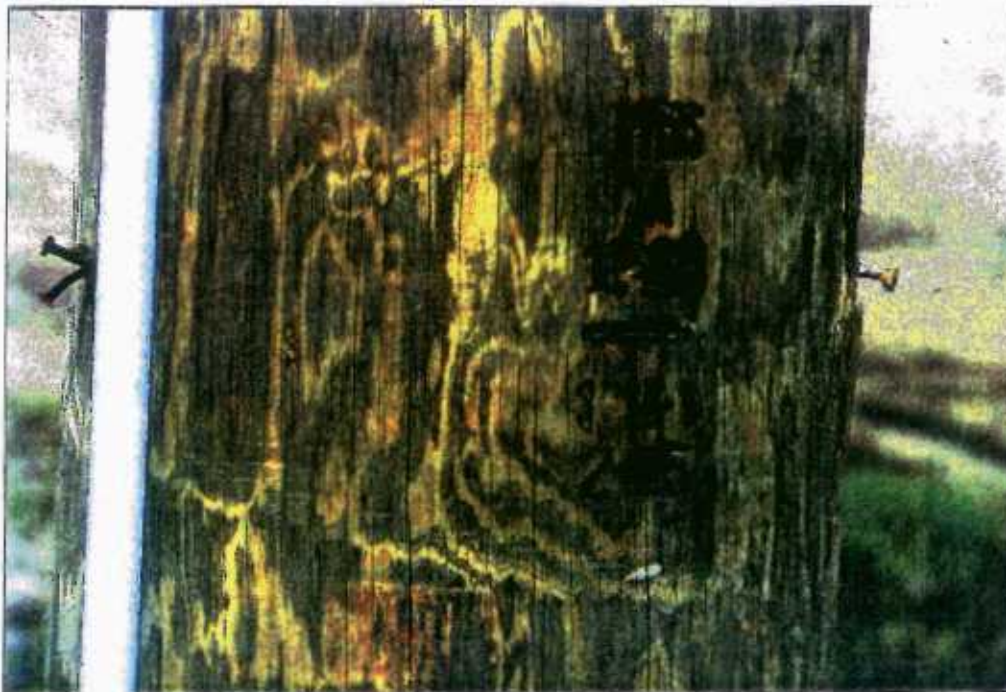
50 Poles are marked with manufacturer's recommendations for embedment

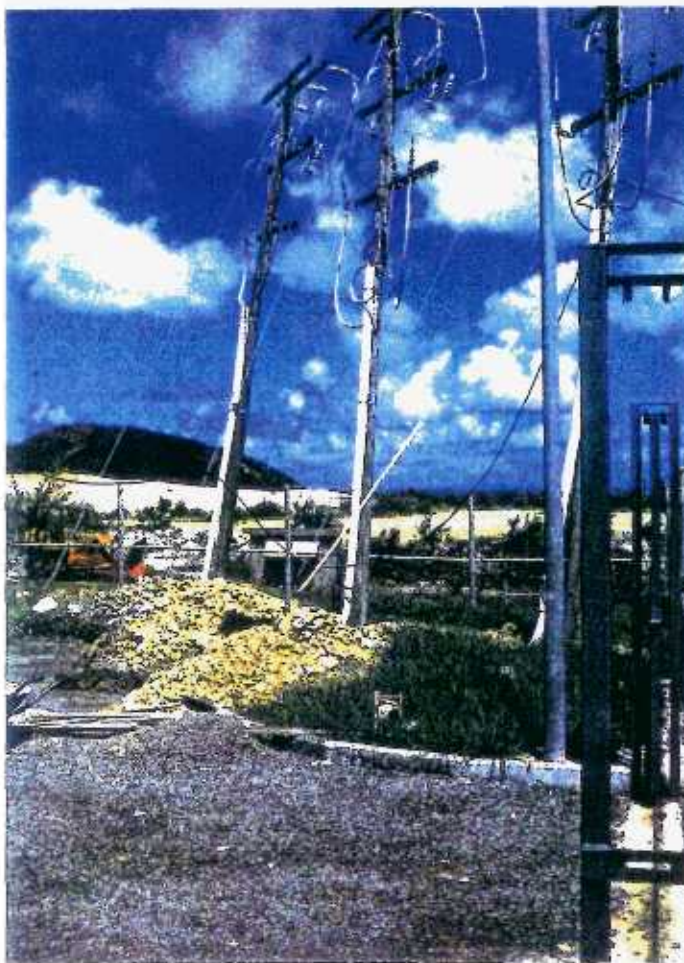
51 End of the line at Five Islands Substation - note the leaning poles indicating incipient failure of the anchorages

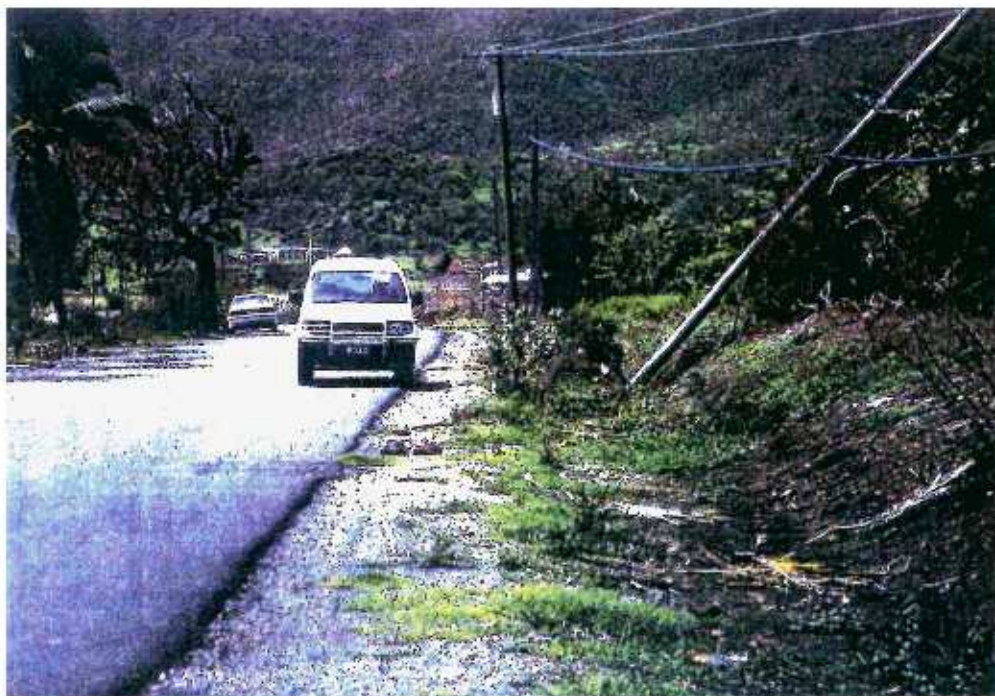
52 The leaning poles were planted before the road was excavated (west of Old Road). This led to less eventual foundation depth than was intended.

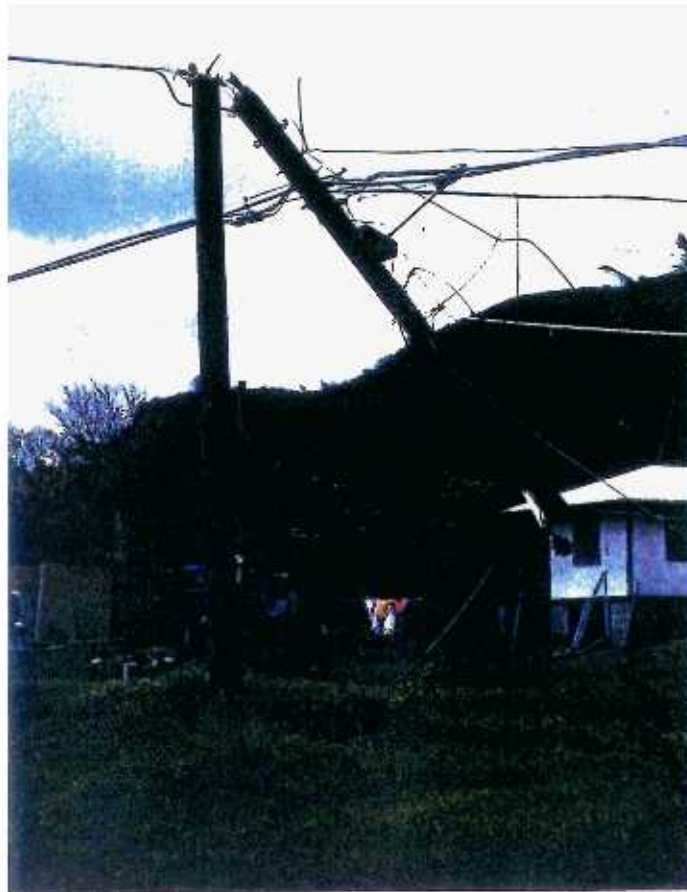
53 The pole broke at the location of a drilled-through tie anchorage

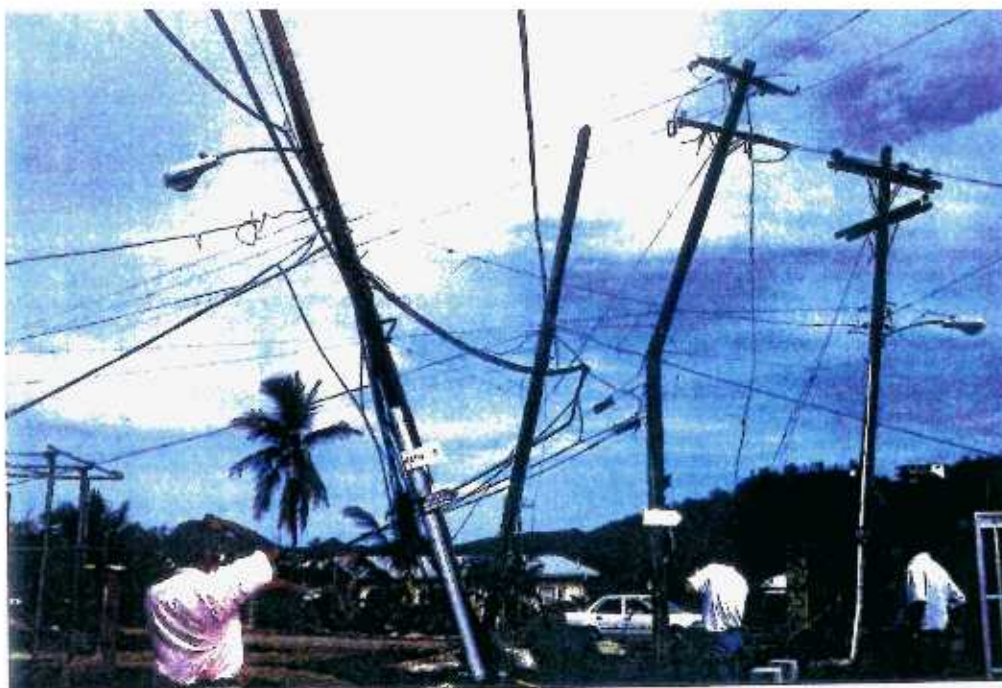
54 Total chaos at the Falmouth-Piccadilly Junction

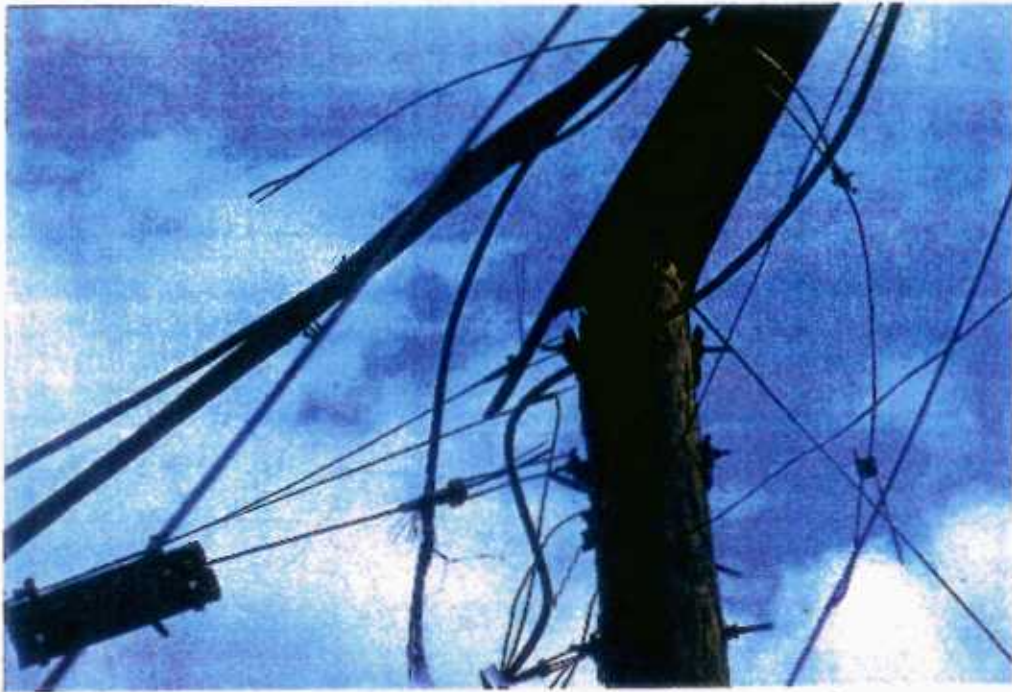
55 Close-up of broken pole in No 54

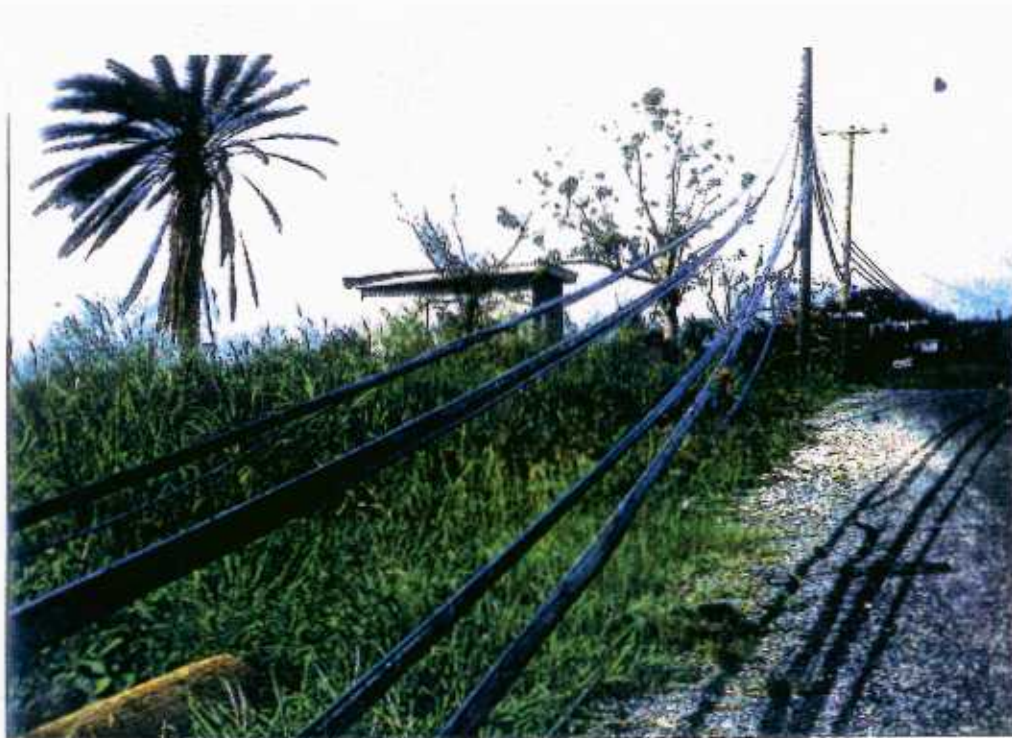
56 Many of the poles were overloaded with telephone and television cables (Jonas Road)

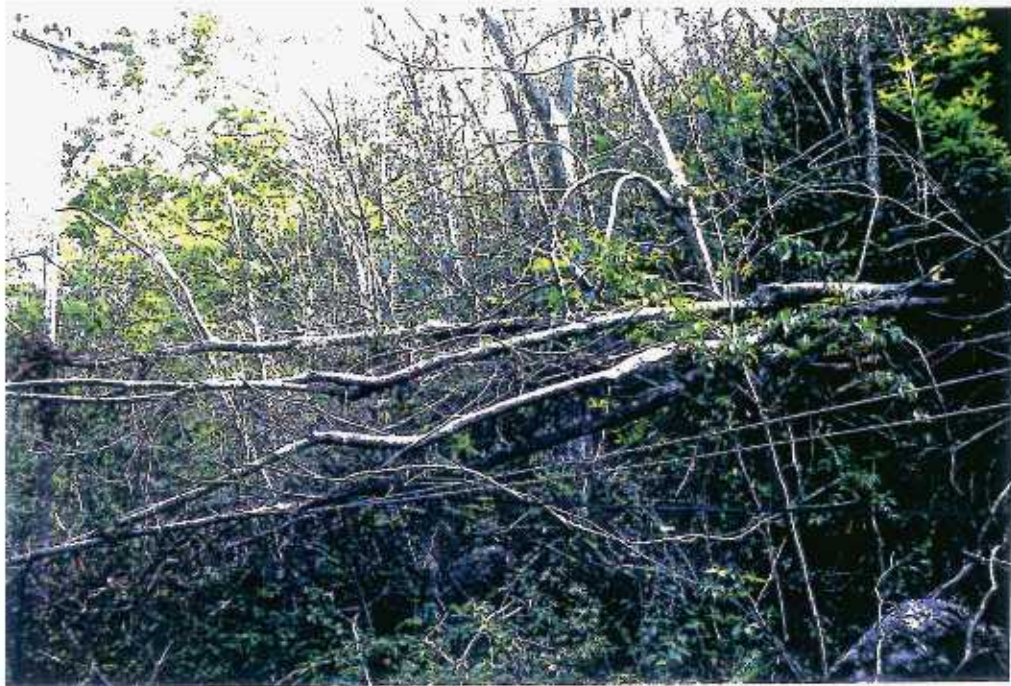
57 Damage due to trees was not common-place in Antigua (John Hughes area)

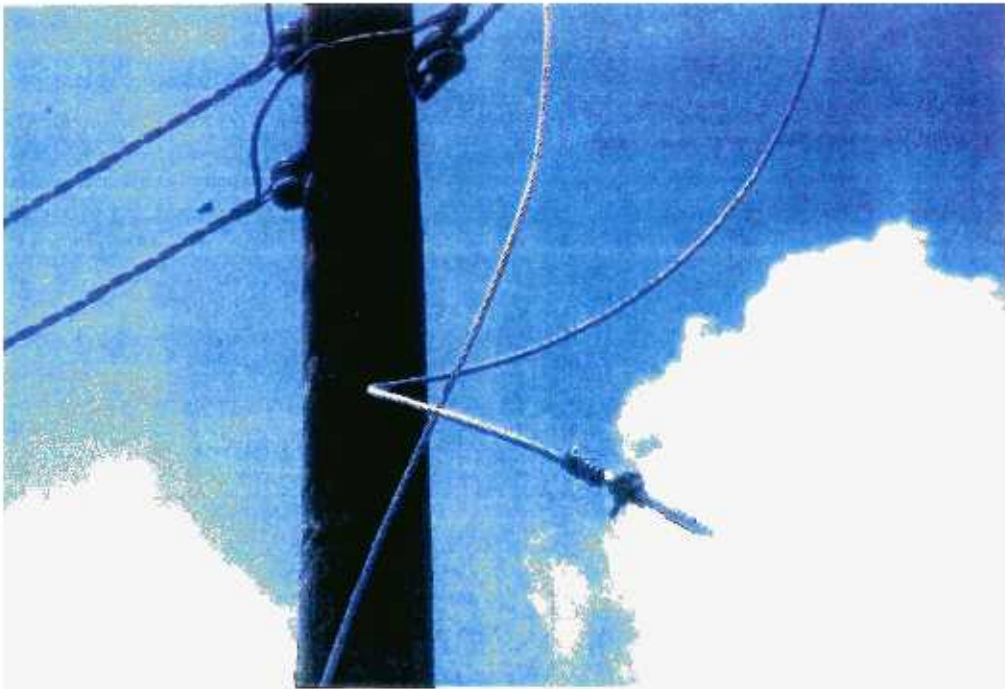
58 There were 160 examples of broken conductors

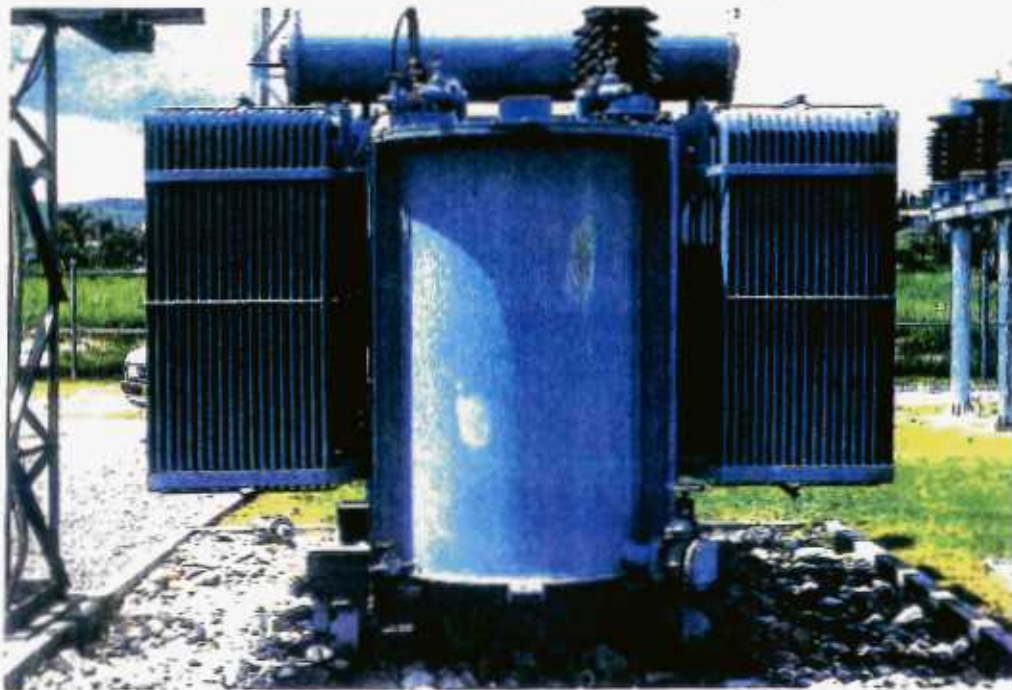
59 Heavy equipment may not be vulnerable in hurricanes, but need to be anchored for the earthquake hazard.
