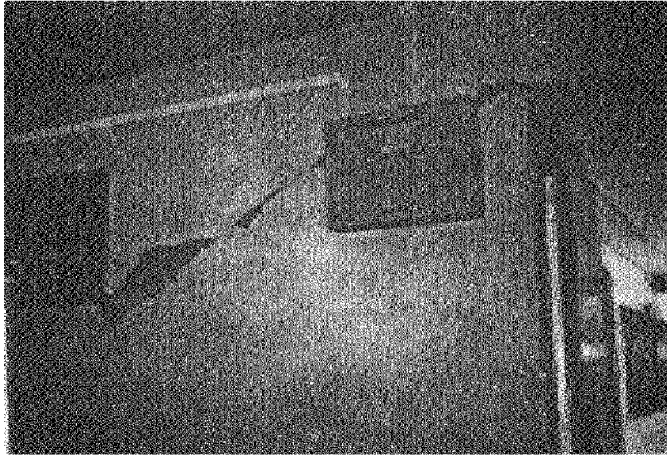
photo NO. 11 wall is cracked

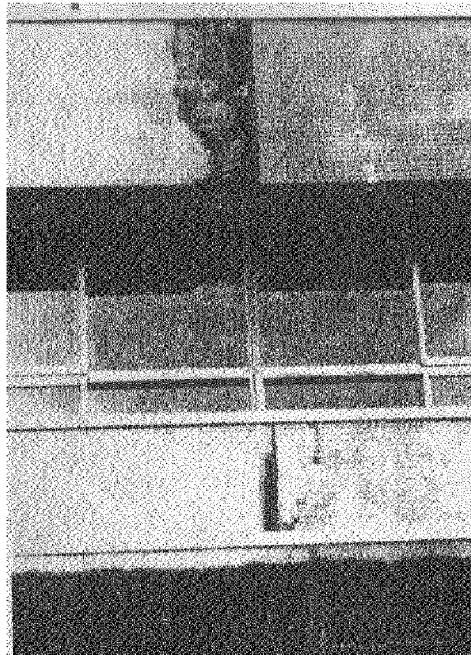
photo NO 12 exp-joint is cracked

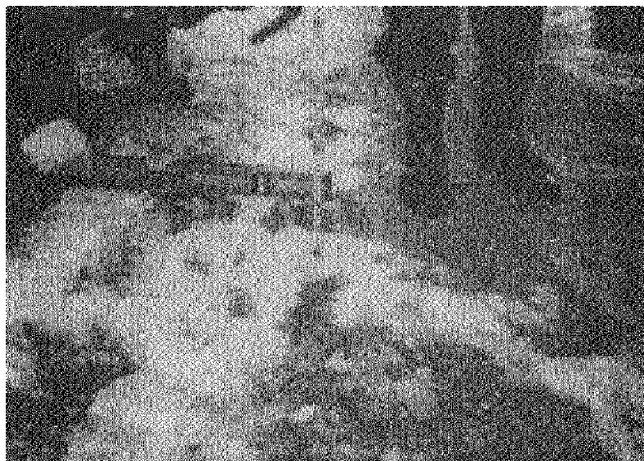
photo NO. 13 subsidence in the ground

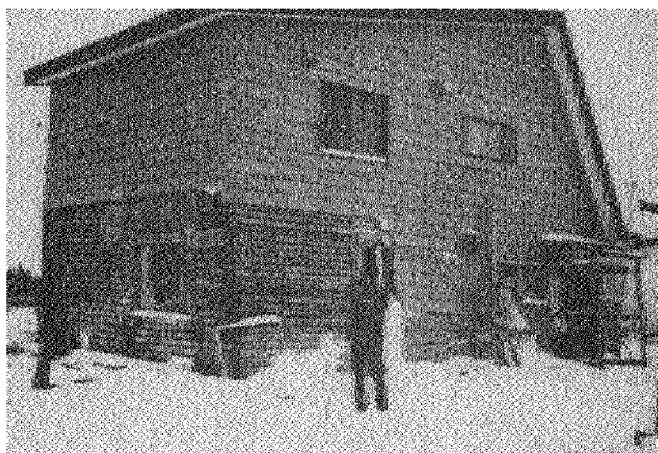
photo NO. 14 destroyed brick wall

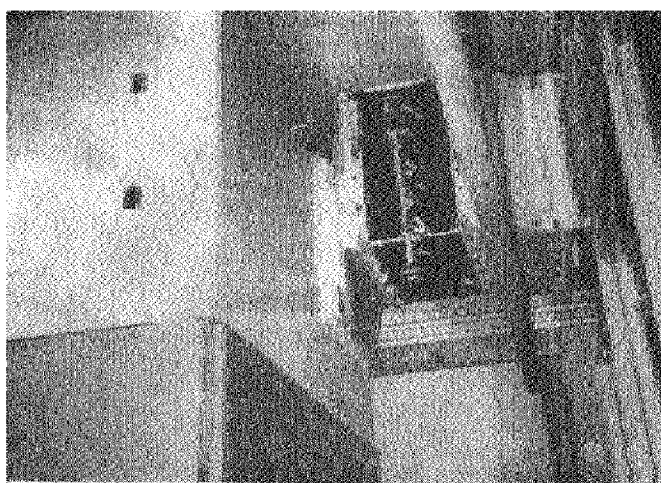
photo NO 15 pipe laying is differ
