4.2 Wind Observations: Damages and Successes

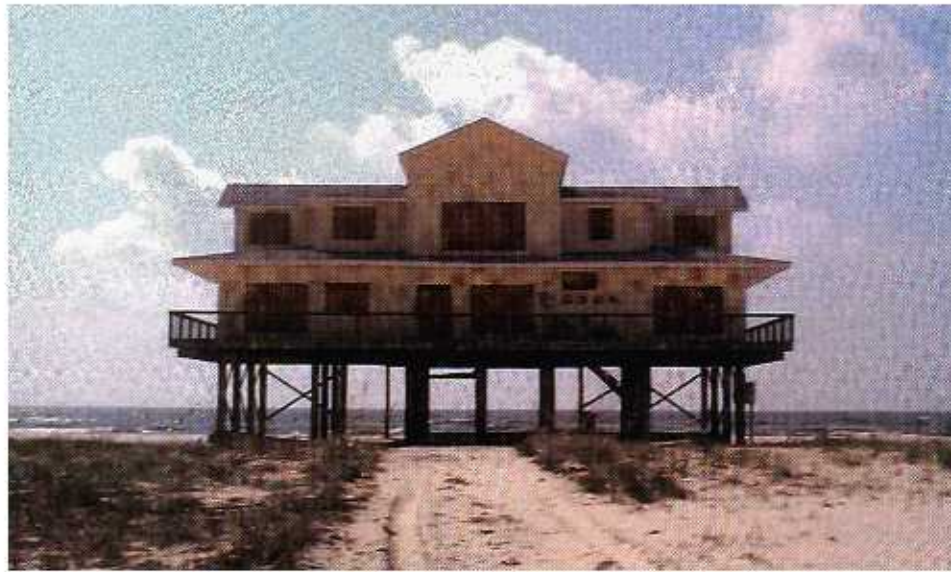
FIGURE 4-18 This house sustained no damage with the exception of loss of stairs and items stored below the first-floor elevation.

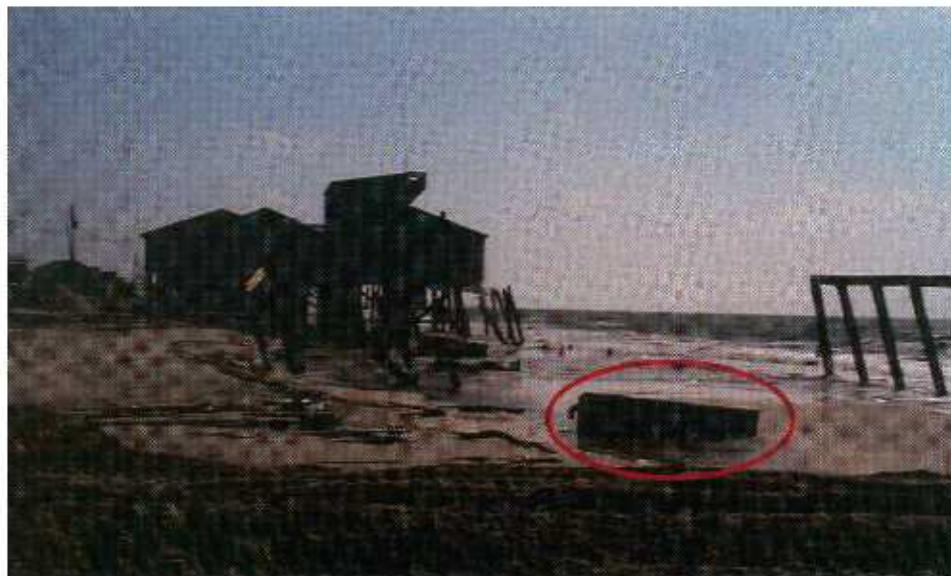
FIGURE 4-19 Old concrete septic tanks (circled) and drain fields have been superseded by the new municipal sanitary sewer system. The old systems still create a hazard as waterborne debris.

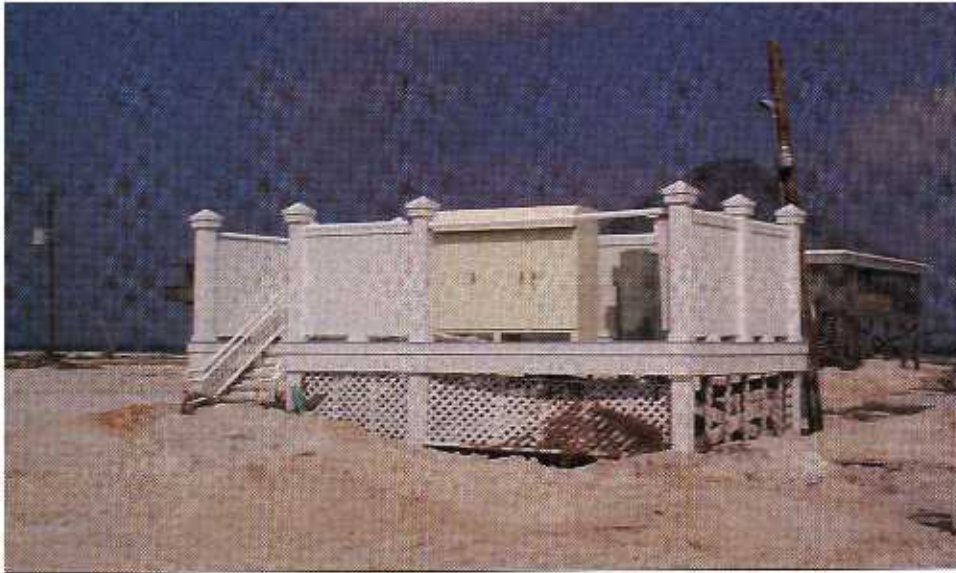
Dauphin Island's attention to utility systems was another example of successful mitigation. In response to repetitive damage to individual septic systems by past storms, the community installed a new municipal sewer system. The system performed well and suffered only minor damage as a result of the storm. Extensive beach erosion from Hurricane Georges would have required complete replacement of the individual septic systems for homes that were converted to the municipal system (Figure 4-19). In addition to the sanitary sewer system, the community is also elevating utility platforms for cable television and telephone switching stations to minimize damage due to coastal surge. As shown in Figure 4-20, the elevated platform performed well and adequately protected the utility boxes.

FIGURE 4-20 Other than losing part of the lattice screening, this elevated utility platform performed well.

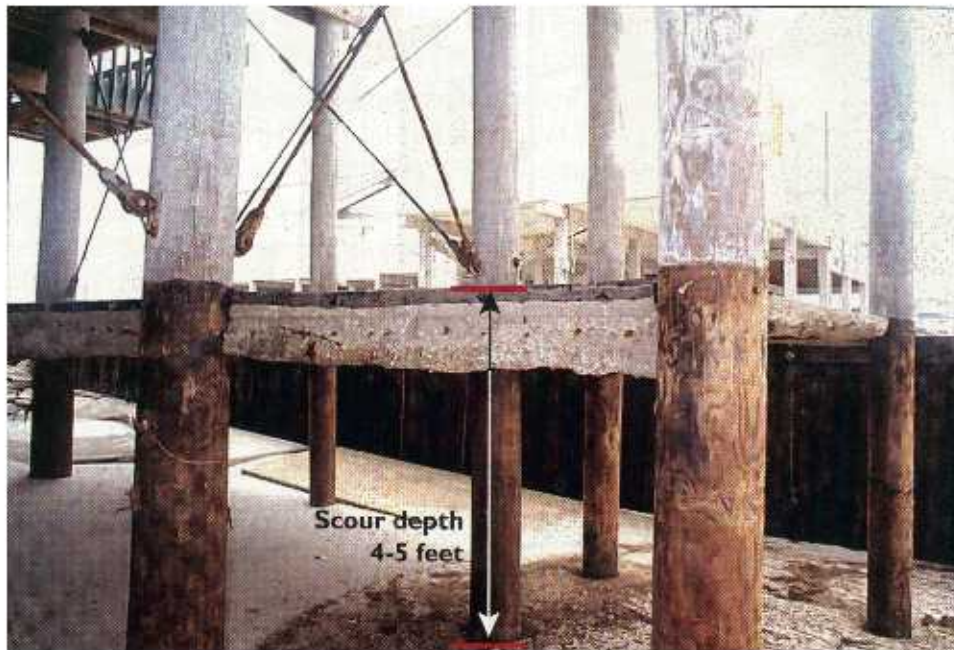
Although damage along the Fort Morgan/Gulf Shores shorelines was less severe than that observed on Dauphin Island, evidence of scour was more prevalent. This was due to more frequent use of at-grade concrete slabs and bulkheads in this area (Figure 4-21). While the depth of piles was not identified as a problem, concrete slab connections to piles or damage to piles as the slabs broke up was a concern due to the creation of unanticipated loads on the building foundations.

FIGURE 4-21 Erosion/scour behind bulkhead and below the concrete slab caused by storm surge. Note the concrete slab did not completely detach from the piles.

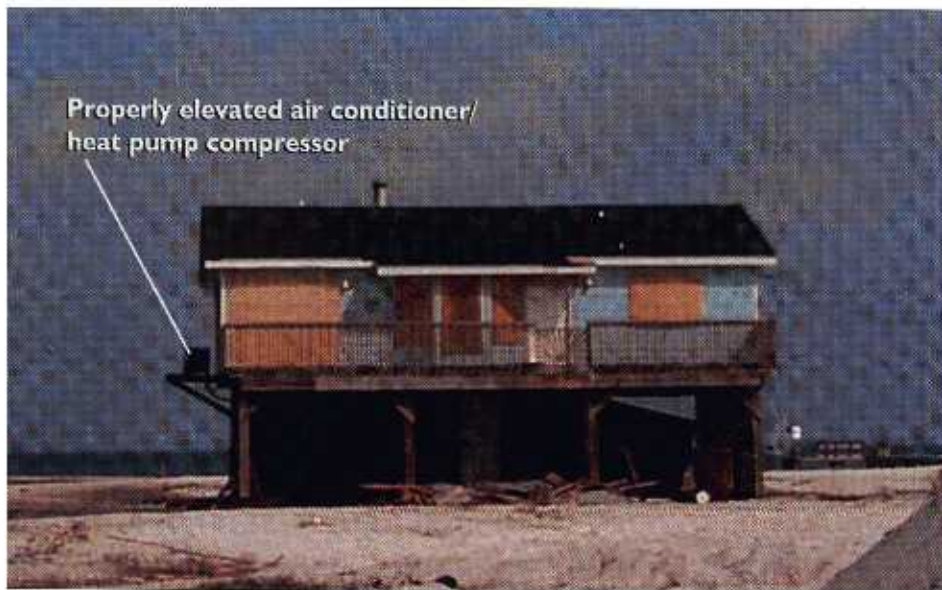
For the most part, when structures were elevated an effort was also made to elevate air conditioning/heat pump compressors and other similar on-site utility equipment. When elevated to the BFE and placed on adequately supported platforms the facilities performed well (Figure 4-22). Where installation was inadequate, they generally failed (Figure 4-23)

FIGURE 4-22 This cantilever platform performed well.

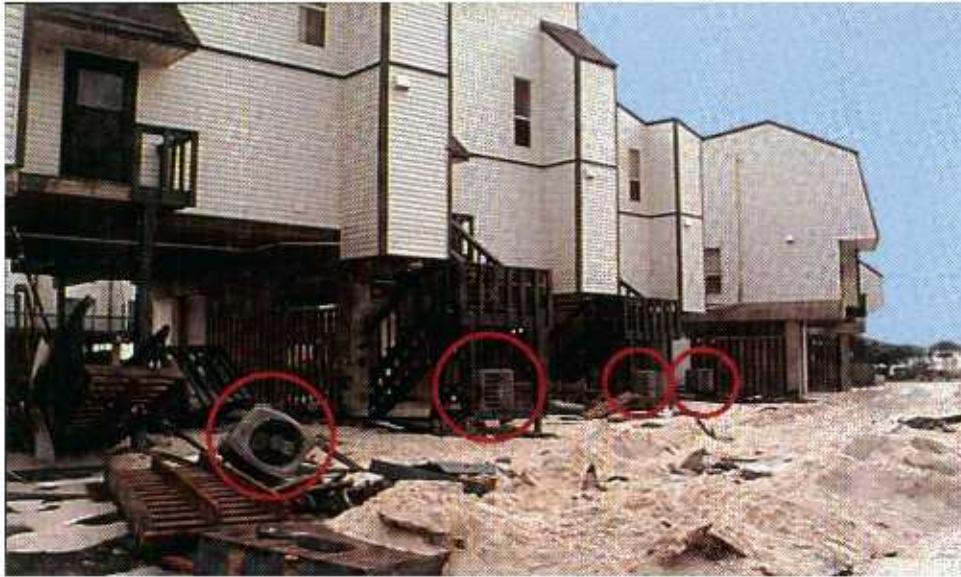
The placement of on-site exterior utility equipment (air conditioner/heat pump compressors) was a concern at both Dauphin Island and Fort Morgan/Gulf Shores areas. In several instances, damage occurred because these utilities were not elevated and not properly anchored.

FIGURE 4-23 These air conditioner/heat pump compressors in Gulf Shores were not elevated and therefore were severely damaged.

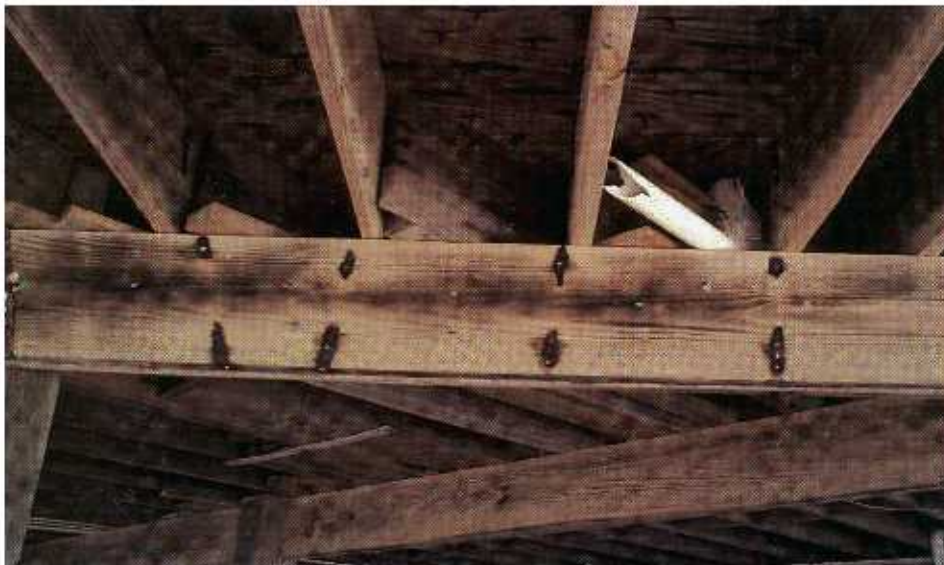
Another issue of concern to the BPAT was the condition of metal hurricane straps, clips, and joist hangers. The salty coastal environment appeared to have caused deterioration of hurricane straps and clips. In some instances, the straps were completely corroded (Figure 4-24). In these cases, only the dead load of the building resisted the overturning or sliding of the building off its foundation.

FIGURE 4-24 Only remnants of corroded hurricane straps remain.

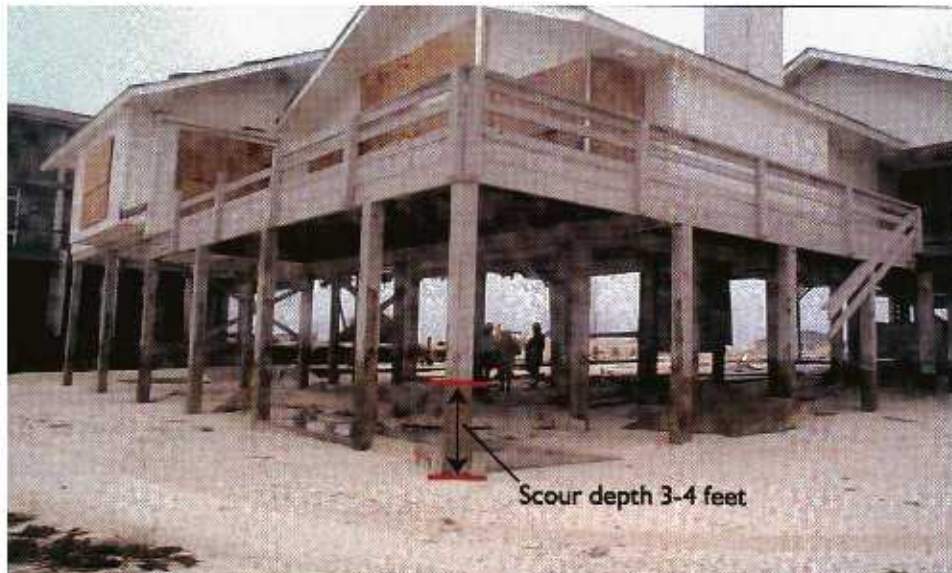
FIGURE 4-25 Despite the loss of 3 to 4 feet of sand, this structure performed well. Note at-grade slabs broke away as intended.

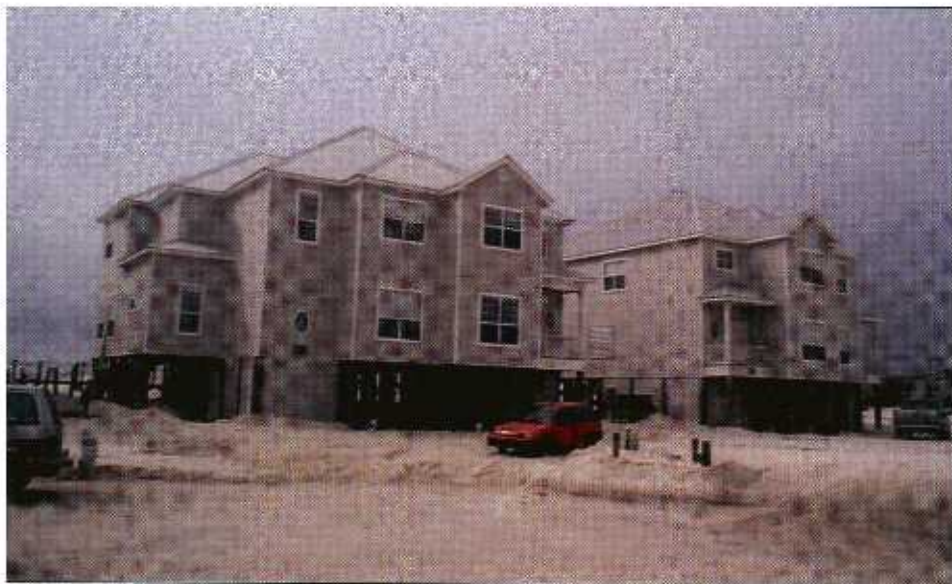
FIGURE 4-26 These multi-family buildings in Fort Morgan suffered no damage from coastal storm surge. Proper elevation, siting, and building materials contributed to their success. Note roof design that minimizes the use of gable ends.

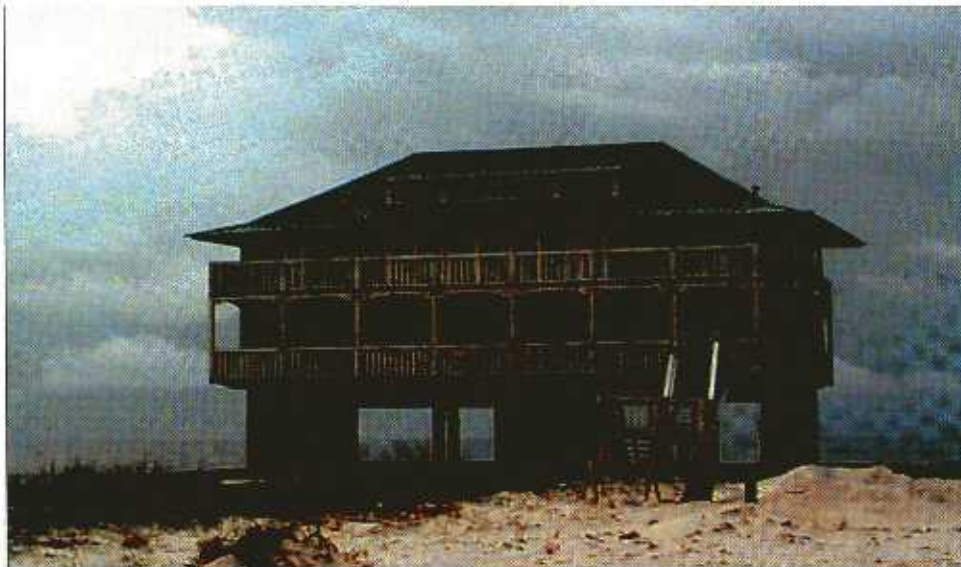
FIGURE 4-27 This properly elevated structure in Gulf Shores suffered no damage other than the loss of breakaway walls and slight damage to its stairs.

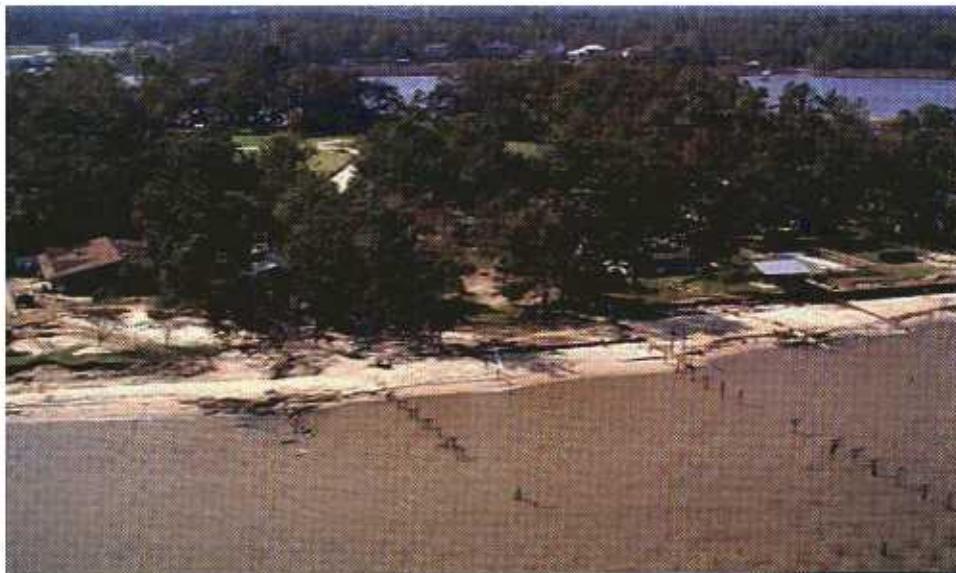
FIGURE 4-28 Typical shoreline erosion along low-lying areas adjacent to Mobile Bay.

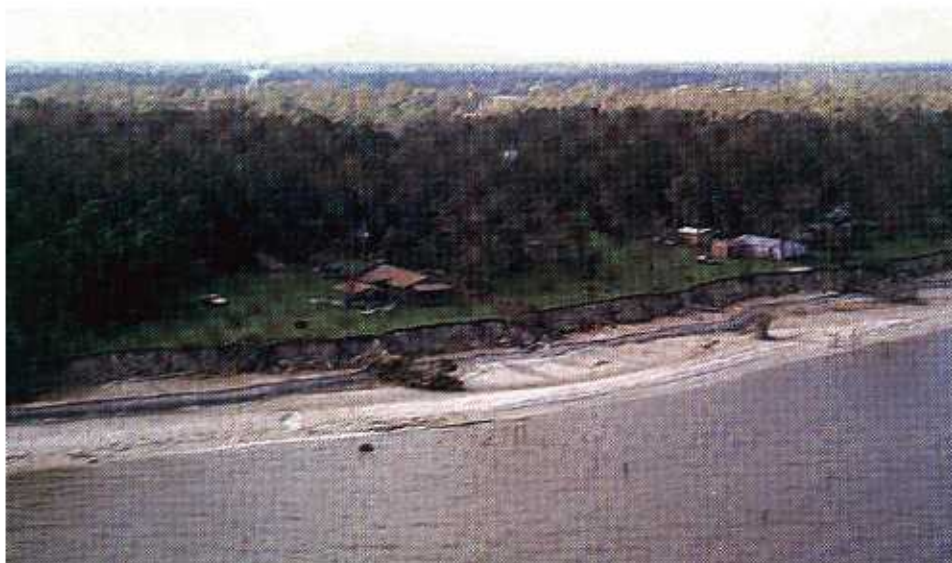
FIGURE 4-29 Typical erosion along bluffed shoreline areas of Mobile Bay (western side).

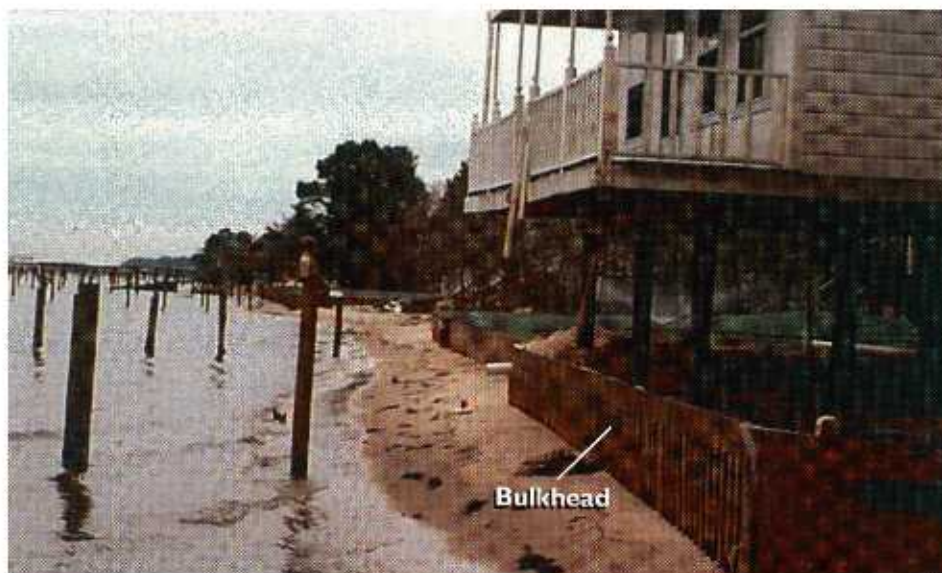
Wave action removed sand in front of bulkheads and overtopping removed much of the material from behind. Erosion was retarded by a relatively resistant, hard red clay layer located at a depth of 8 to 14 inches below grade. Following the hurricane, most bulkheads were still structurally sound as shown in Figure 4-30. Additional horizontal scour adjacent to bulkheads, caused by wrap-around focusing of wave energy, was common along Mobile Bay.

FIGURE 4-30 Bulkheads on Mobile Bay still in place after storm.

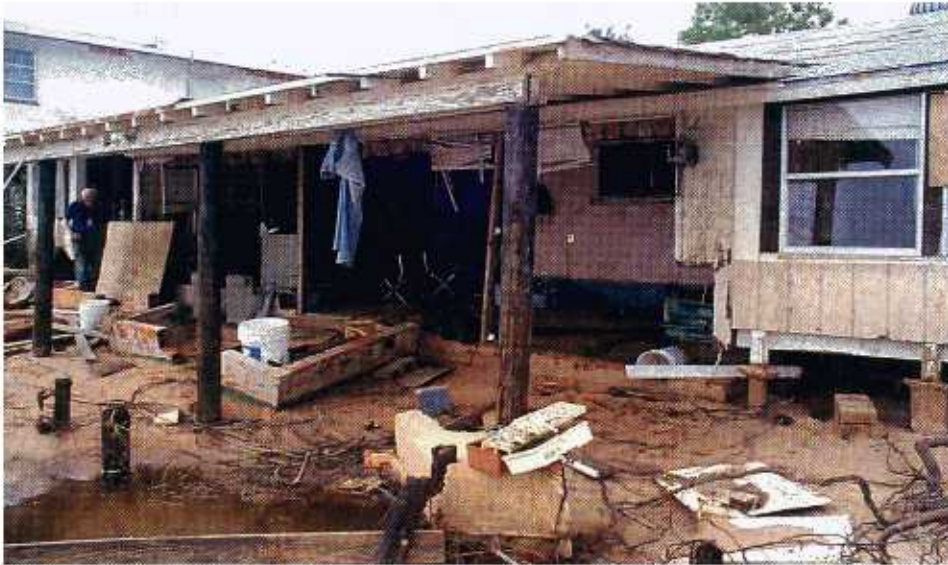
FIGURE 4-31 Non-elevated pre-FIRM structure severely damaged by coastal storm surge.

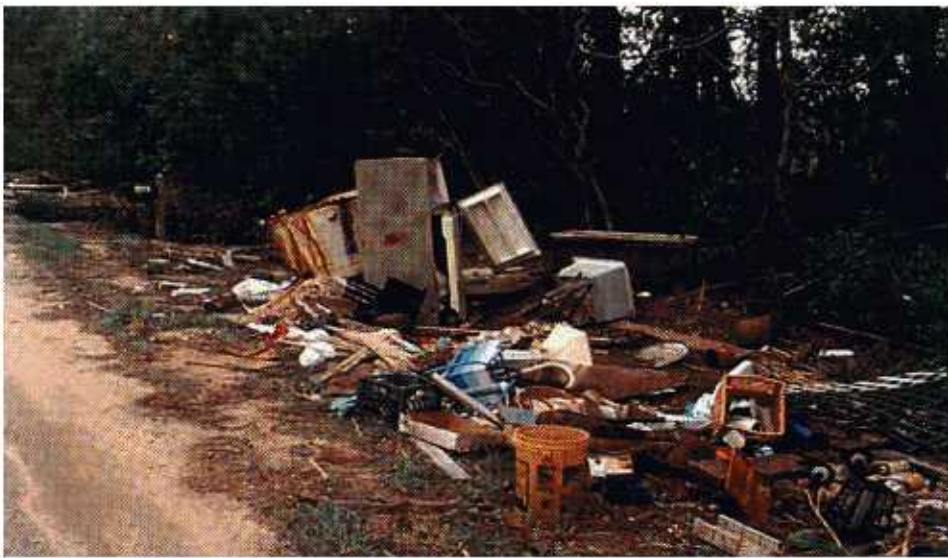
FIGURE 4-32 Debris accumulation along coastal roadway.

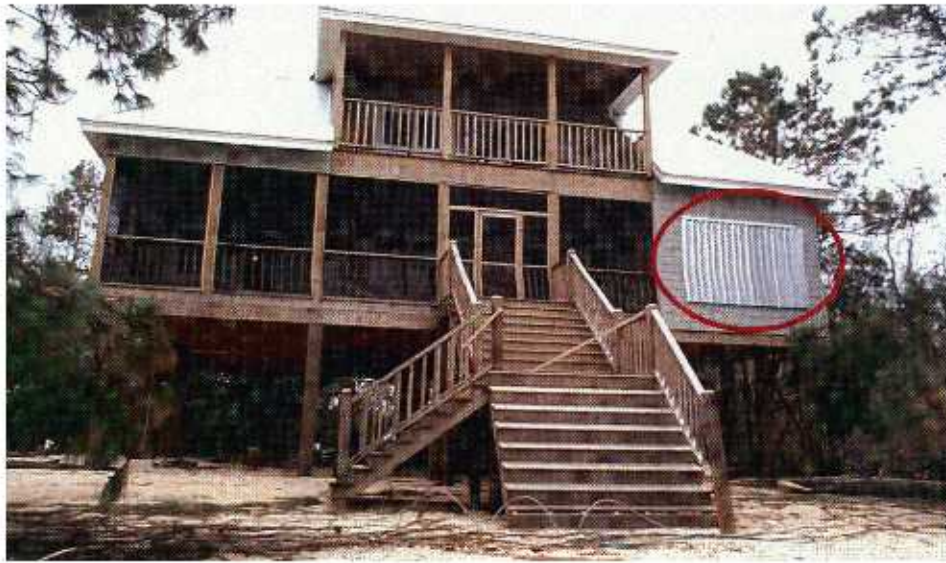
FIGURE 4-33 A properly elevated post-FIRM front-row coastal house that suffered only minor damage to stairs. Note the storm shutter on the front window.

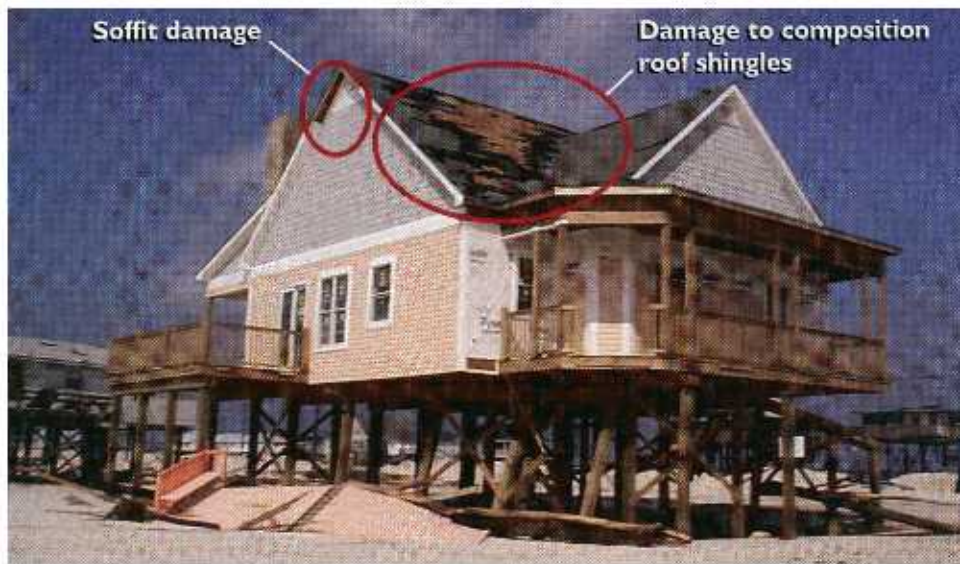
FIGURE 4-34 Wind damage to composition roof shingles and siding on newly built coastal home.

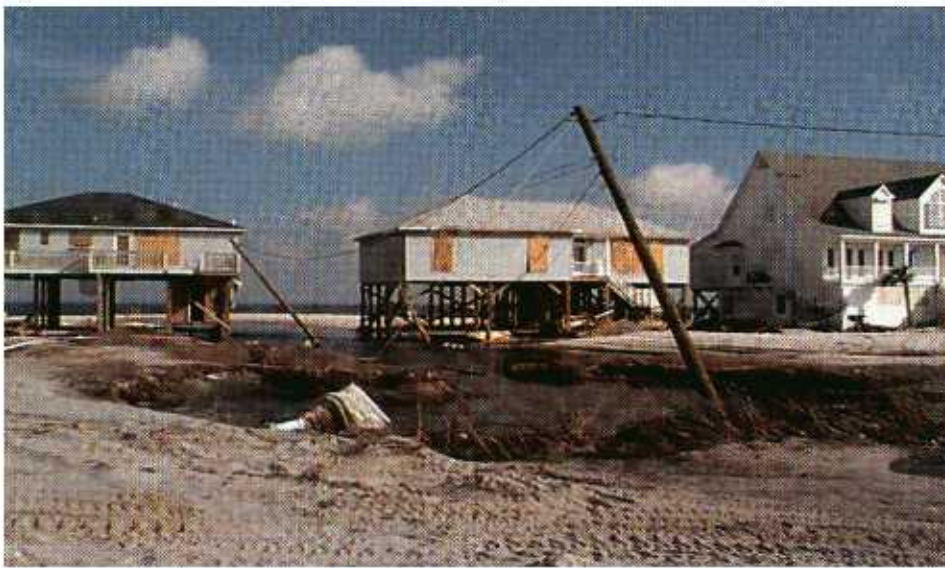
FIGURE 4-35 Utility poles damaged by wind, coastal surge, and erosion.

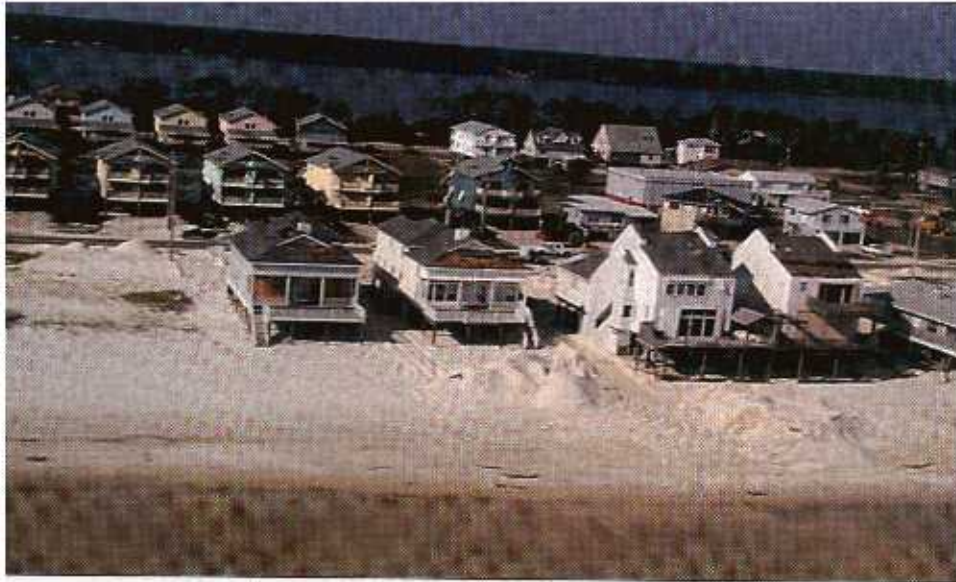
FIGURE 4-36 Houses in Gulf Shores with roof damage. Note loss of roof covering on front-row buildings.

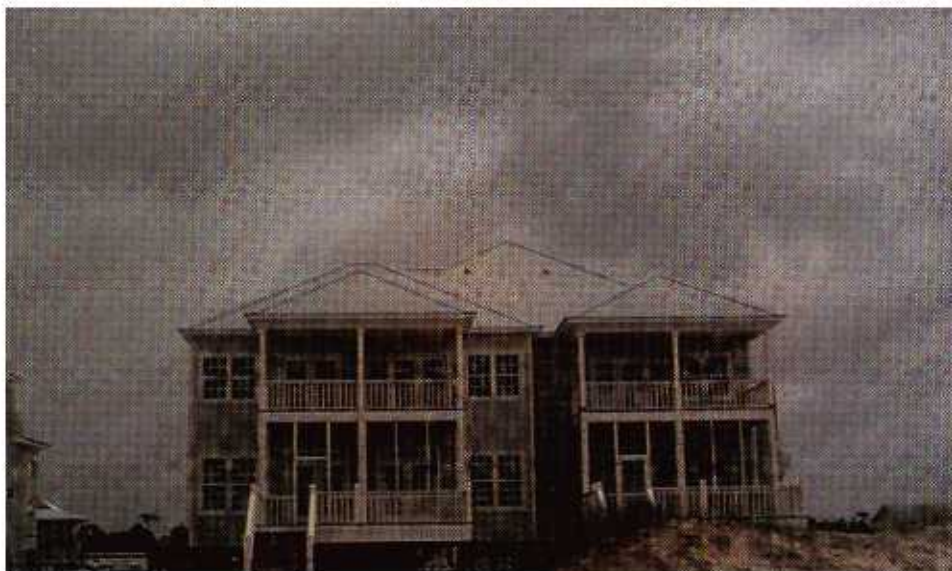
Metal roofs are becoming more common along the Alabama coastal and inland areas, specifically on Dauphin Island, Gulf Shores, and the Mobile Bay area. During this disaster, metal roofs appeared to have sustained little damage (Figure 4-38). However, since they are relatively new, their success must be further evaluated and based on longer exposure to salty, corrosive conditions and other environmental factors. The long-term performance of fasteners/connectors has been a particular concern in the past. In addition, most metal roofs the BPAT observed probably were not exposed to design level or greater winds.

FIGURE 4-38 Metal roofing system on multi-family building in Fort Morgan performed well.

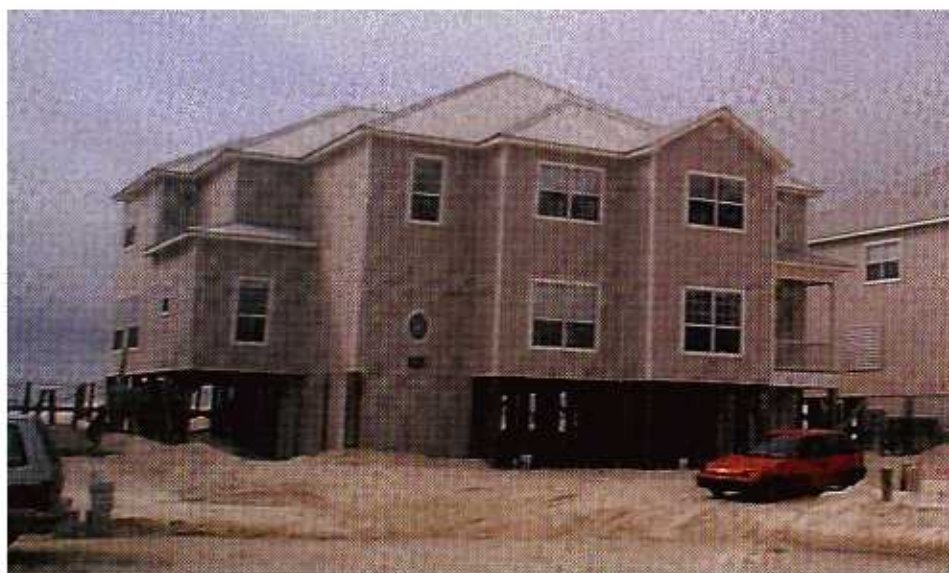
The BPAT discovered two structures in the Fort Morgan area with fiber-reinforced concrete siding. Upon inspection, this siding appeared to suffer no wind damage. The strength and rigidity of the material, the use of stainless steel nails, and the adherence to a specified nailing pattern apparently contributed to the successful performance of the siding (Figure 4-39).

FIGURE 4-39 Fiber-reinforced concrete siding suffered no damage.
