5.3 Manufactured Homes in the Florida Keys

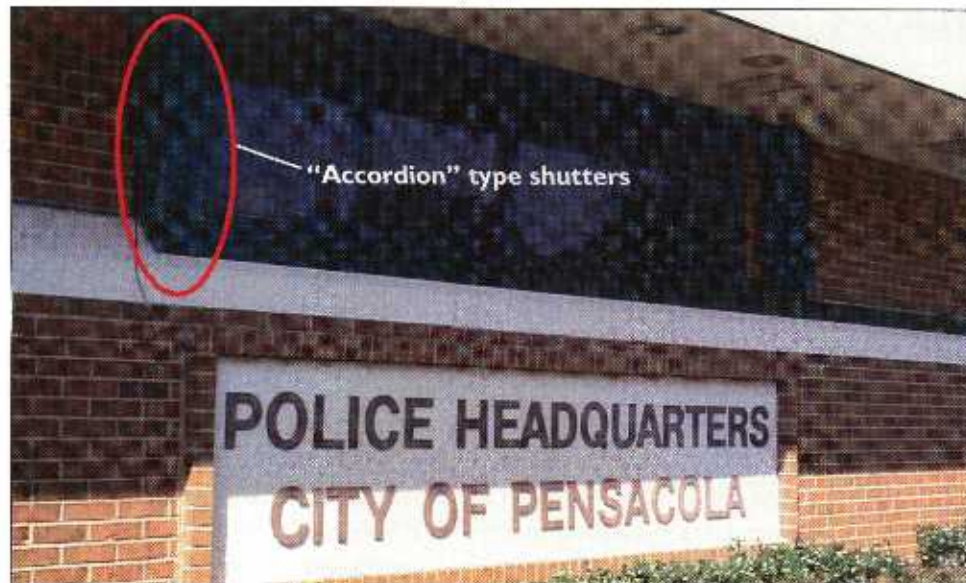
FIGURE 5-15 Window shutters on the Pensacola Police Headquarters.

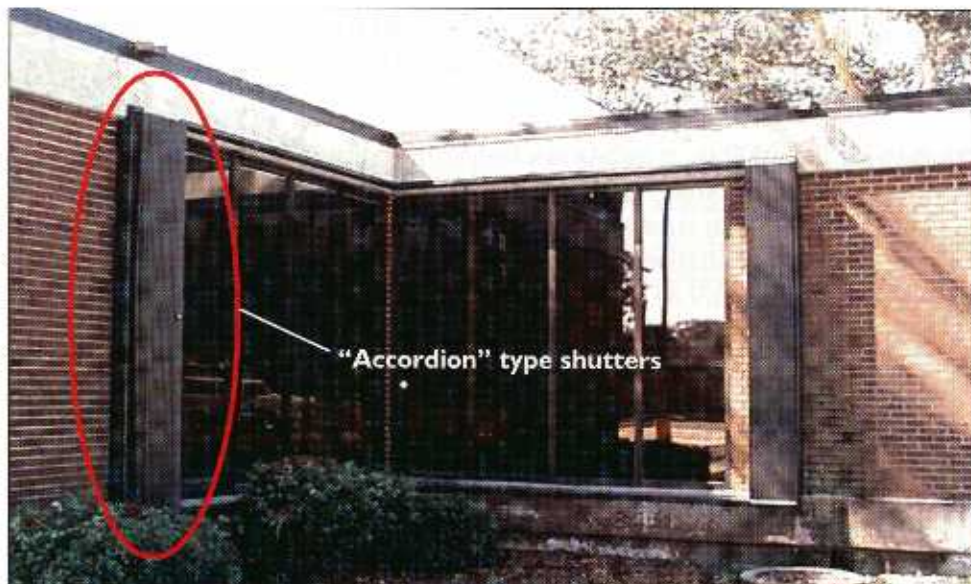
FIGURE 5-16 Window shutters on the Escambia County Administration Building.

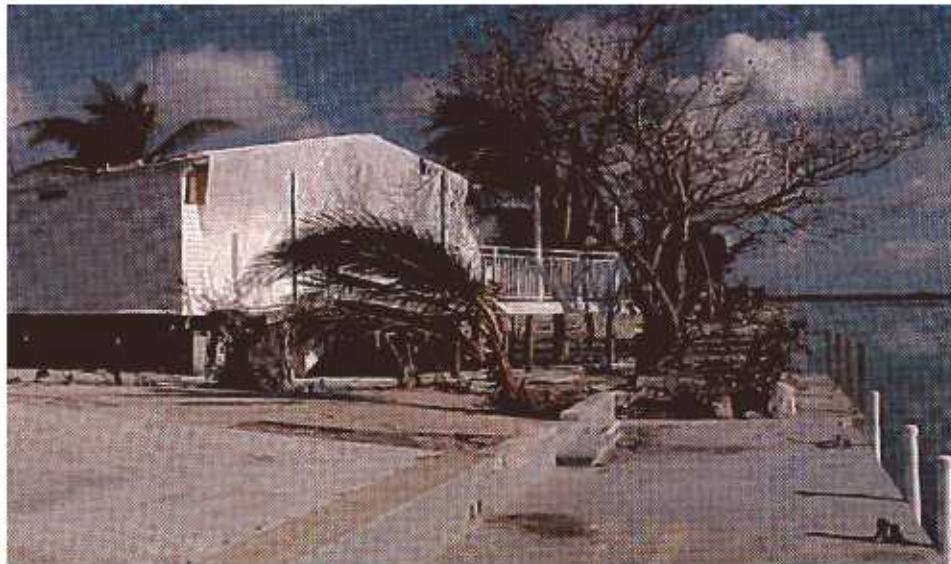
Wind and coastal storm surge damages were evaluated on Cudjoe Key. Elevated homes were exposed to only limited storm surge; most damage was attributed to wind. In general, manufactured homes built after implementation of the new HUD and state regulations (July 1994) performed much better than older (pre-1994) manufactured homes. Damage to the newer homes was superficial and often could be attributed to an attached awning or the impact of airborne debris from an adjacent structure. The manufactured home in Figure 5-17 was located directly in the path of the storm just to the east of the eye and received maximum wind exposure. The home itself sustained only ancillary damage as a result of the awning being torn away.

FIGURE 5-17 This home suffered damage when its awning blew off. The lot next door contained an older manufactured home that was completely destroyed by high winds and coastal surge.

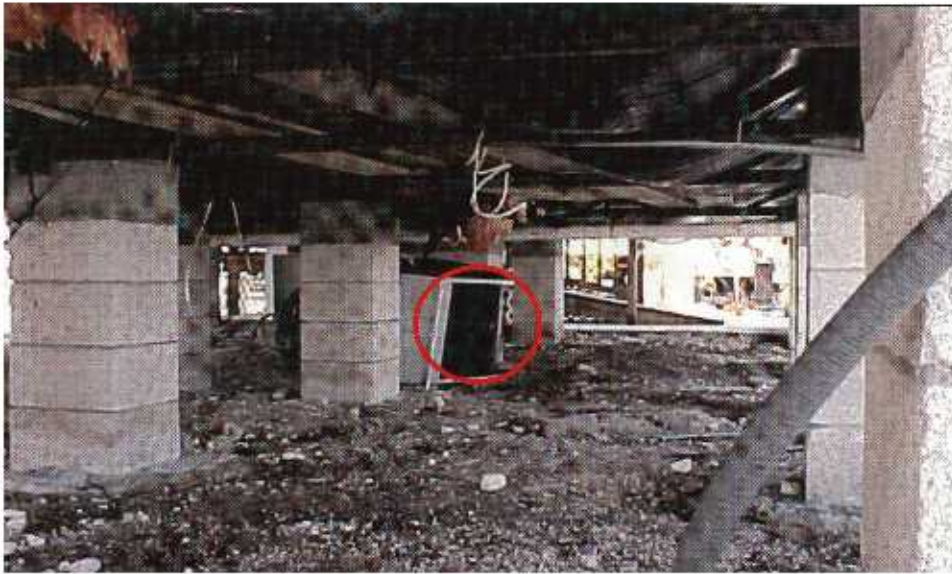
Foundation systems for the manufactured homes installed during the past four years were typically reinforced concrete or reinforced masonry piers (Figure 5-18). These homes were at or above the coastal storm surge elevation experienced during Hurricane Georges. Most of these homes experienced only non-structural damage to lower area skirting. In some cases, water damage occurred to insulation below the floor.

FIGURE 5-18 Reinforced masonry pier foundation system under a newer manufactured home that performed well. The air conditioner compressor (circled) washed under the home provides evidence of the coastal surge at this location.

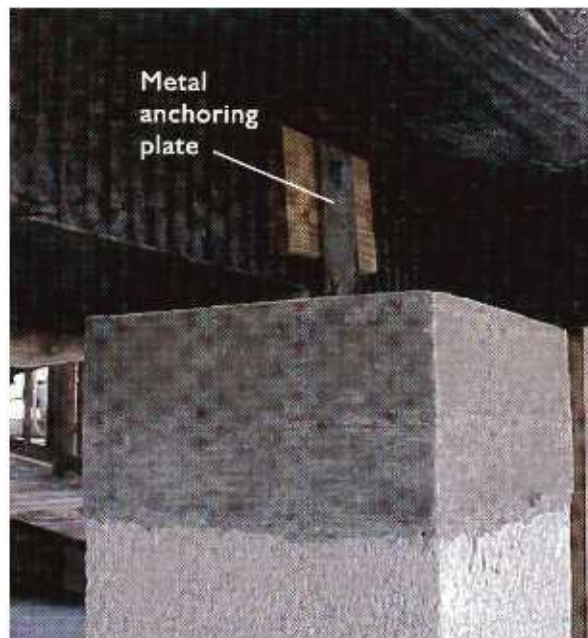
Homes generally appeared to be well anchored to the foundation piers. Many had steel plates attached to the piers and secured to the frame with large bolts (Figure 5-19). There were usually at least three connections per beam under the home. The minimum number observed was two, located at the ends of each beam.

FIGURE 5-19 Reinforced masonry pier with metal anchoring plate.

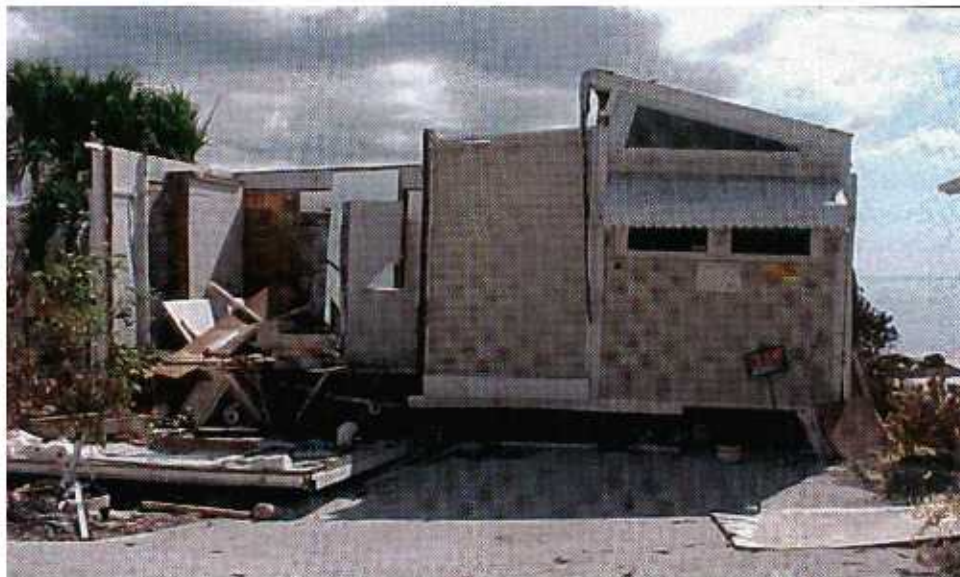
Older manufactured homes were typically elevated 1 to 2 feet on dry stacked blocks. These homes were damaged and sometimes destroyed by a combination of wind and coastal storm surge (Figure 5-20).

FIGURE 5-20 Older, non-elevated manufactured home with an addition that sustained substantial damage.

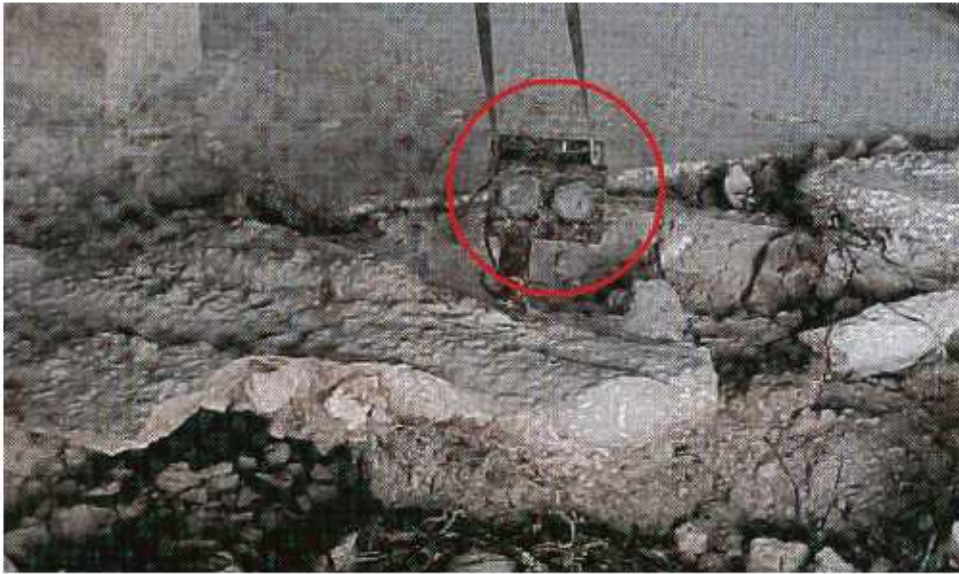
Some of the anchoring and installation problems observed on older homes included poorly attached anchors, lack of corrosion resistant materials, and homes not anchored tightly against support piers (Figures 5-21 to 5-23). Another anchoring problem observed was improperly attached tie-down straps (Figure 5-24). Figure 5-25 shows a correct strap installation that was observed.

FIGURE 5-21 This anchor is only encased on the edge of the concrete fill pad and could easily be dislodged when the home is subjected to more severe wind or flood loads.

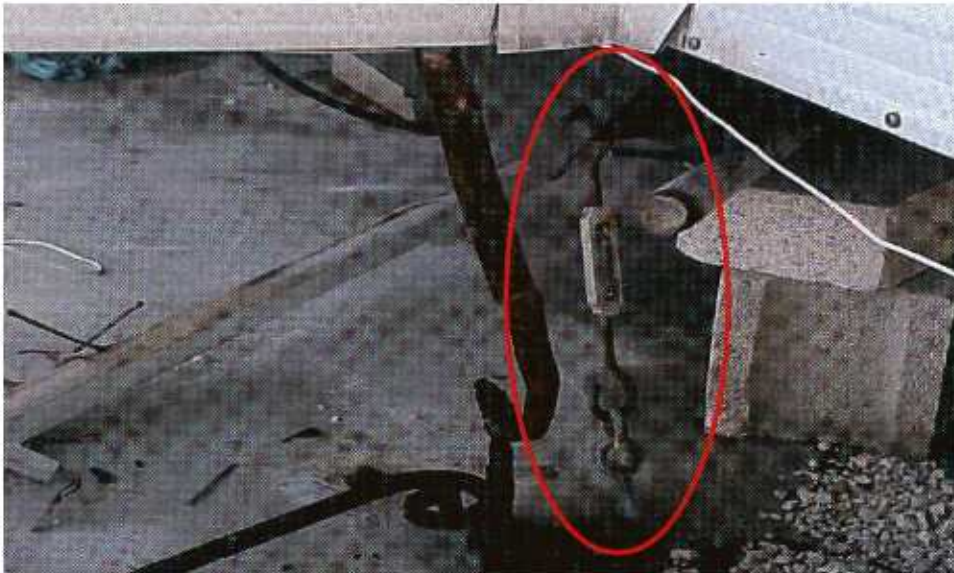
FIGURE 5-22 Inadequate turnbuckle anchor installed by homeowner on this older manufactured home. The home was severely damaged due to the lack of elevation, an unreinforced foundation system, and poor anchoring.

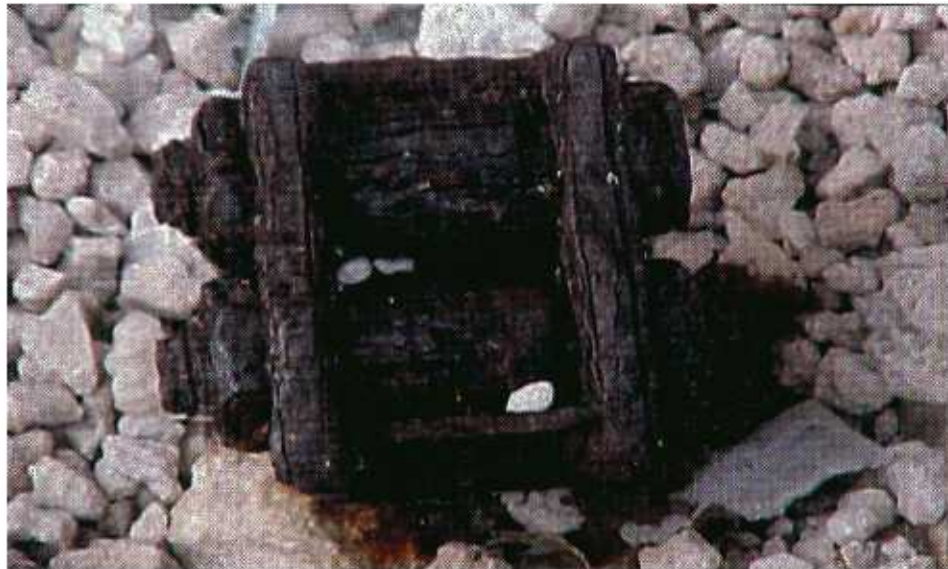
FIGURE 5-23 Rusted anchor under an older manufactured home. The State of Florida mandated galvanized anchors after January 1, 1999.

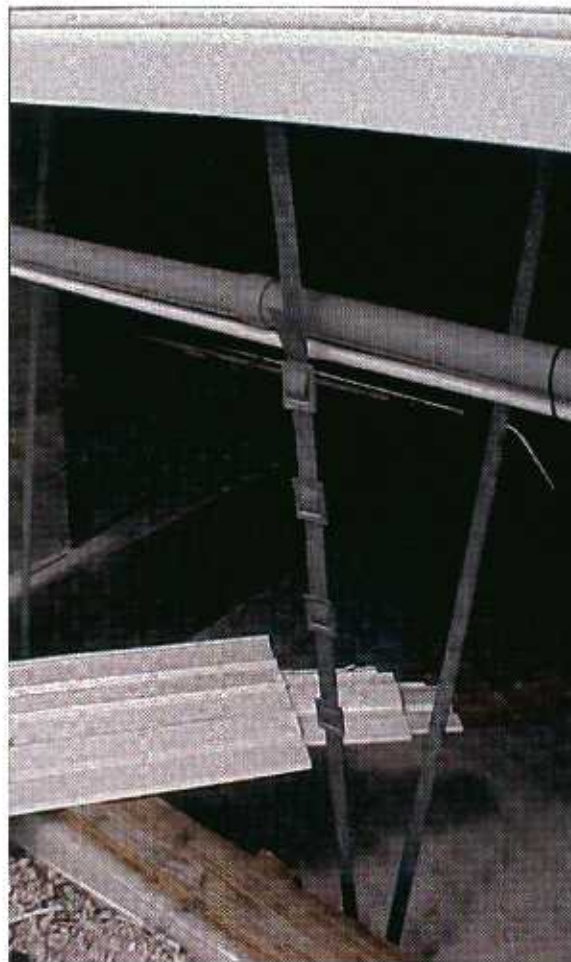
FIGURE 5-24 Improper strap installation. The buckle should be positioned where the strap wraps around the beam as shown in Figure 5-25.

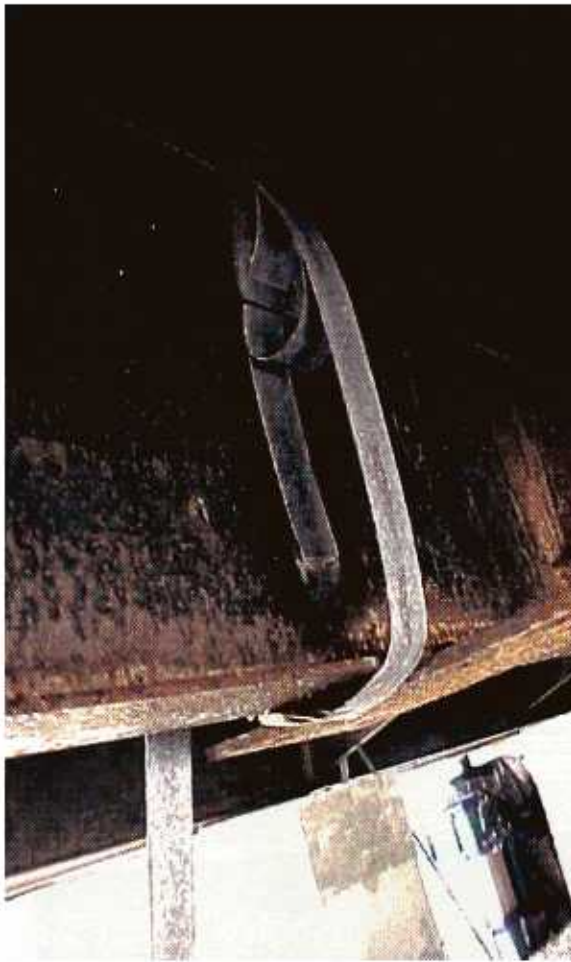
FIGURE 5-25 Proper strap installation.

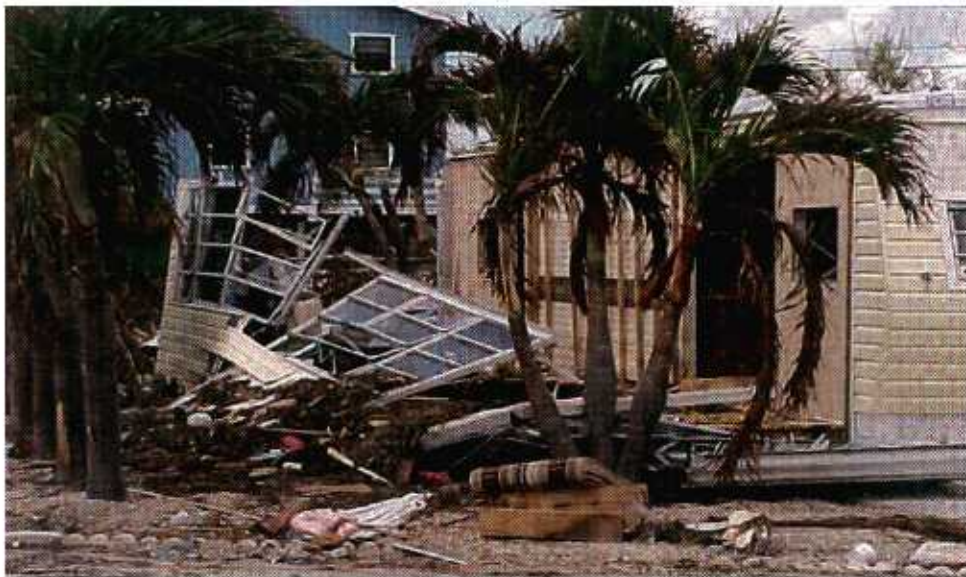
Manufactured homes that sustained the most damage appeared to be older homes with attached decks, porches, and awnings (Figure 5-26). Although undamaged during this storm, the manufactured home in Figure 5-27 could sustain significant damage if hurricane-force winds or storm surges were to get under the deck and pull it away from the building. It should be noted that site-built, attached additions to manufactured homes are no longer permitted after March 1997.

FIGURE 5-26 The addition to this manufactured home was destroyed, causing considerable damage to the rest of the home.

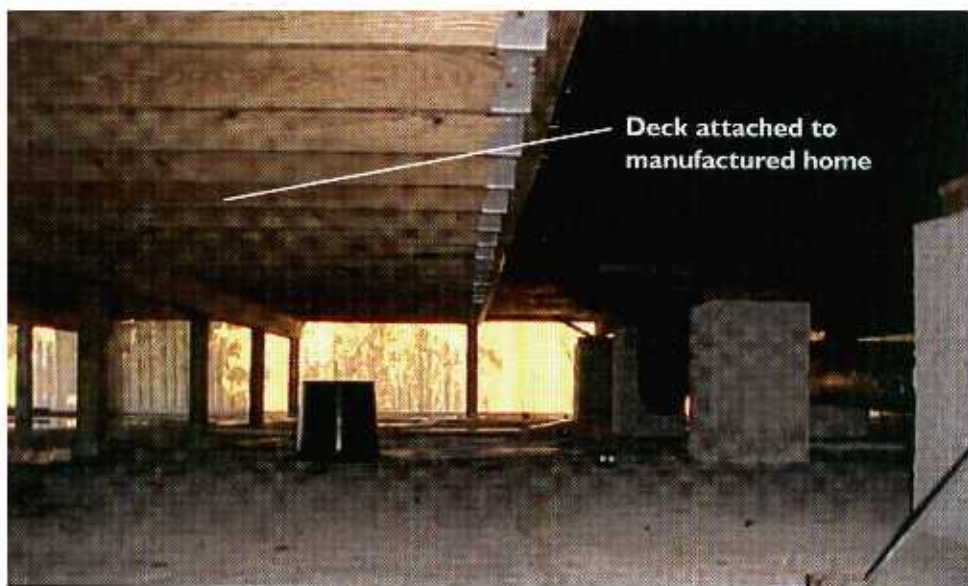
FIGURE 5-27 The underside of a deck that has been attached to the sidewall of a new manufactured home. The deck is not anchored as well as the home.
