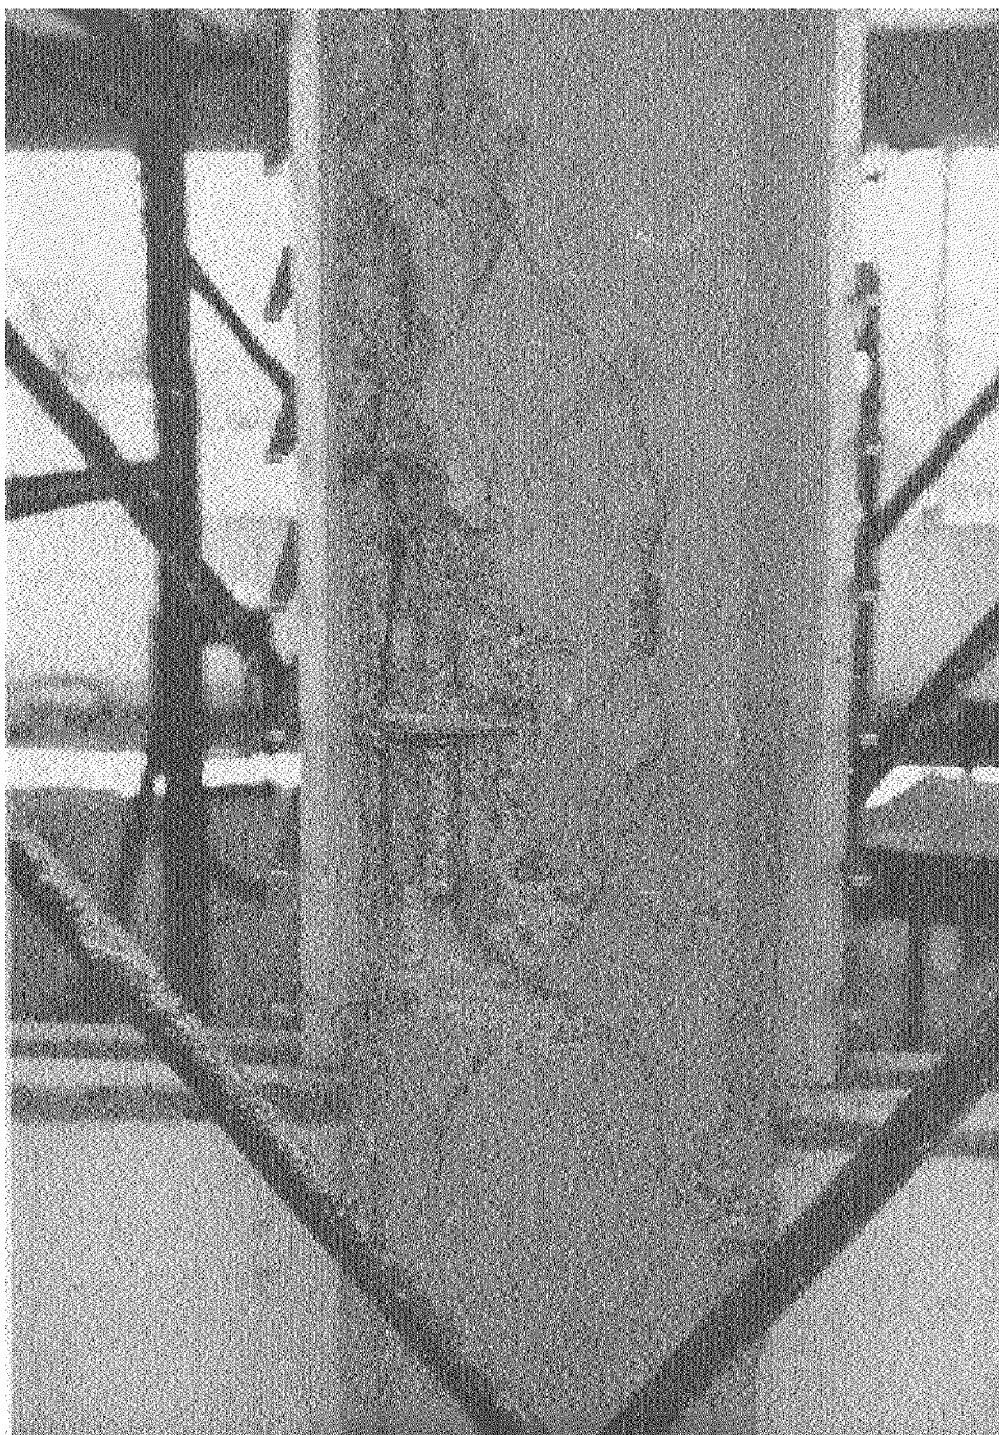
Foto 2.- Columna localizada en la parte Norte de la edificación, mostrando falla por cortante [1].

Photo 2.- Column failed in shear located on the northern part of the structure [1].
