### 3) Edificio del Ayuntamiento de Ciudad Lázaro Cárdenas

### 3) City Hall Building at Ciudad Lázaro Cárdenas

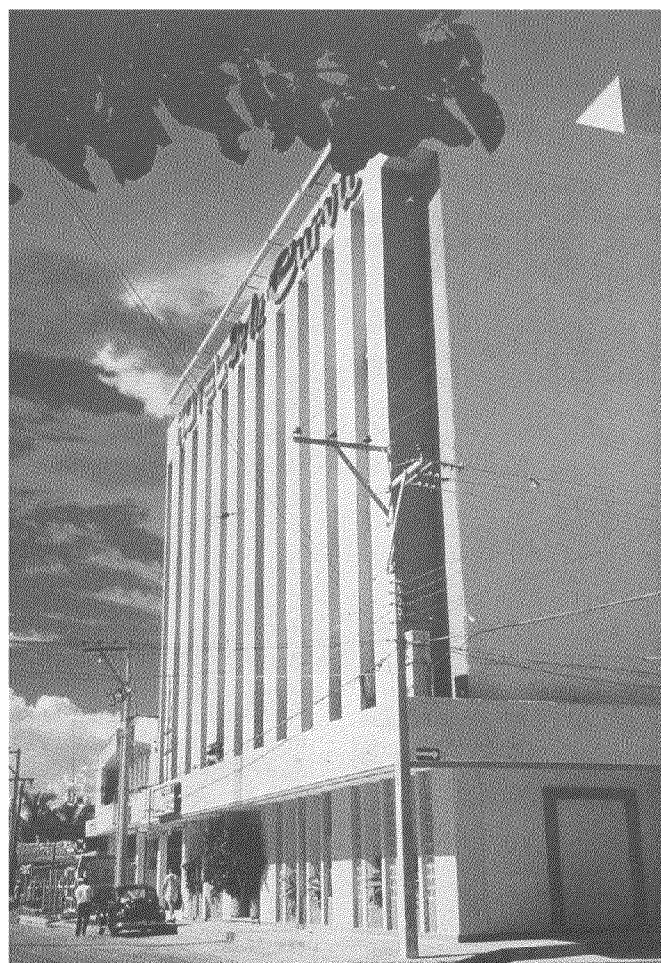
Foto 11 - Hotel de la Curva (en septiembre de 1993)

Photo 11.- Hotel de la Curva (during September 1993).
