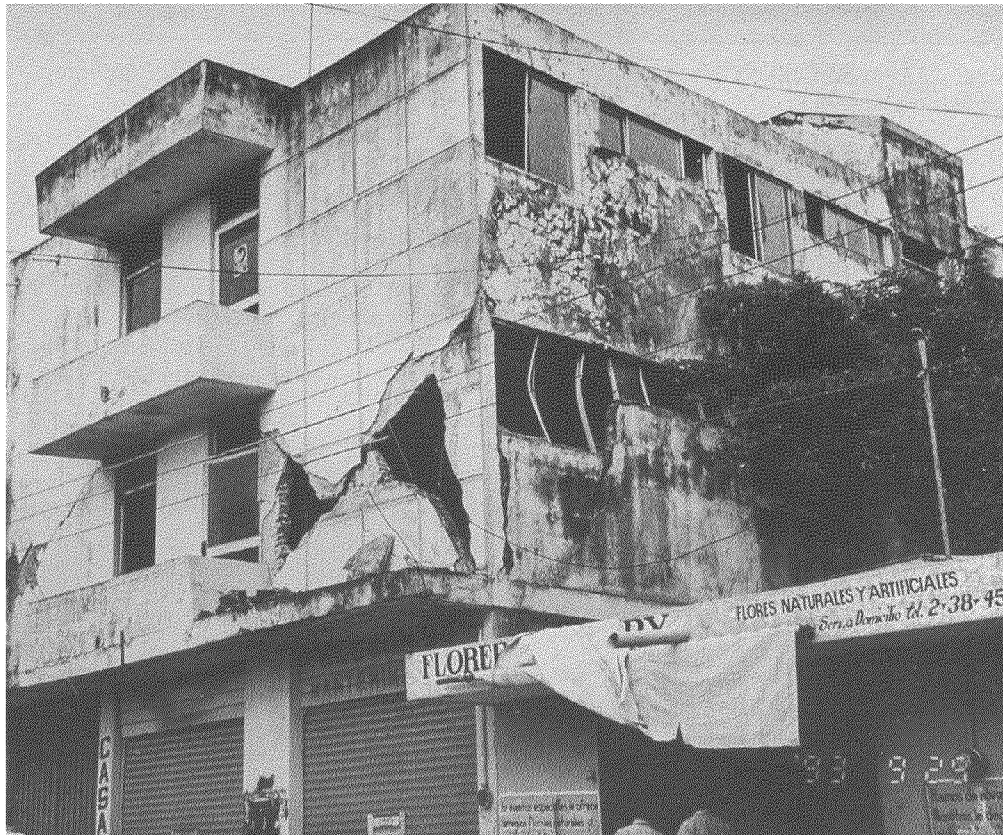
**Características del refuerzo:** La estructura permanece en el mismo estado de daño que presentaba después del sismo de 1985. El edificio cambió de dueño y actualmente la planta baja se emplea como bodega (Foto 28). La parte más dañada del segundo nivel fue apuntalada con polines de madera con el fin de soportar las cargas verticales. Sin embargo, la estructura es inestable ante cargas laterales debido a que los elementos que resistirían dichas fuerzas fueron severamente dañados. En la colindancia hacia la calle Santos Degollado, donde se concentró el daño en la estructura, se encuentra una estructura de un nivel empleada actualmente como florería, existiendo un alto riesgo de colapso hacia dicho establecimiento colindante.

**Repair and/or strengthening method:** As of september 1993, the structure show the same level of damage described. The building ownership changed and now the ground floor is used as a warehouse (Photo 28). The worst damaged area in the second floor was shored with wooden 4x4's to support the vertical loads. However, the structure is unstable against lateral loads because the elements which resist forces are severely damaged. Next to the edge towards Santos Degollado Street, there is a one-story flower shop. There is a high risk of collapse onto the flower shop.

Foto 28.- Edificio "Médico General" que permanece dañado desde el sismo de 1985.

Photo 28.- "Médico General" building without repair since 1985.
