**4) Hotel El Presidente (now Hotel Stouffer Presidente)**

Located in the southeast boundary of the Hotel Holiday Inn. An RC structure identified with number 11 on the AIJ report.

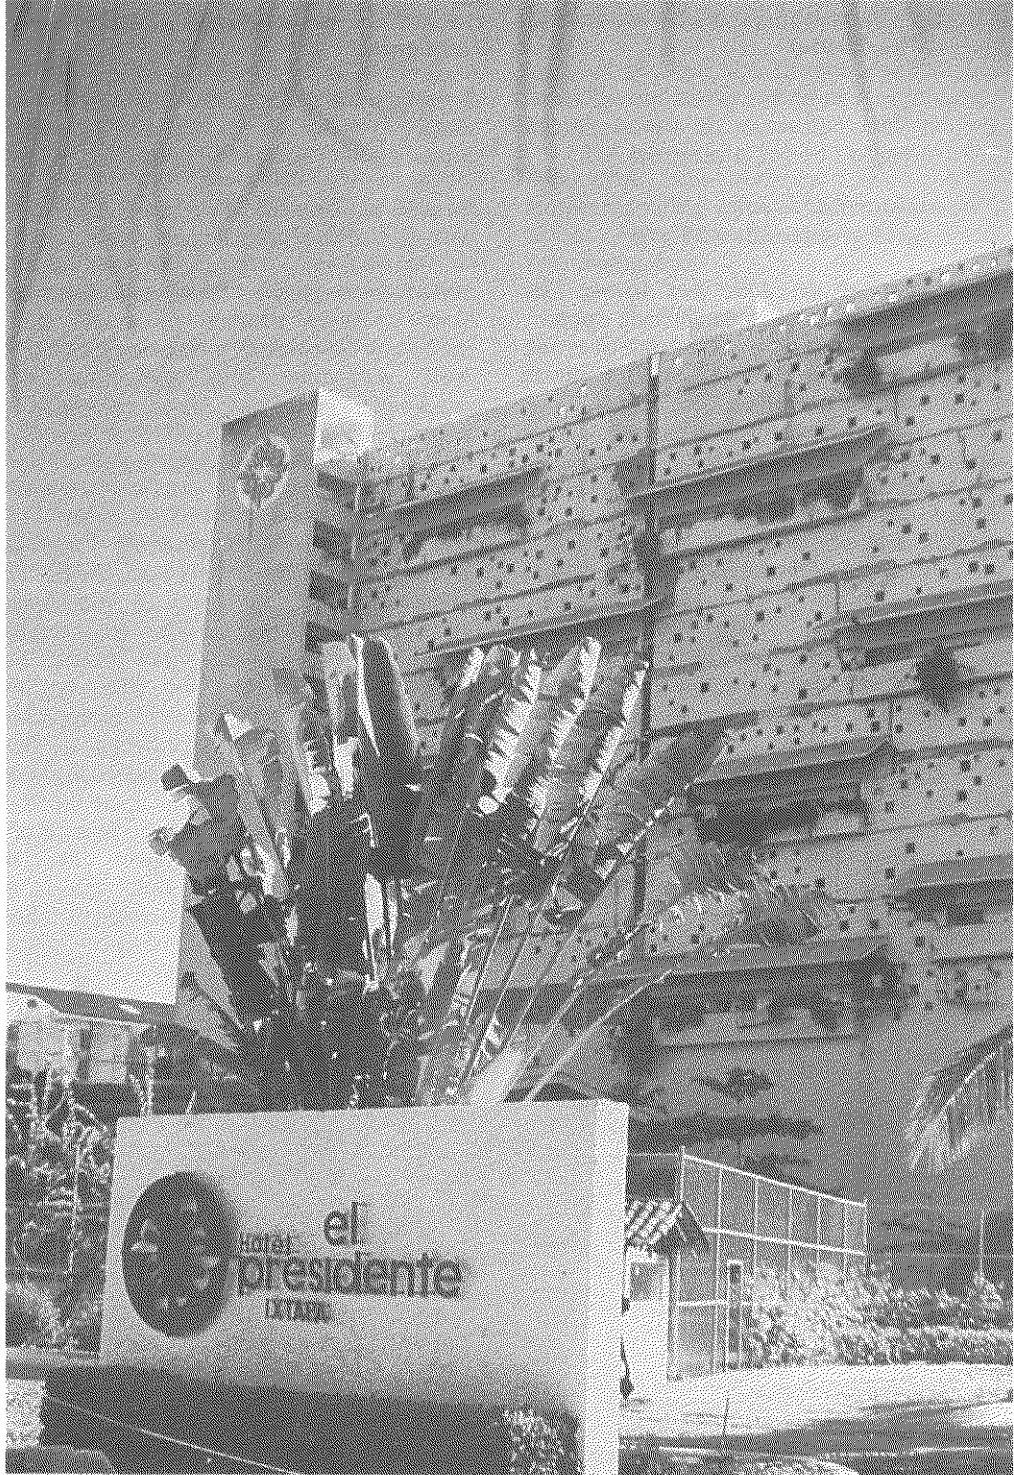
**Características del daño por sismo:** Los muros de mampostería de fachada cuentan con un sinnúmero de pequeños agujeros con distribución aleatoria, que generó agrietamientos notables en los muros. En el interior se tienen referencias de daños estructurales, sin embargo la información no pudo ser confirmada.

**Seismic damage:** The facade masonry walls have a large number of small holes randomly distributed, which contributed to wall weakening and significant wall cracking. There was some reference to structural damage inside the hotel; however, this information was not confirmed.

Foto 50.- Hotel El Presidente después de los sismos de 1985 [1].

Photo 50.- Hotel El Presidente after the 1985 earthquakes [1].

**Repair and/or strengthening method:** During the September 1993 visit, the head of maintenance of the hotel (a mechanical engineer) was contacted. This engineer has held his position for three years. The engineer reported that the structure was indeed retrofitted after the 1985 earthquakes. There are no structural drawings to bear witness to this fact. The facade walls were repaired. A drill is enforced upon the staff every six months on what to do in case of a natural phenomenon. There is no information available for hotel guests on procedures, methods, exit routes, etc. There are only instructions in case of fire.
