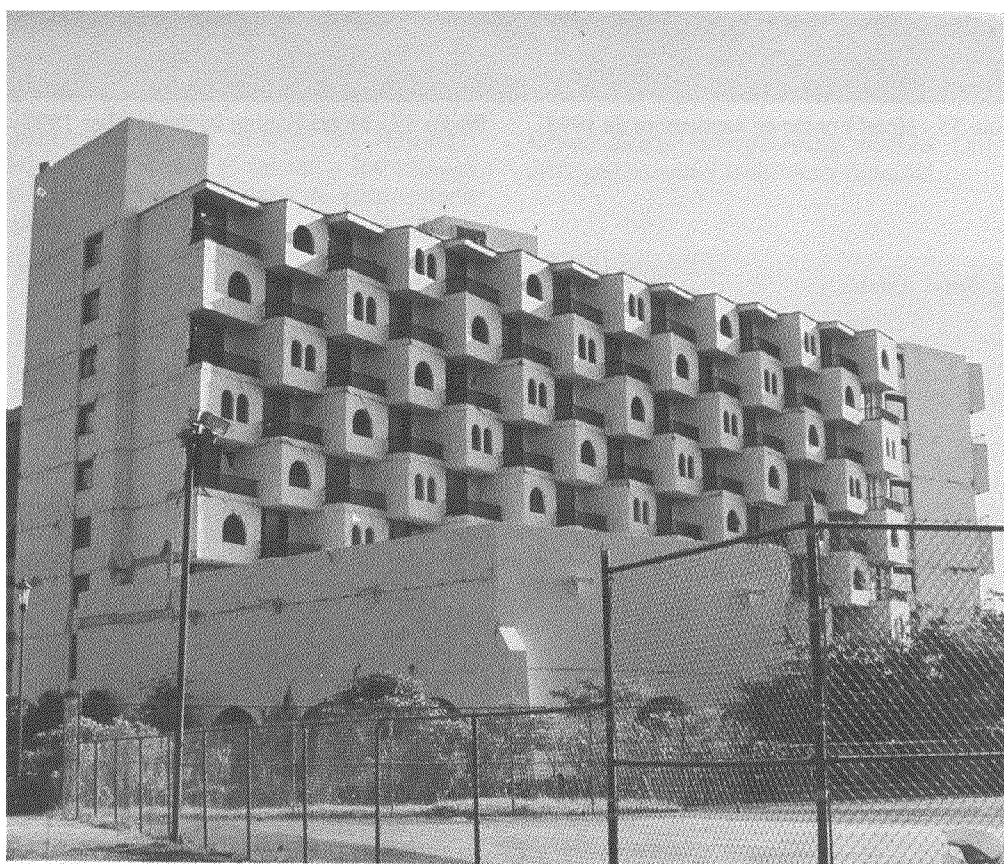
Foto 54.- Hotel Aristos después de los sismos de 1985 [1].

Photo 54.- Hotel Aristos after the 1985 earthquakes [1]
