Buildings and Earthquake Vulnerability in Eastern Anatolia

2.4 Earthquake Field Studies

2.5 Mechanism of Damage and Failure

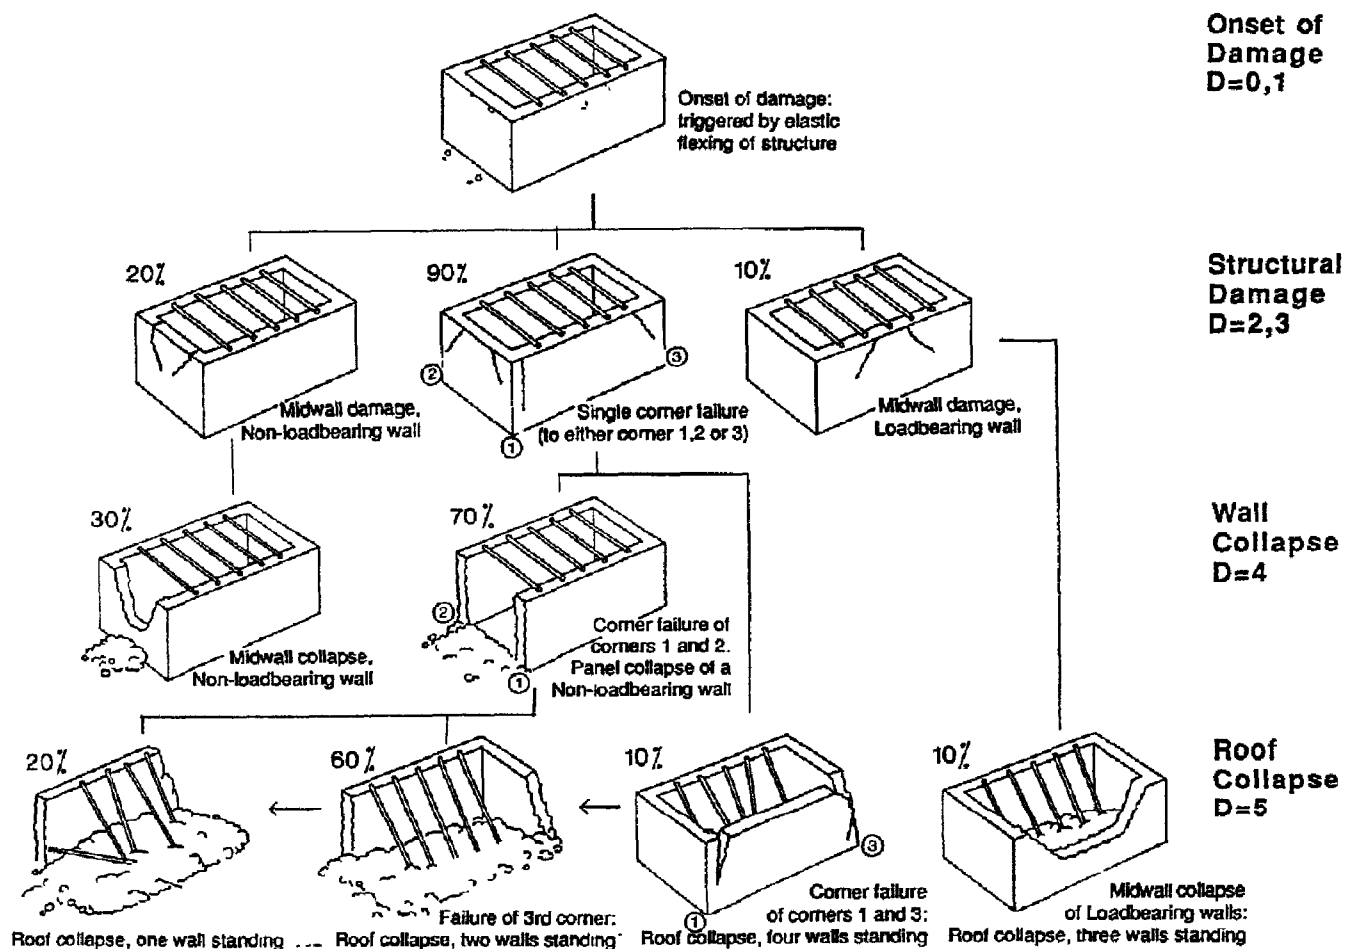
Figure 2.6 Observed Progression of Earthquake Damage

result of the failure of three corners; first the two corners of a non-loadbearing wall, leading to the most common type of wall collapse, 'panel collapse of a non-loadbearing wall', followed by the failure of one of the remaining corners and the collapse of the unrestrained loadbearing wall. Similarly other damage types are the failure of other elements or a different order of failure and are less common. Sequences of failure and the relative frequency of occurrence of damage types suggest that the rules which govern damage progression are:

- (1) Corners are more likely to fail than midwall elements.
- (2) Any panel between two corner failures is unrestrained and is unlikely to remain standing.
- (3) Non-loadbearing panels are more likely to fail than loadbearing.
- (4) Elements generally fail one after another.
- (5) The failure of one element increases the probability of failure of neighbouring elements.
