III. PACOIMA MEMORIAL LUTHERAN HOSPITAL

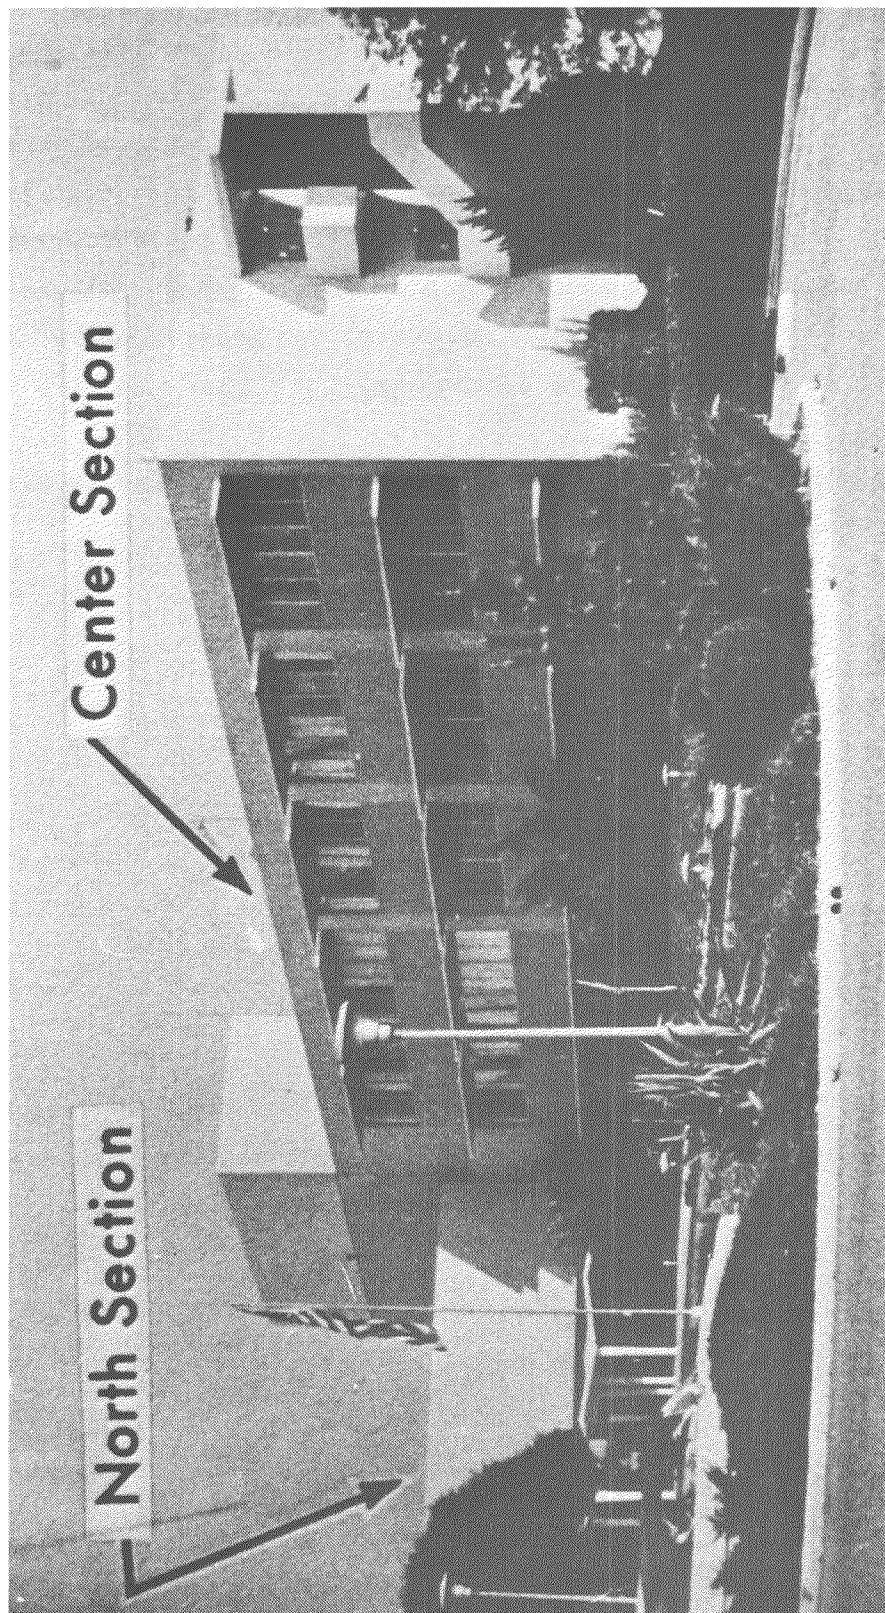
Figure 5: View of Pacoima Memorial Lutheran Hospital from the North, showing three story center section and two story north wing. (Photograph from: Lew, H.S., "Engineering Aspects of the 1971 San Fernando Earthquake," National Bureau of Standards, Washington, D.C., 1971).
