#### IV. HOLY CROSS HOSPITAL

##### a. Structure and Damage:

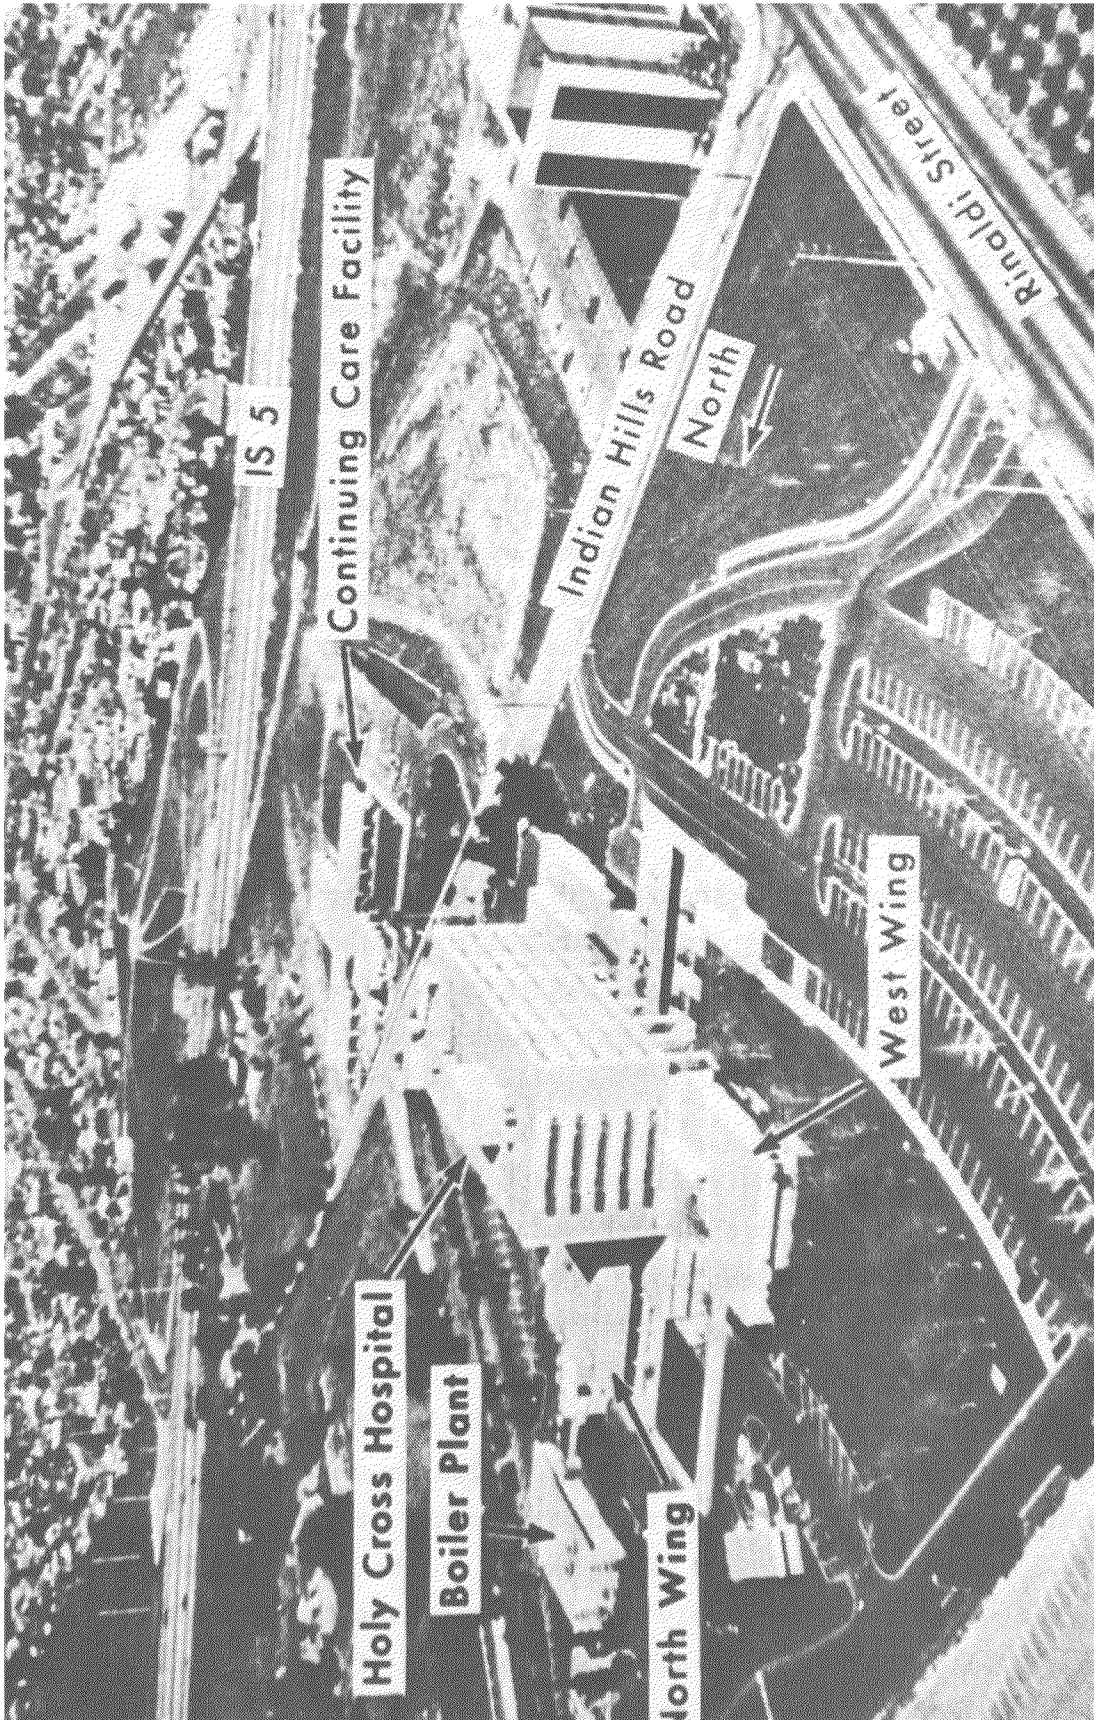
Figure 7: Holy Cross Hospital before the earthquake. (Photograph from: Lew, H.S., "Engineering Aspects of the 1971 San Fernando Earthquake," National Bureau of Standards, Washington, D.C., 1971.)
