**Caribbean Disaster Mitigation Project**  
**Organisation of American States**  
**Caribbean Electric Utility Services Corporation**

**Vulnerability Audit**  
**St Lucia Electricity Services Ltd**  
**Final Report**

**August 1995**

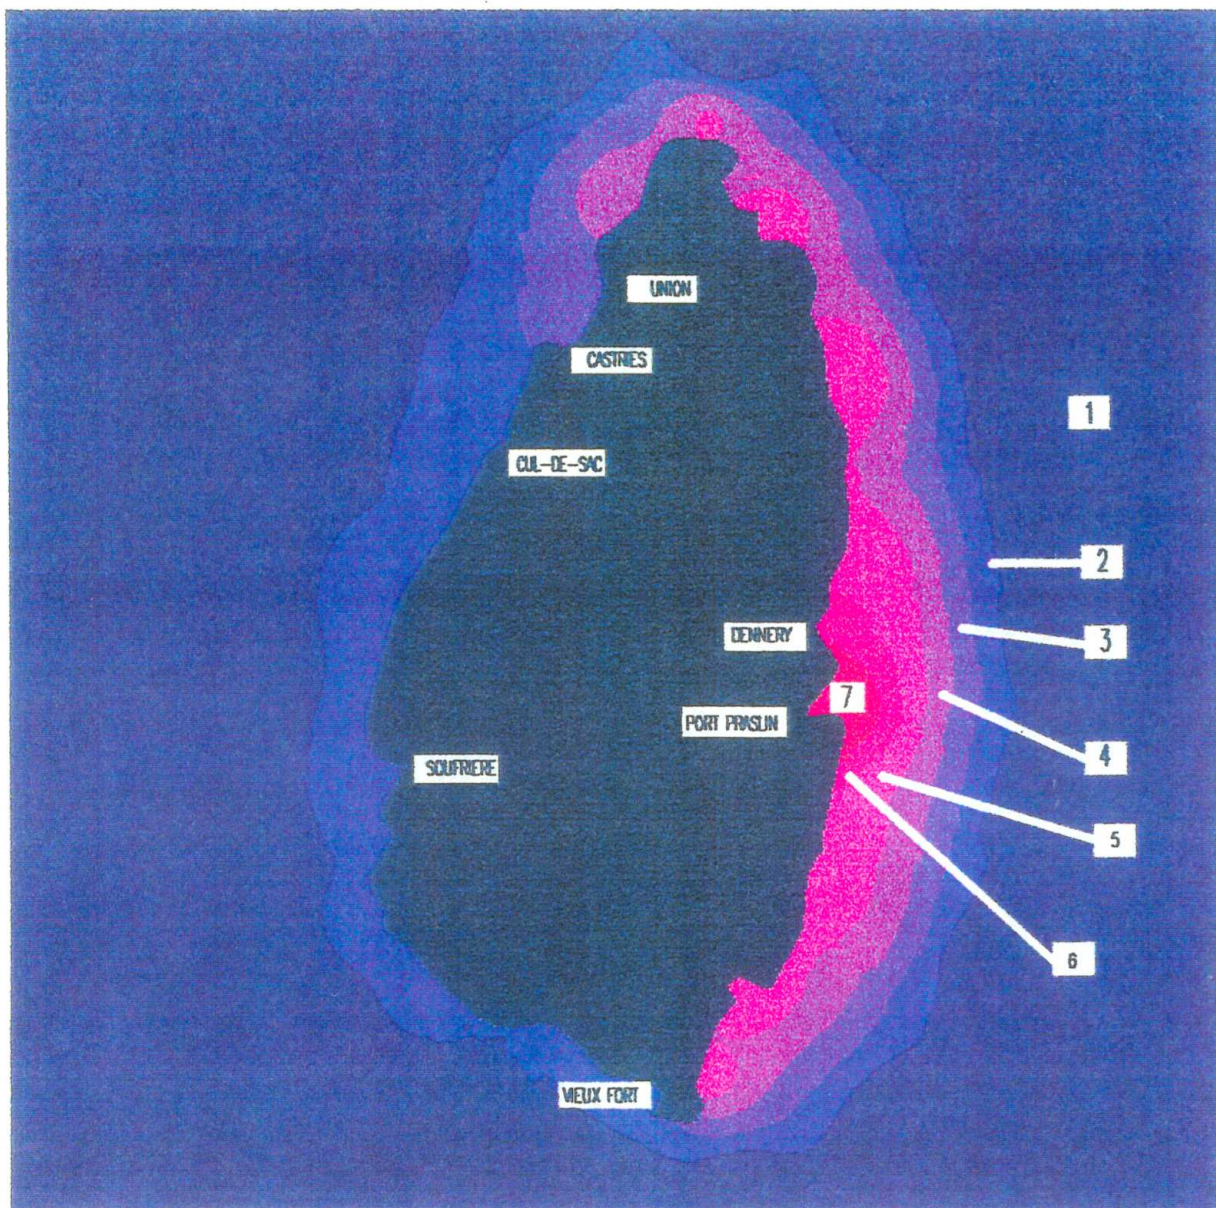
Figure 1

### OAS/CDMP Data for 1-in-100 year Storm Surge Event

Key: Surge heights in metres for areas indicated on map

1 : 0.5m - 0.75m	4 : 1.5m - 1.75m
2 : 1.0m - 1.25m	5 : 1.75m - 2.0m
3 : 1.25m - 1.50m	6 : 2.0m - 2.25m
4 : 1.50m - 1.75m	7 : 2.25m - 2.5m

For St Lucia, the model indicates that the greatest surge heights can be expected on the east coast of the island, with a maximum of 2 to 2.5m around Port Praslin. The value given for the area around Castries (1.25 to 1.5m) is approximate as the effect of the topography of Castries harbour is not given detailed consideration in the model.
