Introduction

R. L. Schuster, U.S. Geological Survey, Denver, Colorado

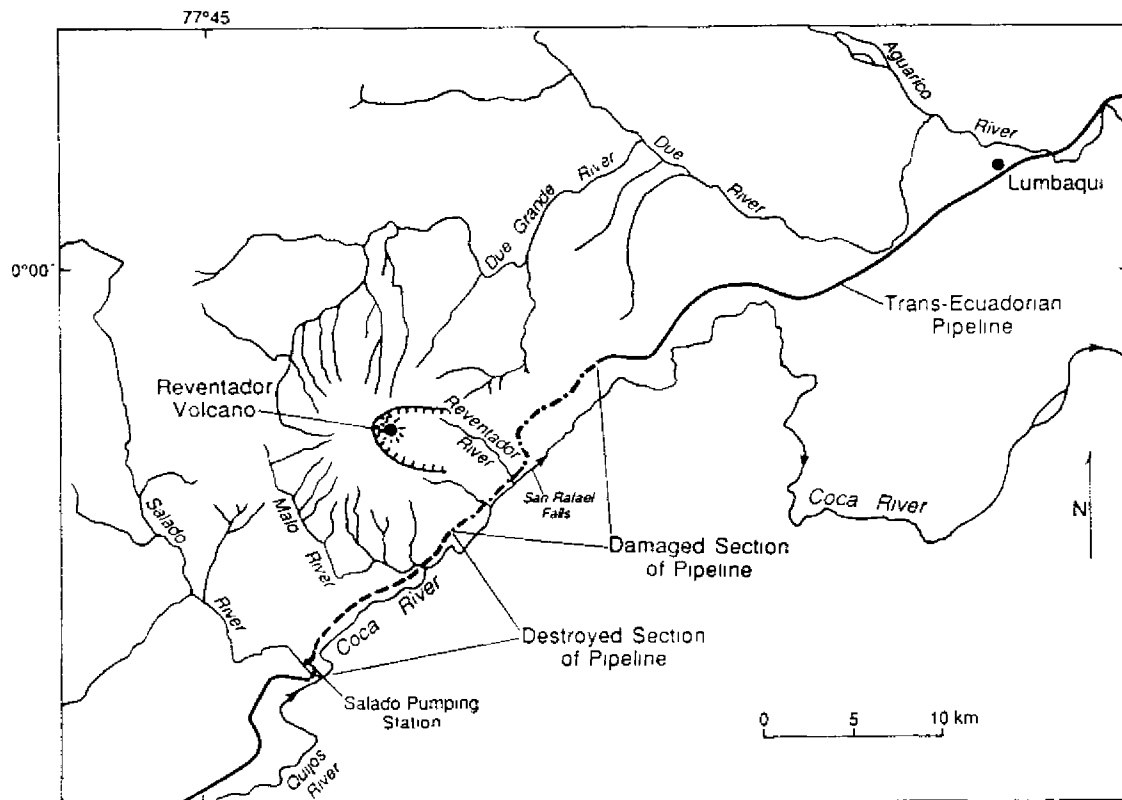
FIGURE 1.2 Area of study of mass wasting and flooding caused by the 1987 earthquakes, showing sections of damage to the Trans-Ecuadorian pipeline.

The area of eastern Ecuador hardest hit by mass wasting due to the March 5, 1987, earthquakes was S of the epicentral area in the vicinity of Reventador Volcano (Figure 1.2). Most casualties from the earthquakes occurred in this region (Figure 1.4); the greatest damage to the Trans-Ecuadorian oil pipeline and highway occurred along the Coca River immediately SE of Reventador Volcano, upstream from beautiful San Rafael Falls (Figure 1.5). Because of the volcanic activity and river downcutting, the region exhibits strong relief. The average valley slopes range from 35 to 45°; before the 1987 landsliding, these slopes were generally covered by residual soils of variable thickness and by a dense, subtropical jungle.
