Intensity and Damage Distribution

A. F. Espinosa, U.S. Geological Survey, Denver, Colorado

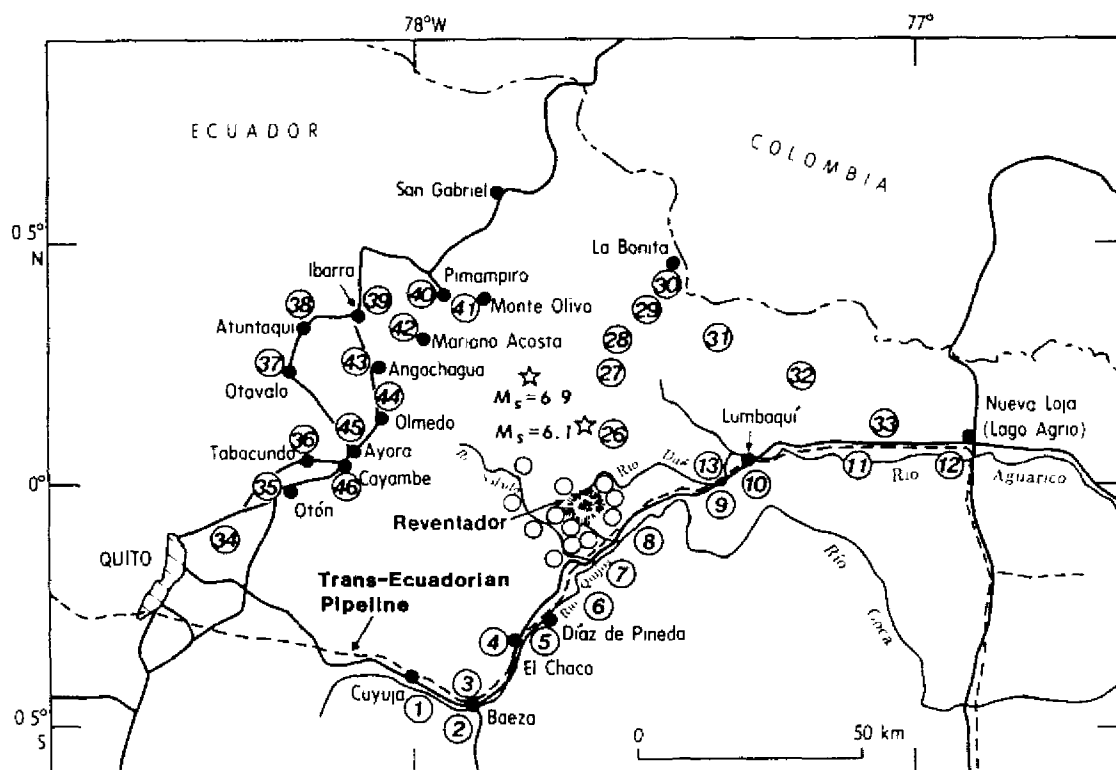
FIGURE 4.3 Intensity sampling distribution obtained in this postearthquake study around Reventador Volcano and along the main access roads to the N and E of Quito. Also shown are those areas in which an intensity evaluation was performed from helicopter reconnaissance flights. The circled numbers represent the areas where damage to dwellings and to the environment was documented using a video camcorder and 35-mm photographs.

As of May 13, 1987, the number of dwellings that sustained damage in the region interandina totaled 12,083; 2,308 structures were damaged beyond repair. For example, in the town of Olmedo (Figure 4.3), due W of the March 5 epicenters, 1,631 dwellings sustained damage beyond repair.

The towns of Cangahua and Ayora (Figure 4.3), just N and S of Olmedo, sustained damage to 1,300 and 323 dwellings, respectively; 570 and 302 of these dwellings were damaged beyond repair. In the towns of Tabacundo and Cayambe (Figure 4.3), which are SW of the epicentral locations, much

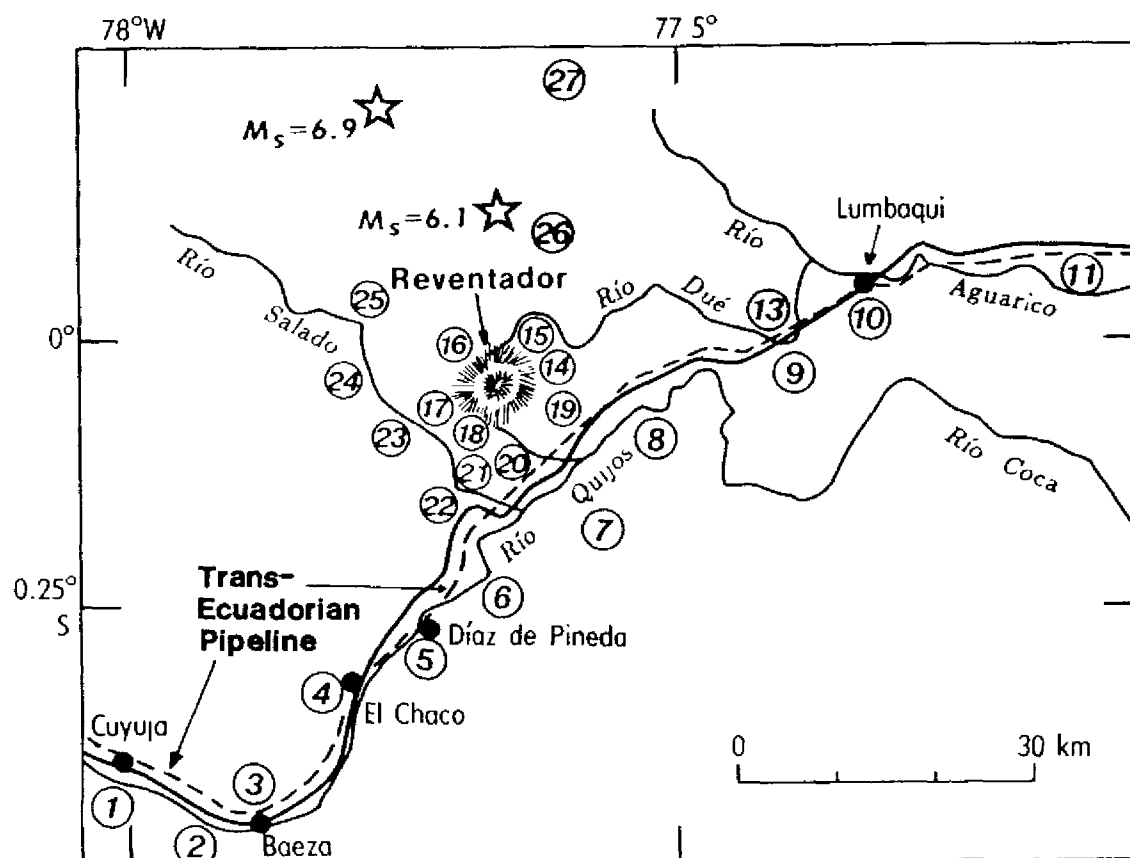
FIGURE 4.4 Intensity sampling distribution detail around Reventador Volcano and the region around the Salado River, the Quijos River, and part of the Aguarico River. Identification of circled numbers is explained in the caption of Figure 4.3.

Figure 4.4 shows the location of Reventador Volcano and the areas mentioned above that sustained high damage to the environment. The number of landslides in this area around and on the volcano was very high, and several large landslides that most likely were caused by water-saturated soils occurred E of the epicentral region; however, very few occurred to the N.

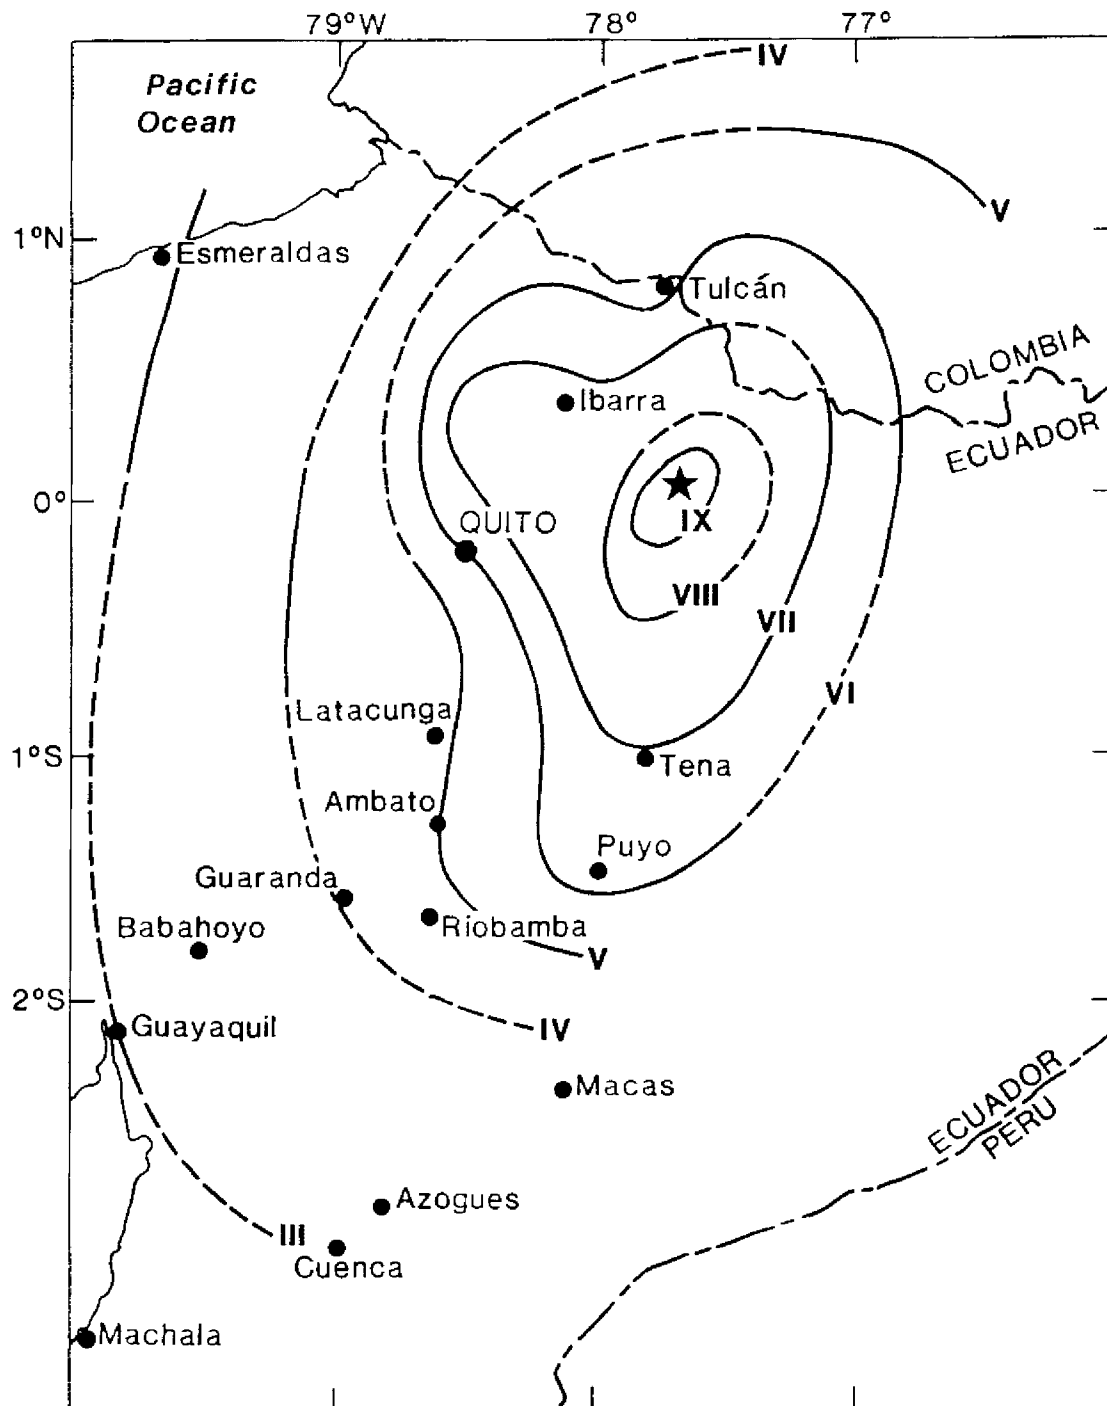
The isoseismal in Figure 4.5 shows a preliminary distribution of the main earthquake in Ecuador in March 1987. The isoseismals for intensities VIII, VII, and VI follow the general trend of a system of faults trending N-S. The intensities attenuate over a shorter distance more rapidly to the SW, and more slowly to the S and to the NNW. The isoseismal map was plotted on a 1:1,000,000 scale geologic map of Ecuador (Baldock, 1982a,b), and no simple correlation was found between gross surficial geology and intensity distribution.

Other factors that may enter into the intensity distribution pattern shown in Figure 4.5 are seismic amplification effects, topographic seismic wave amplification, influence of surficial soil conditions, and depth of the water table. Moreover, construction practices in this part of the country are highly mixed, and in the mountainous area the population settlements are small and scattered.

FIGURE 4.5 Intensity distribution in Ecuador from the main earthquake of March 1987. The solid star indicates the epicenter. Dashed lines indicate approximate isoseismic extension or continuation. Also shown are the locations of important cities and towns in Ecuador.
