## Mass Wasting and Flooding

*A. S. Nieto*, Department of Geology, University of Illinois, Urbana

*R. L. Schuster*, U.S. Geological Survey, Denver, Colorado

This chapter deals with slumps and slides, debris avalanches, debris flows, and flooding, the processes that account for the largest amount of destruction and number of deaths induced by the March 5, 1987, earthquakes.

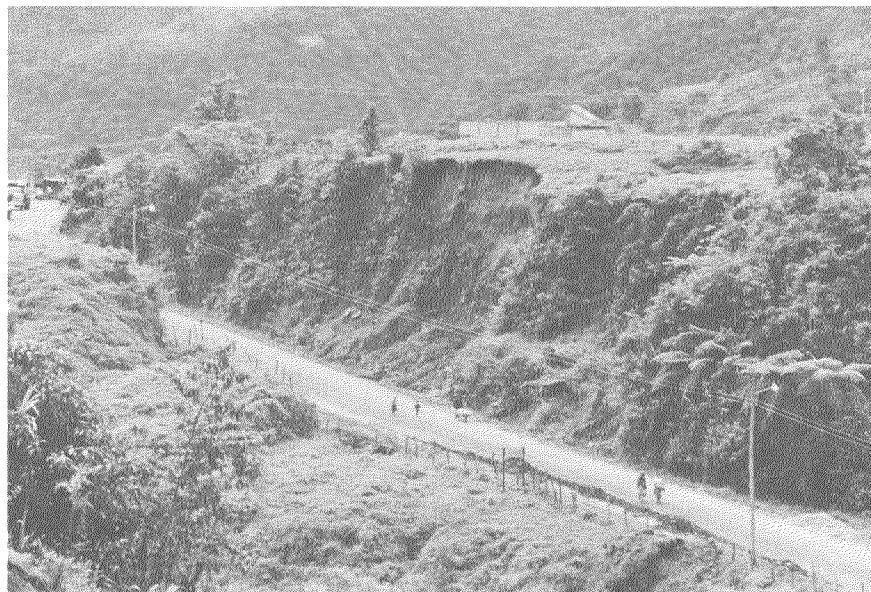
FIGURE 5.2 Thin earth slide (center of photo) on steep face of alluvial terrace on western edge of the town of Baeza.

Young alluvial terraces, 15 to 20 m high near Baeza, have been created by stream degradation (Papallacta River and tributaries). Intense chemical weathering has modified these alluvial deposits, giving them certain characteristics of residual soils. This veneer of residual/alluvial materials commonly was involved in slip/debris-flow failures of the steep terrace slopes. The relatively unweathered alluvial material (probably cemented) underneath this veneer remained unaffected.

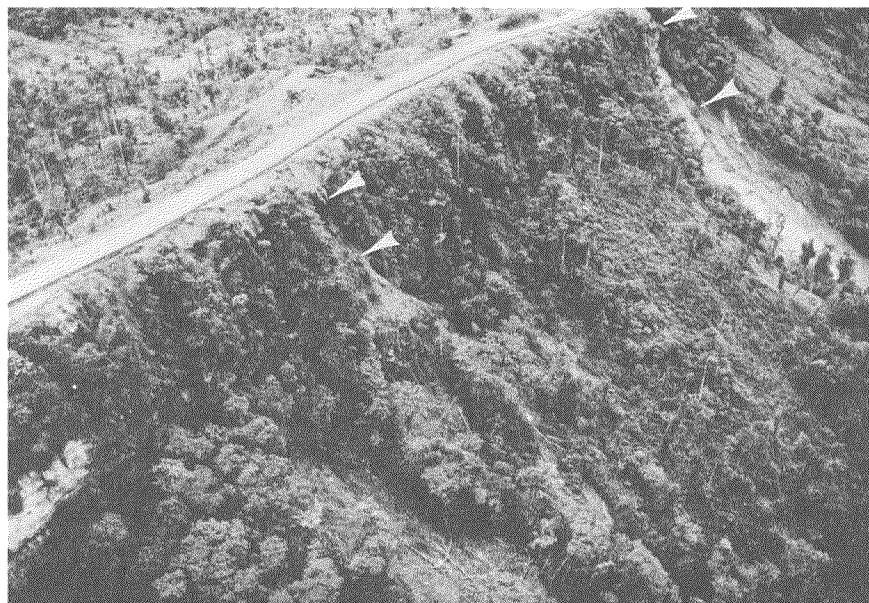
FIGURE 5.3 Landslides (largest examples are indicated by arrows) in residual soils at the top of the N valley wall of the Quijos River between El Chaco and the confluence of the Quijos and Salado Rivers. Because slide-resistant sedimentary bedrock (light-colored outcrop at the lower left) is close to the surface, these slides/avalanches are shallow and generally limited to existing gullies. Although the slides endangered the Trans-Ecuadorian pipeline and highway (angling across top of photo above the landslides), they caused little actual damage because they were so shallow.
