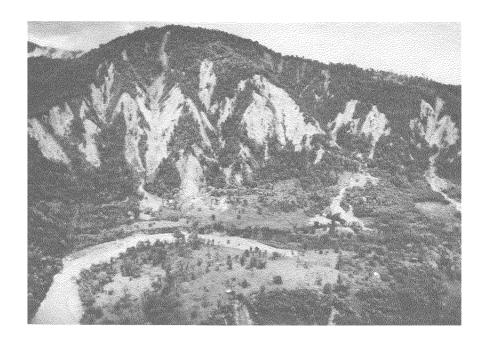
FIGURE 5.4 Landslide activity on the NW (left) valley wall of the Quijos River just upstream (SW) from its confluence with the Salado River. The earthquake-triggered slope failures began as thin slips on the steep (45 to 50°) headwalls of the slopes, and were transformed into debris avalanches and debris flows that cascaded down the gullies onto the low terrace that forms the left bank of the river.

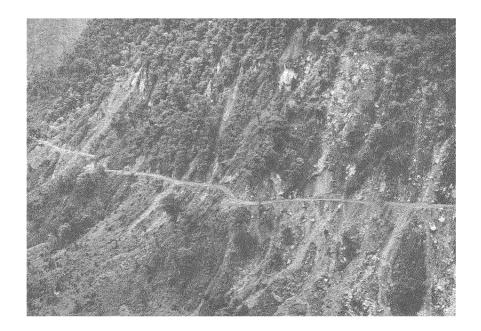
FIGURE 5.5 Landslides along the Trans-Ecuadorian highway 3 km W of its crossing of the Salado River. These rock falls, slides, and avalanches, which were triggered by the March 5, 1987, earthquakes, had blocked the highway almost continuously in the stretch shown in this photograph. The highway was passable at the time of this April 25, 1987, photograph because of the efforts of Corps of Engineers (Ecuadorian Army) highway maintenance crews.
