Areal Distribution of Landslides and Denudation Intensity

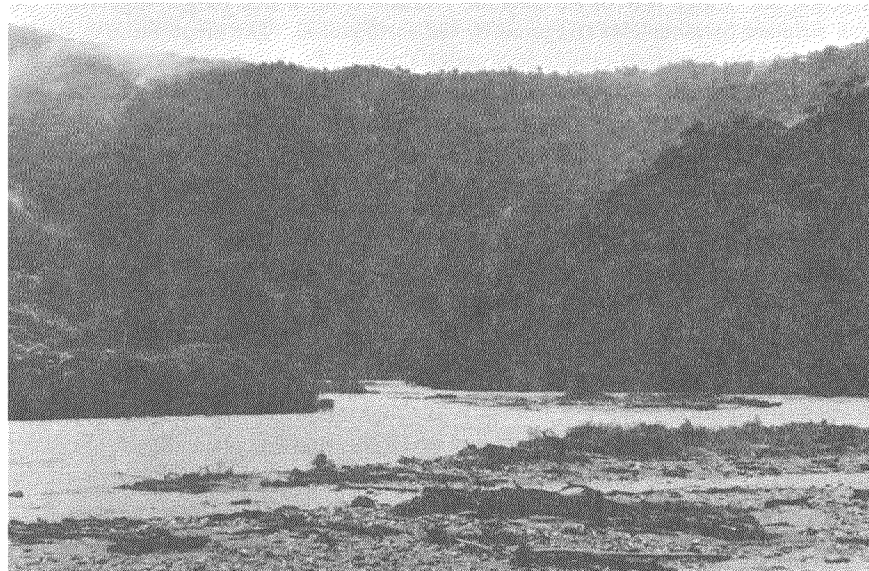
FIGURE 5.9A 1978 view showing the jungle-covered right (SE) valley wall of the Coca River at the confluence (photograph by S. D. Schwarz).

FIGURES 5.9A, B, C Views down the Salado River to the confluence of the Salado and Quijos Rivers to form the Coca River.

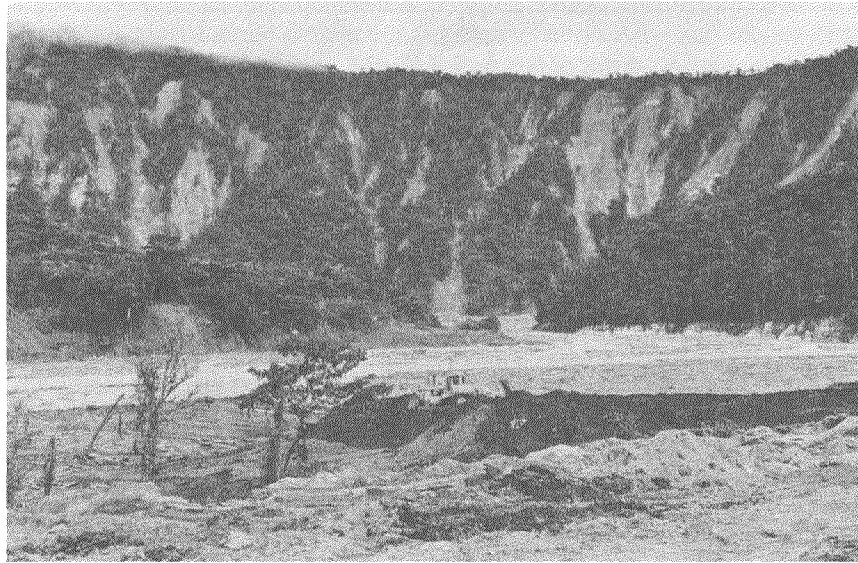
Coca River, between the Salado pumping station and the Malo River, failures occurred mainly on slopes steeper than 35 to 40°. The same threshold values were obtained for the valley walls of the Salado River and of the Coca River at the confluence of the Salado and Quijos rivers (Figures 5.9 A,B,C). However, on the upper slopes of the ancient cone of Reventador Volcano at elevations above 3,500 m, we observed failure on slopes between 30 and 35°, involving what appear to be very recent ashes. Other types of landslides (rock avalanches, rock slides along high road cuts, slumps and slides along alluvial terraces, and topples of stress-relief slabs) occurred throughout the entire area, but only sporadically.

FIGURE 5.9B April 1987 view of the same valley wall showing widespread denudation due to March 5 landsliding.

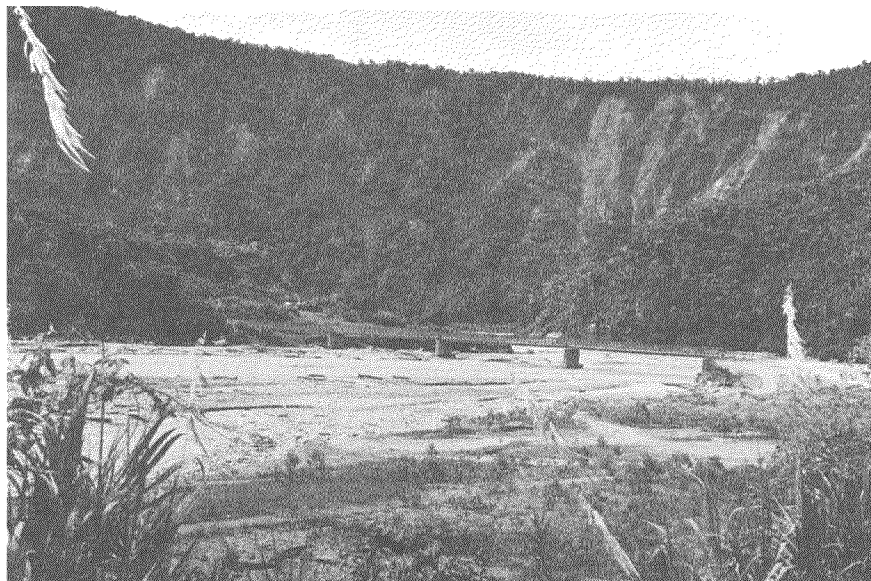
FIGURE 5.9C June 1990 view of the same valley wall showing partial recovery of vegetation on 1987 landslide scars. Note reconstructed Trans-Ecuadorian highway bridge across the Salado River.

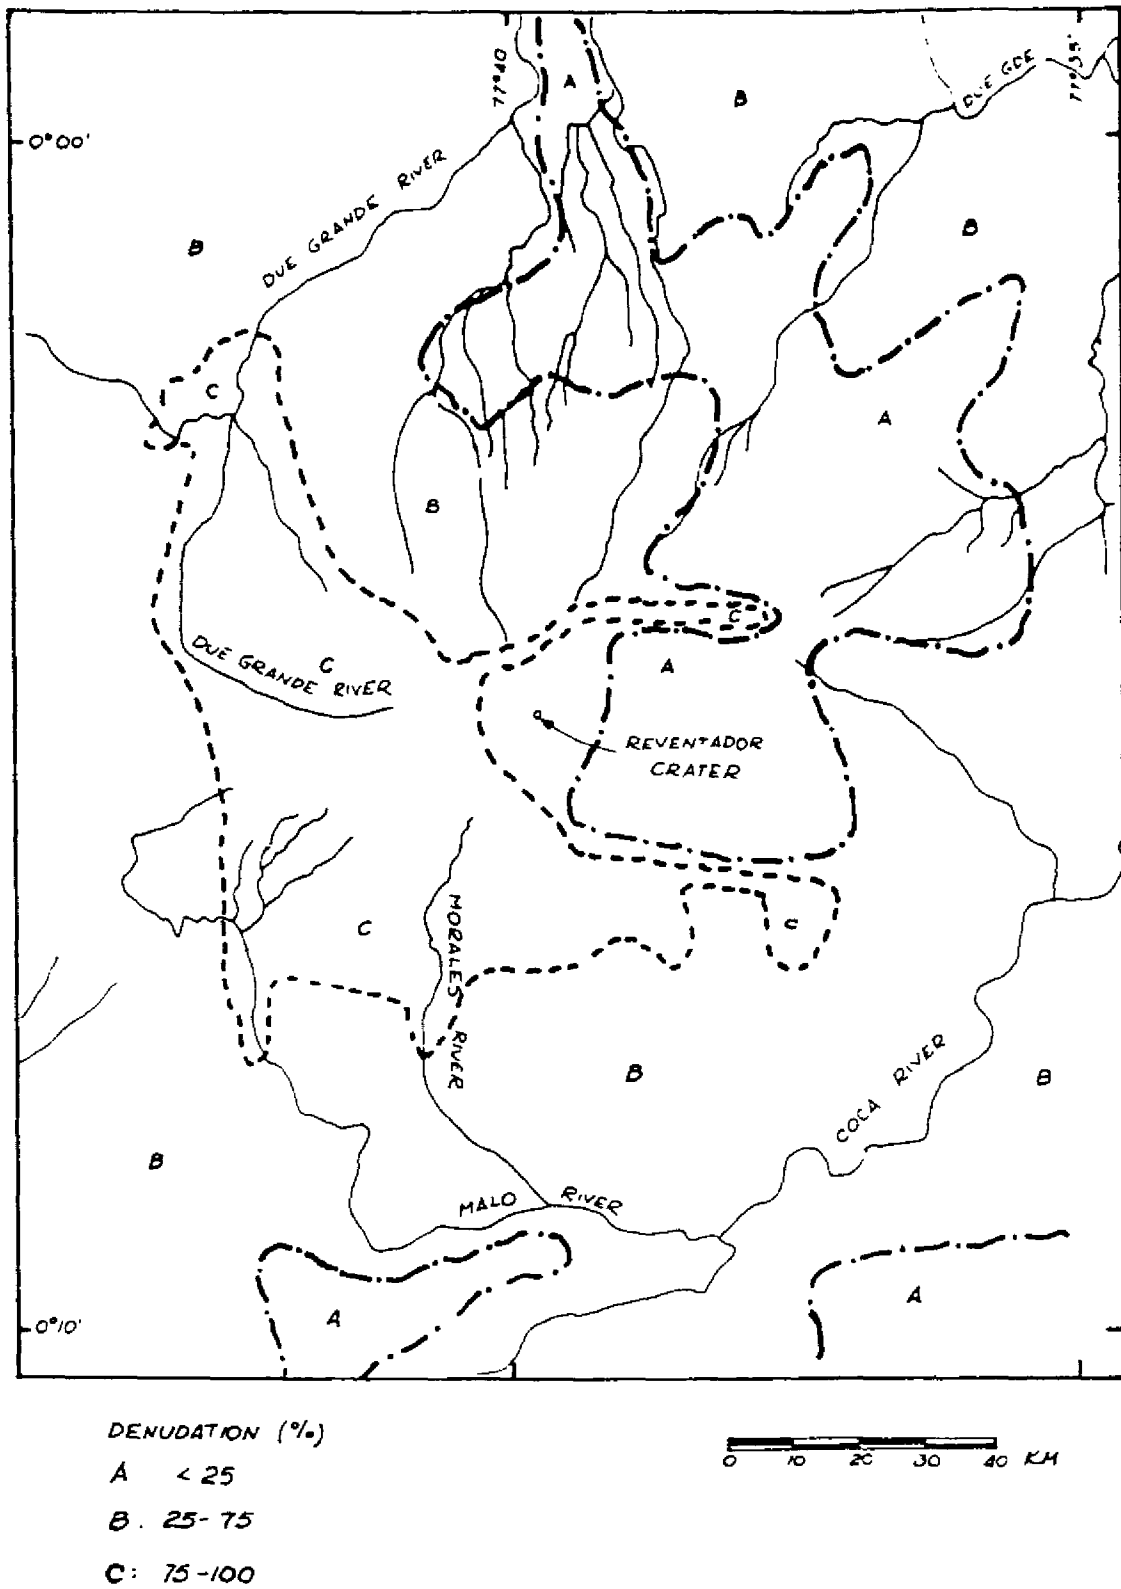
Figure 5.10 shows the approximate limits of areas with different degrees of denudation (expressed as estimated percentage of failed slope area per total area) for the slopes of Reventador Volcano and vicinity. Note the large variation in denudation intensity around the volcano. The degree and characteristics of denudation due to landsliding in nearby valleys are as follows:

FIGURE 5.10 Map showing percentages of denudation of vegetation due to land-sliding in the vicinity of Reventador Volcano, March 5, 1987.
