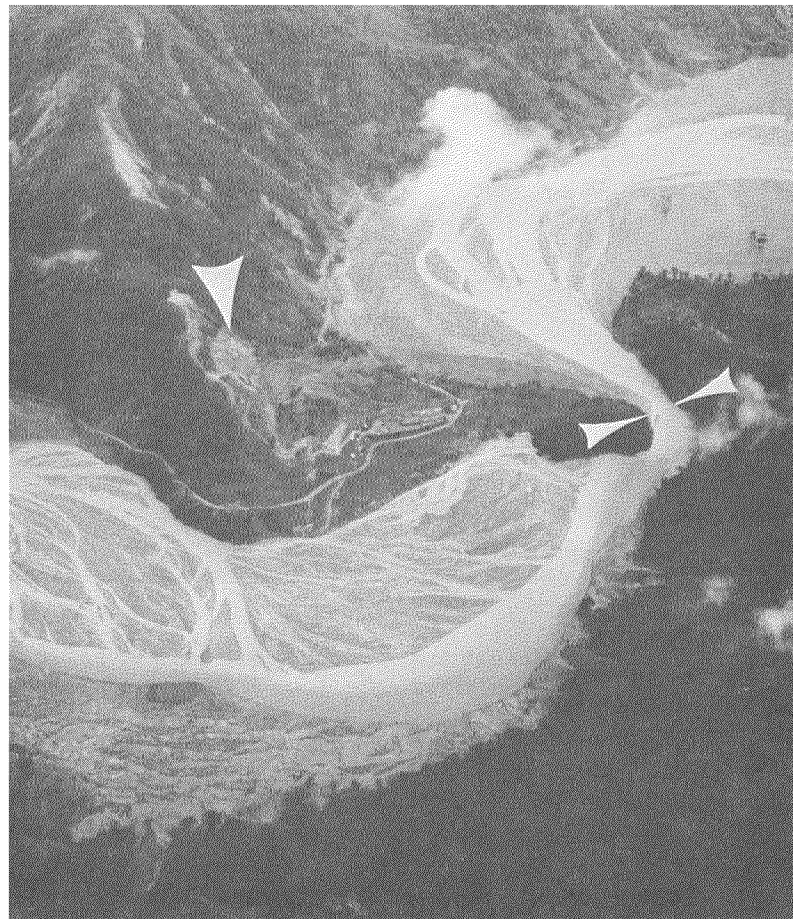
FIGURE 5.16B

floodplain. Bedrock constriction of the Coca River (indicated by two arrows at the right) probably caused short-lived "hydraulic" damming of the river that contributed to upstream flooding and sedimentation. Note landslide (single arrow near center of photo) that badly damaged the Salado pumping plant of the Trans-Ecuadorian oil pipeline.

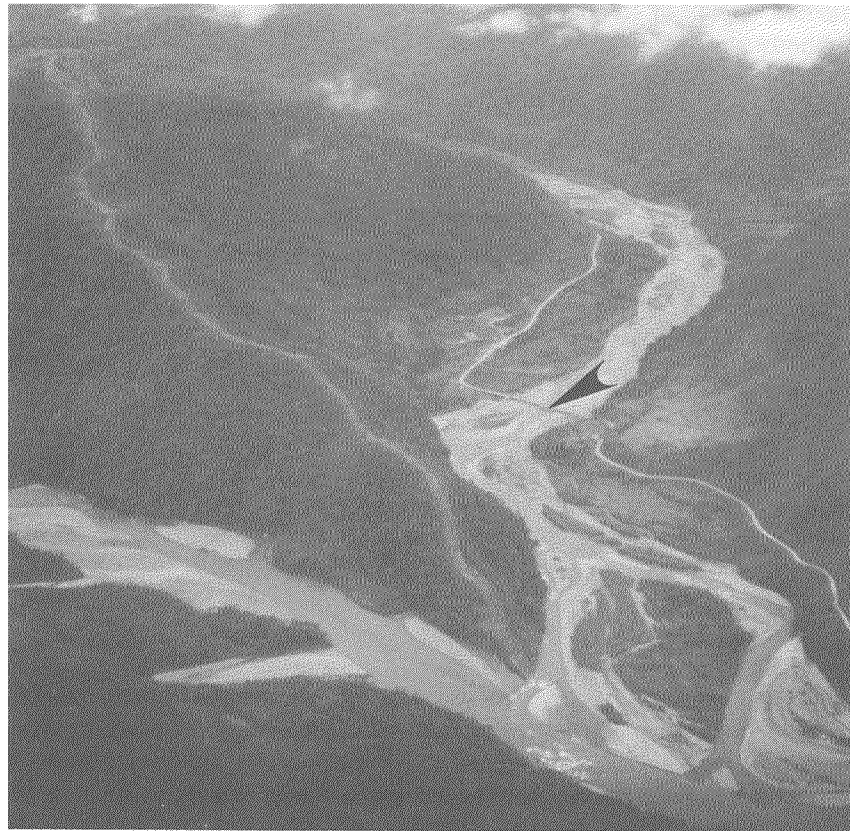
FIGURE 5.17A

FIGURES 5.17 Looking up the Salado River from the confluence of the Salado and Quijos rivers. (A) 1978 photo showing the Trans-Ecuadorian highway bridge (arrow) across the Salado River. Note the Trans-Ecuadorian pipeline where it snakes down the ridge at the left to its crossing at the mouth of the Salado River.
