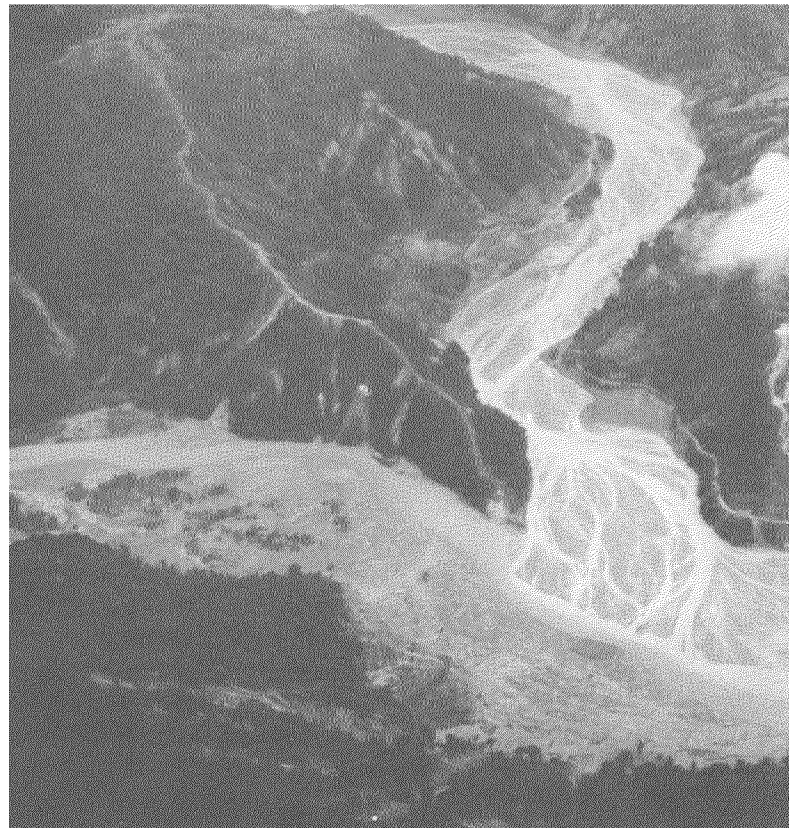
FIGURE 5.17B

(Photograph by William Savage, Pacific Gas and Electric.) (B) April 1987 photograph showing extreme sedimentation in the Quijos, Salado, and Coca river channels due to the March 5, 1987, debris flows and flooding. Note absence of the Salado River highway bridge, which had been washed out.

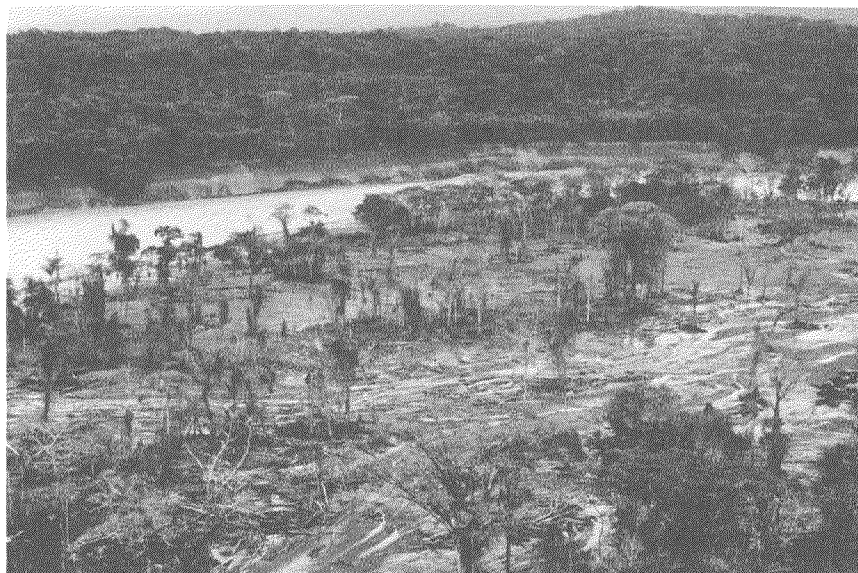
FIGURE 5.18 Evidence of March 5, 1987, flooding on the left (N) bank of the Aguarico River near the town of Lumbaqui. The flood has removed much of the vegetative cover from the low terrace in the foreground.

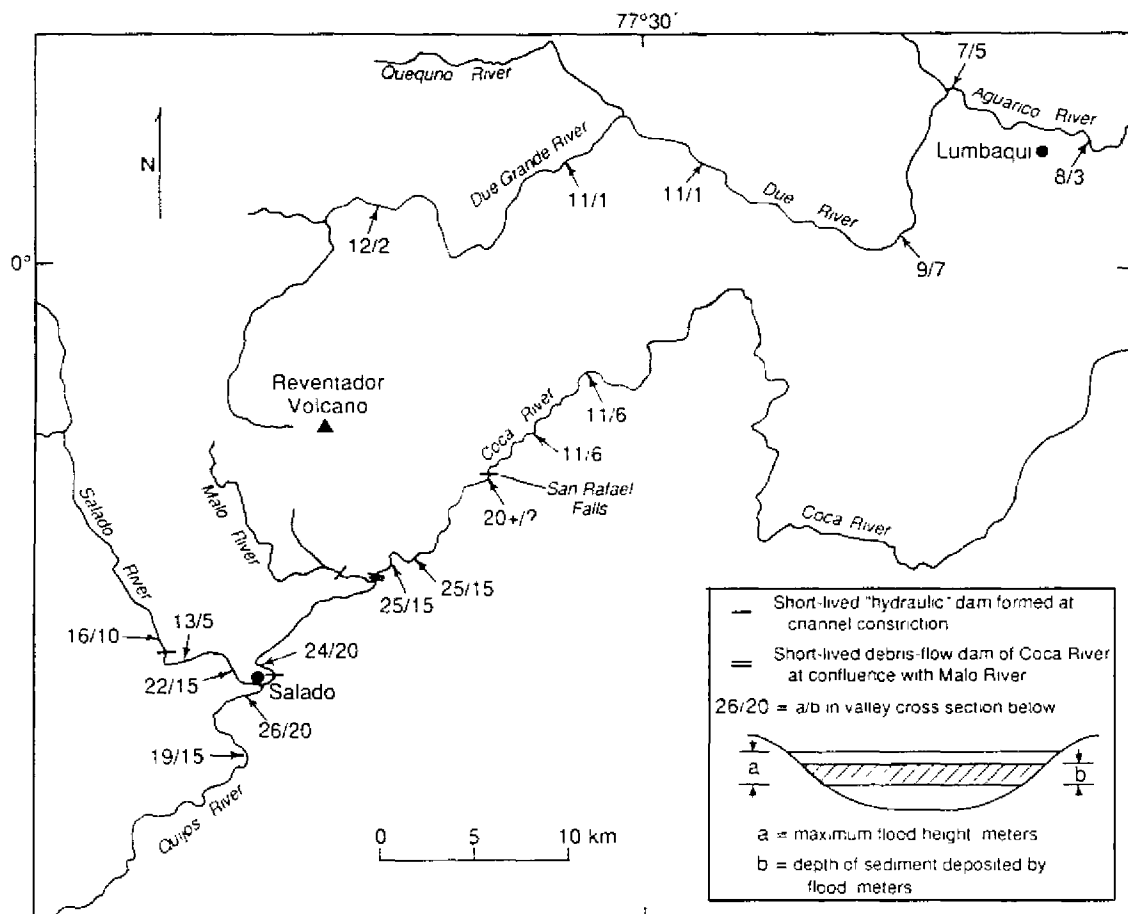
We have noted evidence of "hydraulic" damming at four locations in the Coca River drainage (Figure 5.19): (1) of the Salado River 7 km upstream from its confluence with the Quijos/Coca River (Figure 5.20), (2) of the

Malo River at its falls about 1 km upstream from its mouth, (3) of the Coca River at the bedrock peninsula that juts southward from the Salado pumping station (located at Salado), and (4) of the Coca River at San Rafael Falls. At each of these locations, the occurrence of damming is indicated immediately upstream by (1) trim lines showing the highest level of flow and (2) extensive deposits of sediment. The sediments probably were deposited in very short-lived lakes that formed as a result of damming at the constrictions before the debris "plugs" were flushed out.

FIGURE 5.19 Estimated depths of flooding and sedimentation in river channels in the Reventador area. Estimates were based on low-level observations from a helicopter.
