Effects on Lifelines

*E. Crespo,** Cornell University, Ithaca, New York
*T. D. O'Rourke,** Cornell University, Ithaca, New York
*K. J. Nyman,** Cornell University, Ithaca, New York

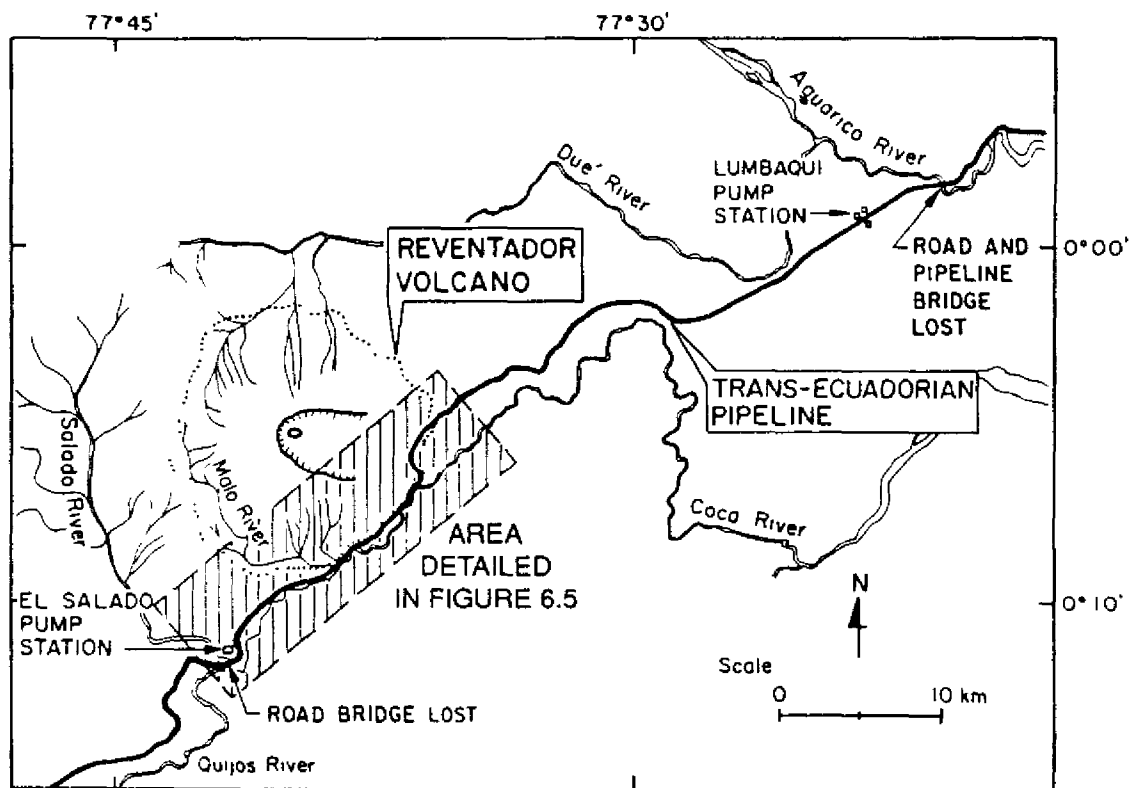
FIGURE 6.2 Area of major pipeline damage.

of the Aguarico River to its crossing of the Salado River. The pipeline alignment follows a SW course along the Coca River basin. Between the Aguarico and Salado Rivers, the pipeline attains a maximum elevation of 1,700 m, after which it descends approximately 500 m to the Coca River floodplain and then follows the N bank of the river to the Salado pump station.

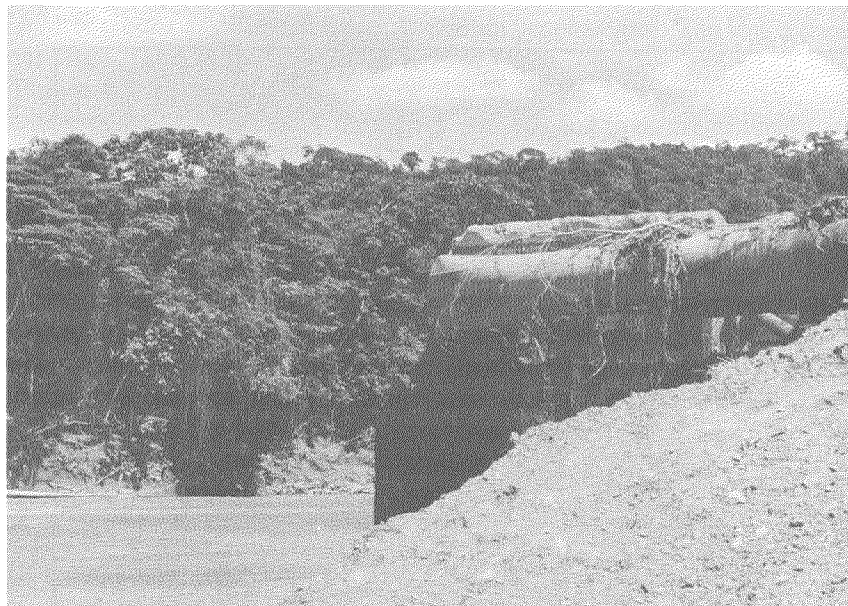
Flooding along the Dué River entered the Aguarico River and destroyed the pipeline and highway bridge across the Aguarico approximately 50 km NE of the Salado pump station. Flood waters reached an elevation of 5 m above the bridge deck. Figure 6.3 shows a segment of the buried pipeline,

FIGURE 6.3 Trans-Ecuadorian pipeline severed by flood waters, E bank of the Aguarico River.

which was severed on the W side of the river at its junction between the bridge and concrete abutment. Figure 6.4 provides a view of the E side of the river where the pipeline had entered the bridge abutment as an aboveground structure. W of this location, the pipeline was pulled longitudinally and displaced off its supports for a distance of 4 km.

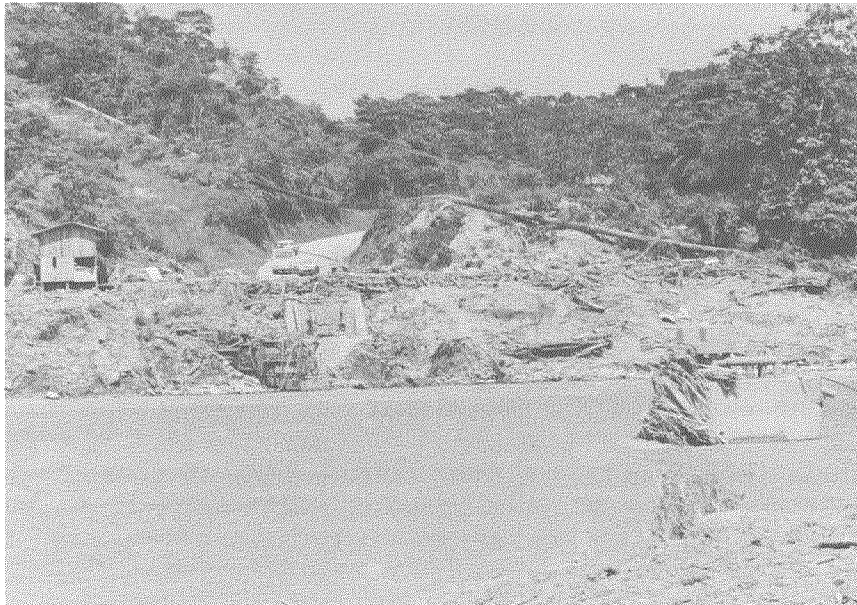
FIGURE 6.4 Trans-Ecuadorian pipeline on the W bank of the Aguarico River pulled southward by flood waters. Note the remnant pier and abutment of the bridge.

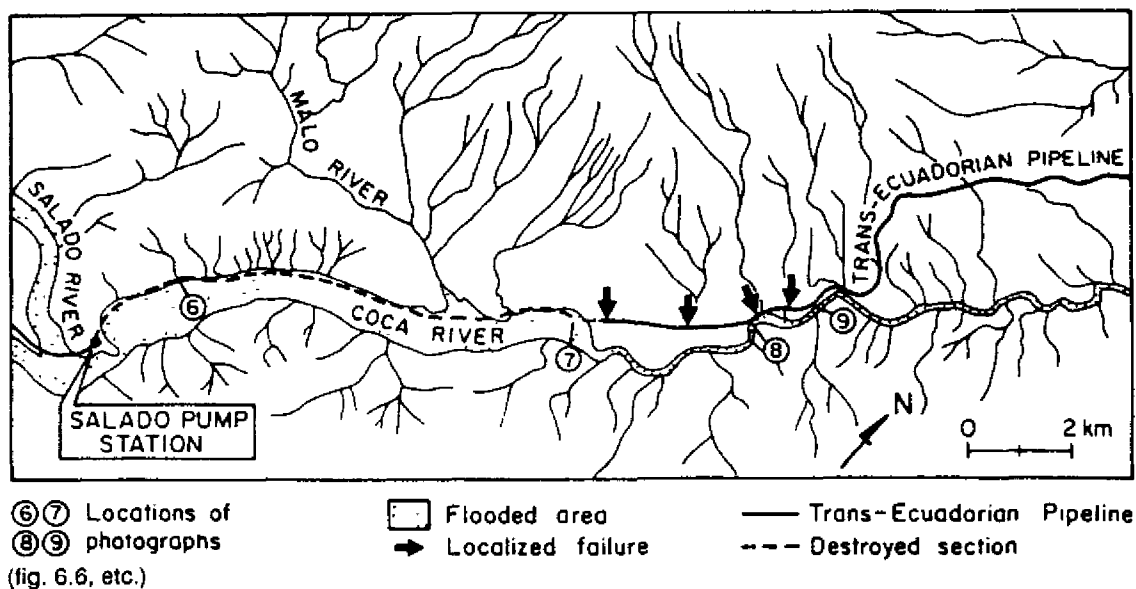
Figure 6.5 provides an expanded view of the area (hachured zone in Figure 6.2) of greatest pipeline damage. Approximately 12 km of the pipeline was destroyed along the banks of the Coca River, from just E of the Salado pump station to a location roughly 12 km E of the confluence of the Salado and Coca rivers. Along this section, damage was generated by landslides and debris flows in the residual soils and igneous parent rock of the hills flanking the N side of the Salado River. Most damage, however,

FIGURE 6.5 Area of flooding, landslides, and debris flows.

was caused by flooding of the Coca River, which is shown by the stippled area in the figure. Flooding encroached upon the pipeline alignment, resulting in severe scouring and removal of the entire pipeline right of way. Two sections of the pipeline, each approximately 1 to 2 km long, were left intact along this portion of the river. These sections were recovered during reconstruction and used on a provisional basis to establish flow in the rebuilt line.

Approximately 5 km of the Trans-Ecuadorian pipeline, immediately E of the section described above, was damaged at locations where landslides and debris flows intersected the line. The black arrows in Figure 6.5 show the points of localized damage, where the pipeline was severed. Many landslides and debris flows in this section originated in the younger volcanoclastic deposits surrounding Reventador Volcano at elevations between 1,400 and 2,000 m.
