SALADO PUMP STATION DAMAGE

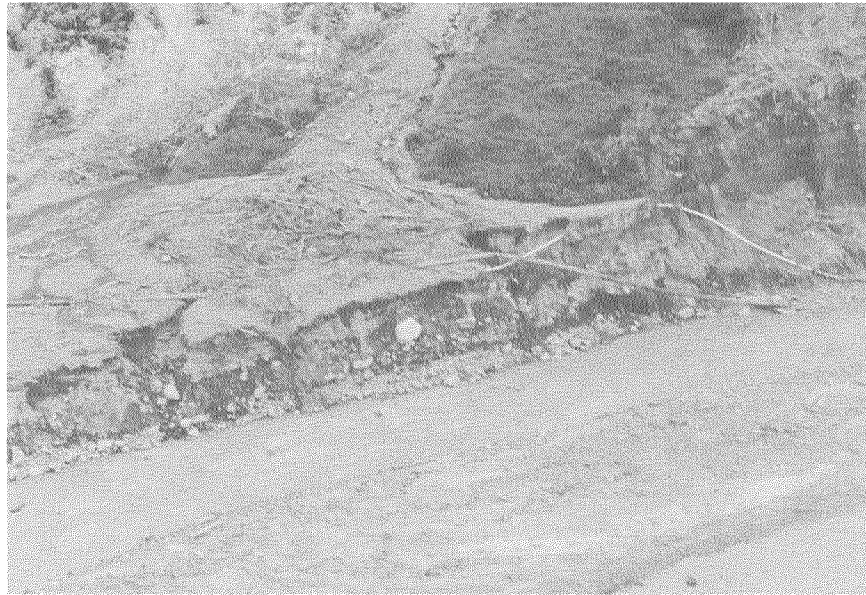
FIGURE 6.8 Trans-Ecuadorian and Poliducto (white) pipelines ruptured by debris flow and deep erosion along the Coca River.

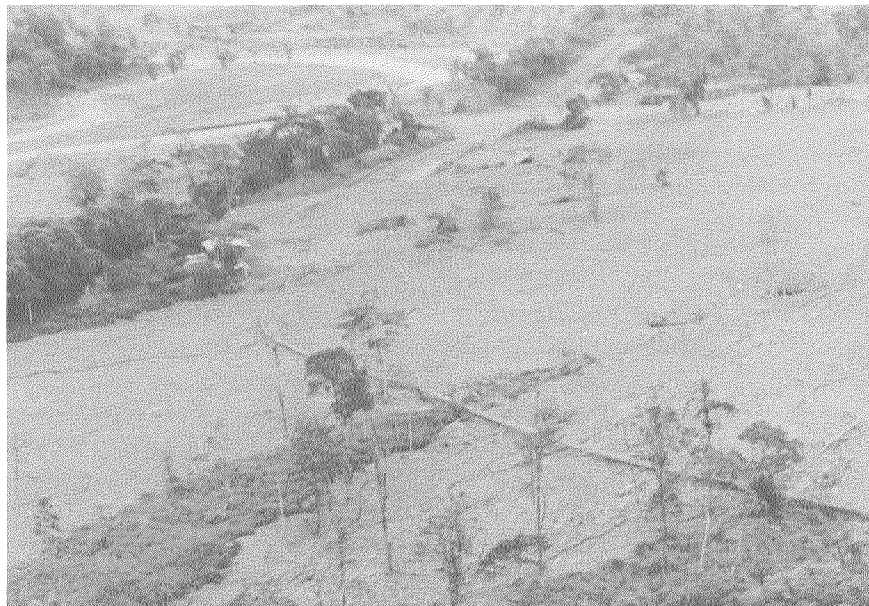
FIGURE 6.9 Broad fan of a very large debris flow with the Trans-Ecuadorian pipeline deformed in the direction of debris movement.

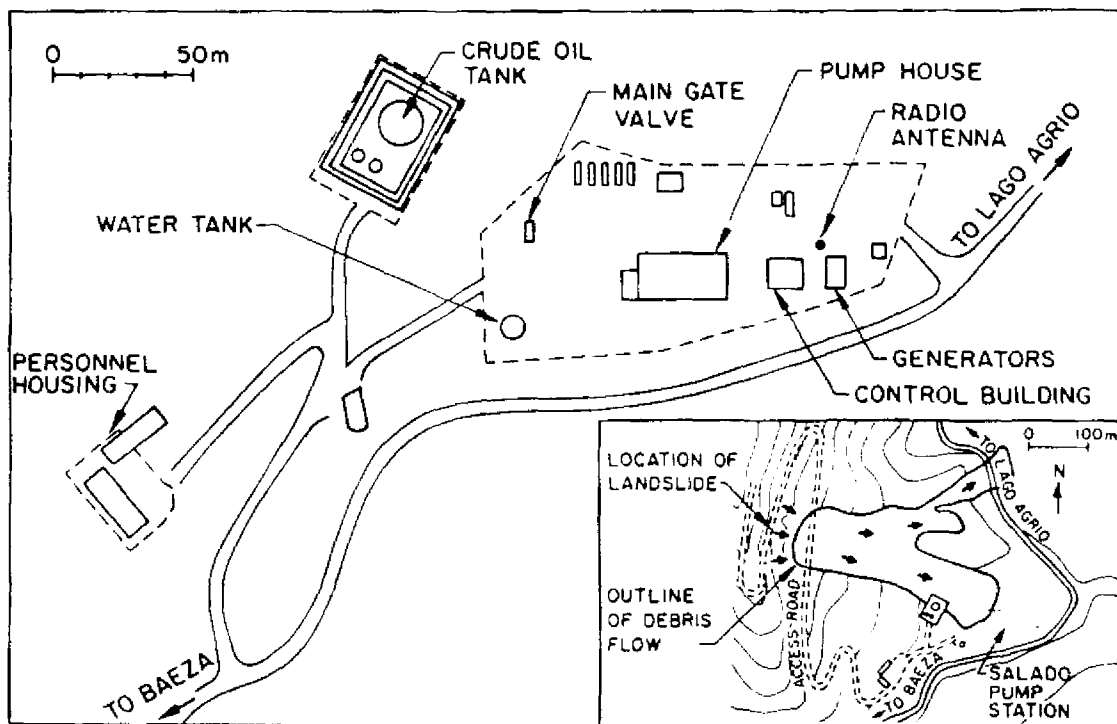
FIGURE 6.10 Plan view of the Salado pump station.

A plan view of the station is shown in Figure 6.10. Severe damage in the station was caused by a landslide that occurred in weathered granodiorite and terrace deposits at an elevation roughly 80 m above the station. The debris from this slide traveled approximately 240 m to the E, where it ruptured the principal oil tank of the station and buried the main gate valve. The location of the landslide and the outline of the debris flow are shown in the inset diagram in Figure 6.10.
