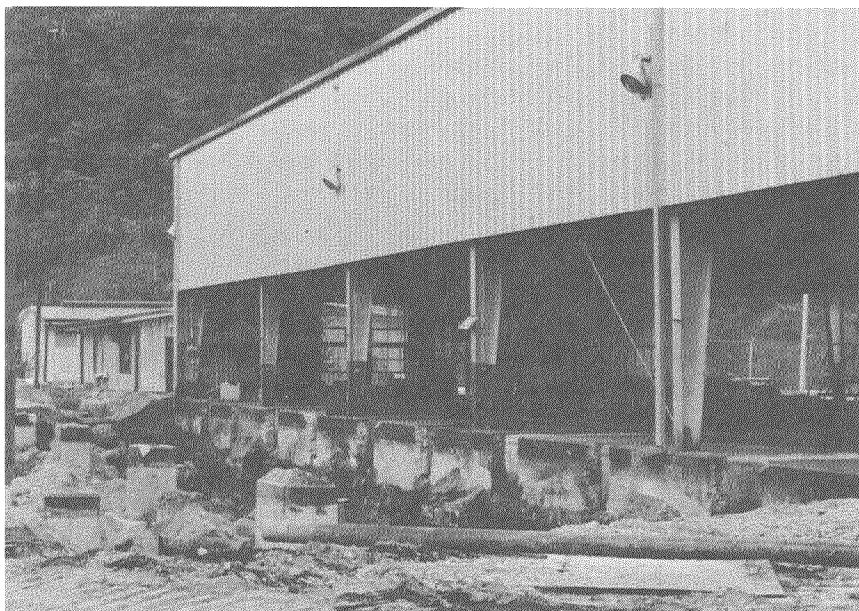
FIGURE 6.11 Pump house at the Salado pump station. Note soil settlement relative to pile-supported foundation blocks.
