TRANS-ECUADORIAN HIGHWAY FROM BAEZA TO LAGO AGRIO

SUMMARY

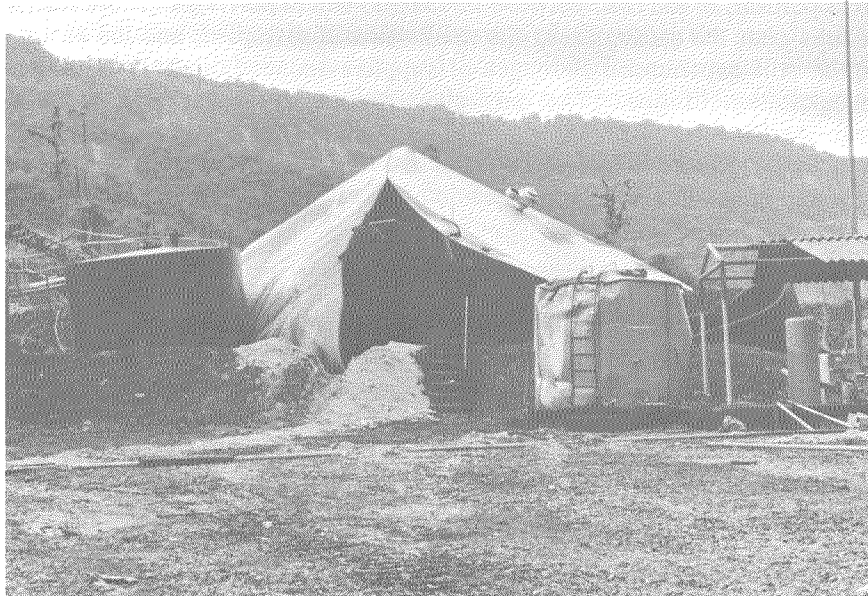
FIGURE 6.14 Oil tank destroyed by landslide debris at the Salado pump station.

structed of 12-mm-thick steel plate and was approximately 10 m high. Debris from the landslide hit the tank, causing it to collapse and to spill roughly 4,500 barrels of oil over the station. Figure 6.14 shows a photo of the collapsed oil tank and two smaller fuel tanks that were destroyed by the landslide and debris flow. Excavation and inspection during reconstruction revealed that oil from the tank had seeped through the ground to the Coca River over 100 m away, infiltrating subsurface soils for a depth of approximately 10 m. An oil fire erupted near the location of the ruptured tank during reconstruction of the station about 2 months after the earthquakes.

structural damage was caused by a landslide that destroyed the crude oil tank at Salado, spilling thousands of barrels of oil across the station. Permanent differential settlements and horizontal displacements were observed at most building foundations and were responsible in part for malfunctioning of control equipment, connections between pumps and heat exchangers, and generators. Seismic shaking damage was especially severe at the water storage tank and radio communications antenna.
