II. Damage

C. Structural Damage to Houses and Buildings

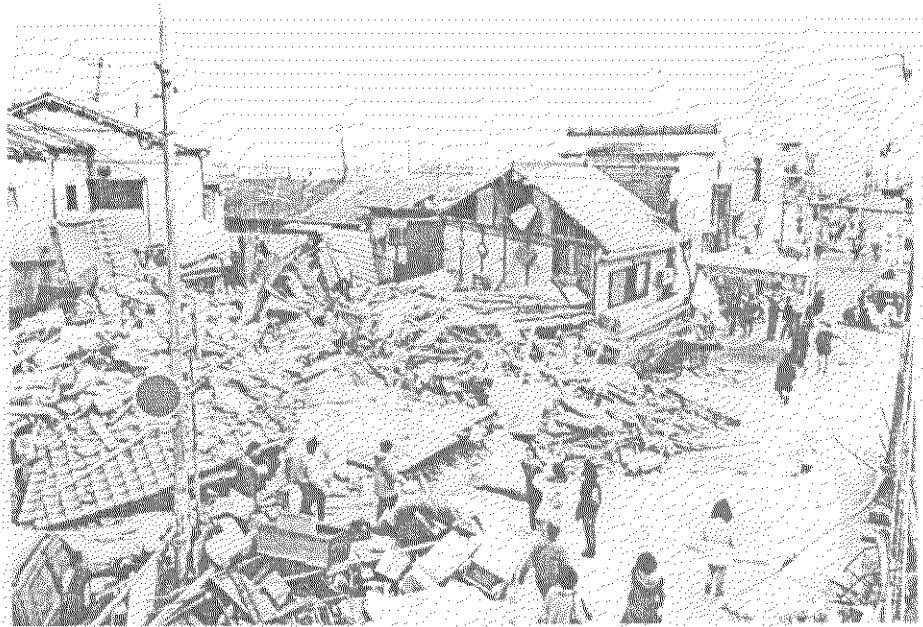
Photo 4 Building Collapse in Suma-Ward Residential District
Collapse of two story wooden housing
Hyogo Prefectural Government

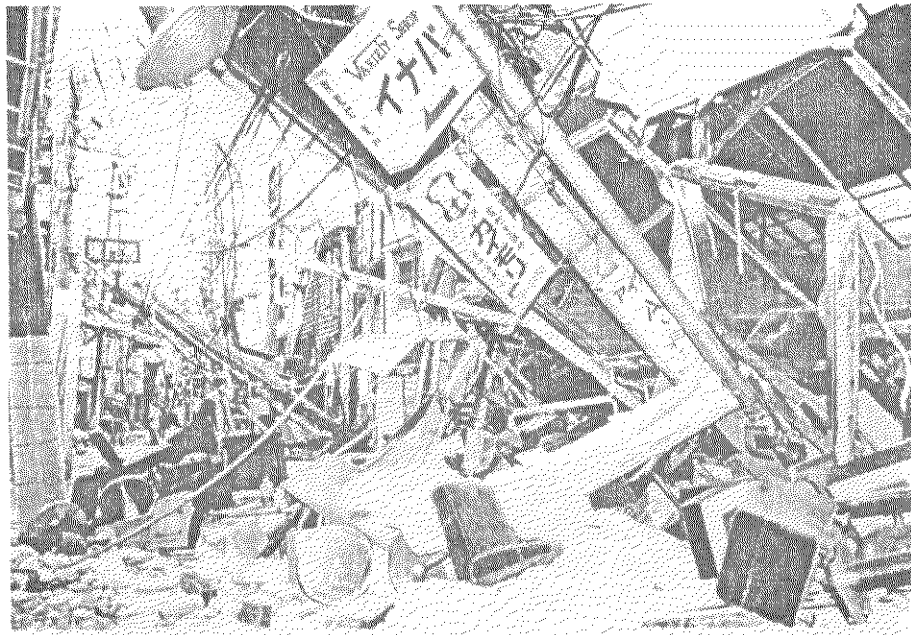
Photo 5 Building Collapse in Chuo-Ward Commercial District
Fallen signposts and debris blocking streets
Hyogo Prefectural Government
