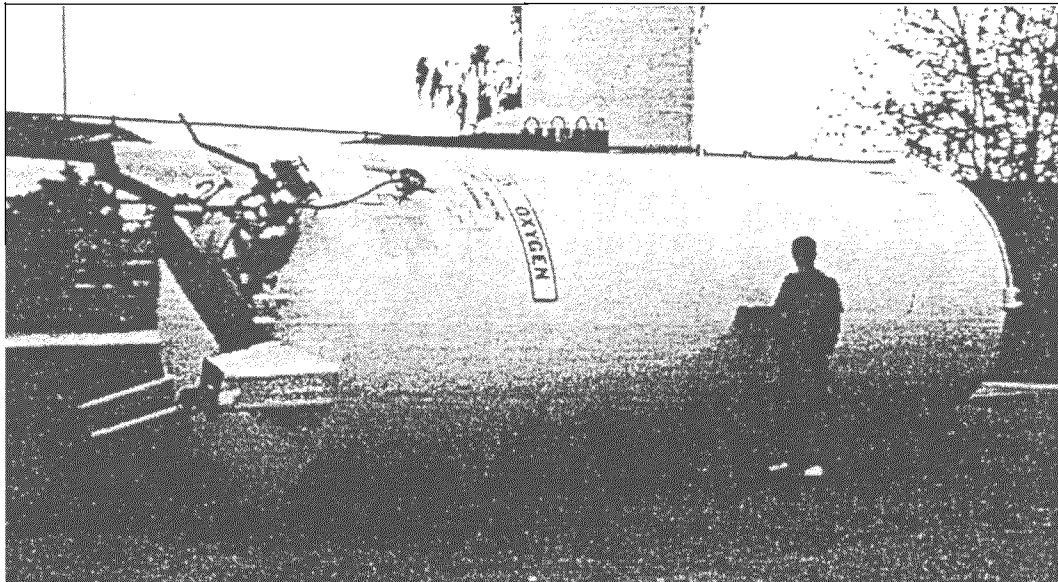
PHOTOGRAPH B7.2: The support pedestal system of this oxygen tank at Olive View Medical Center was damaged, leaving the tank leaning after the earthquake. It is shown after it was removed to allow for installation of a replacement unit. *photo credit: Don Jephcott, Earthquake Engineering Research Institute*
