RESULTS OF THE NORTHRIDGE EARTHQUAKE

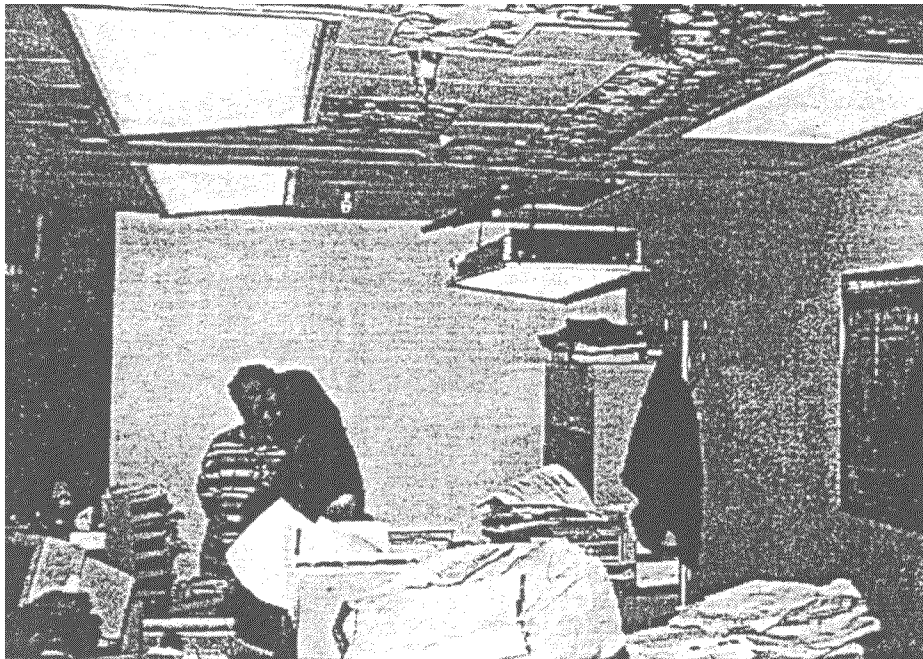
PHOTOGRAPH B7.5. Successful performance of two back-up support wires for fluorescent light fixture, Olive View Hospital. At this facility, this good performance was common and the failure shown in **PHOTOGRAPH B7.4** was rare *photo credit Bob Reitherman, Earthquake Engineering Research Institute*
