TABLE B7.2
Summary of Non structural Damage
to Northridge, Olive View, and Holy Cross Medical Centers

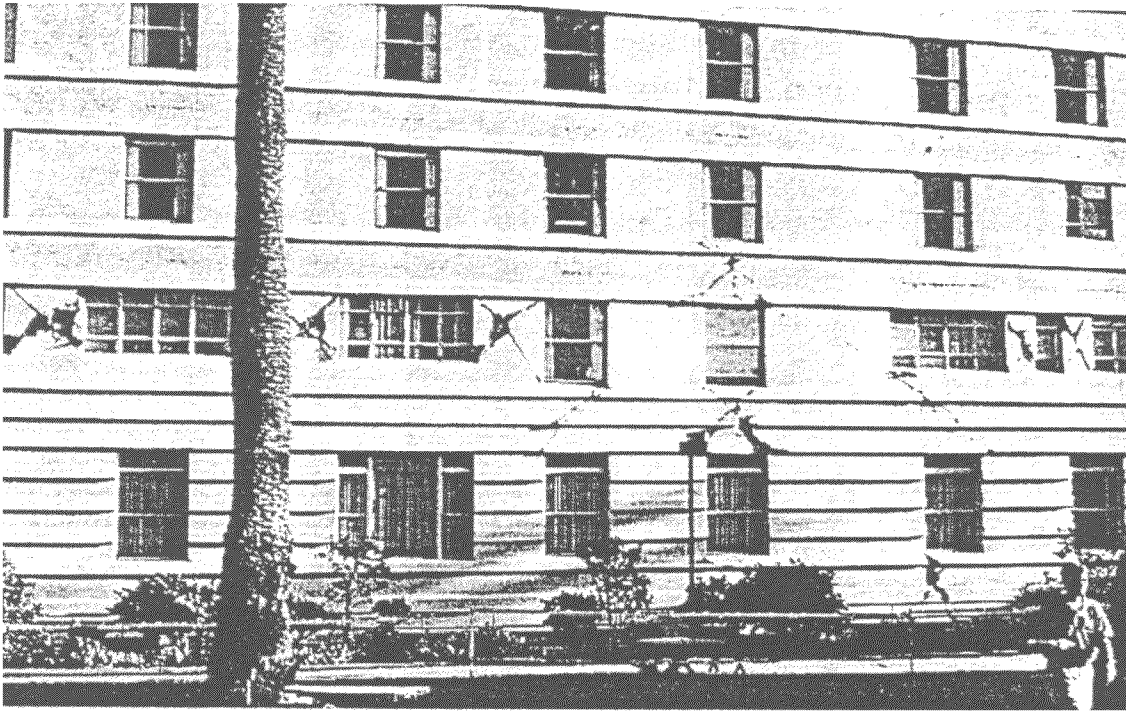
PHOTOGRAPH B7.8: Structural damage that caused "red tag" safety assessment and closure of building, St. John's Hospital, Santa Monica. *photo credit: Marvin Hollings, Earthquake Engineering Research Institute*
