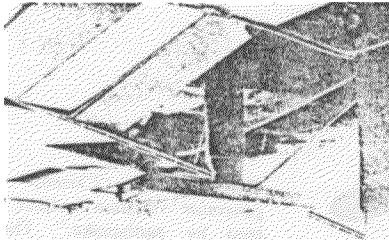
**FIGURE 3.152.** Air bar diffuser and flexible connectors dropped from damaged ceilings. Safety wires could have prevented excessive drooping of this type of equipment. Photograph courtesy of Hayakawa Associates and U.S. Department of Commerce, N.O.A.A.

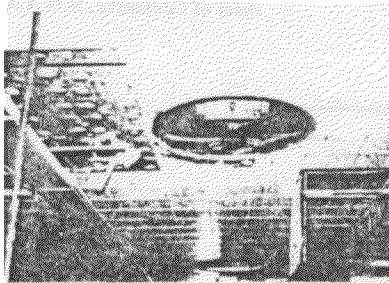
**FIGURE 3.153.** Circular diffuser dropped from ceiling. . . . As in Figure 3.152, safety wires could have prevented this type of failure. Photograph courtesy of Hayakawa Associates and U.S. Department of Commerce, N.O.A.A.

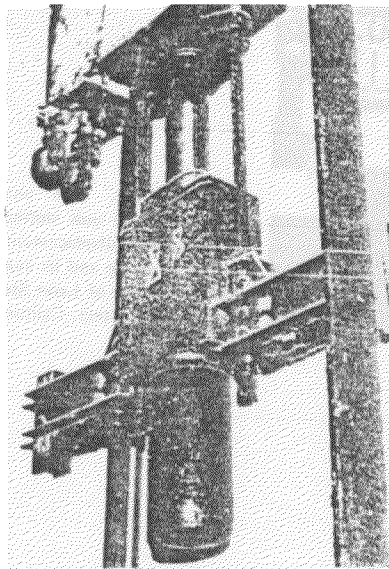
**FIGURE 3.154.** Counterweight and baffle came out of the guide rails. The baffle absorbs shock at the pit bottom in case of over travel. Photograph courtesy of Leon Stein, Office of the State Architect, California.

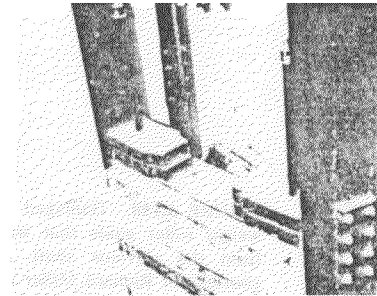
**FIGURE 3.155.** Top view of the counterweight in Figure 3.154. A dislodged rail bracket can be seen at the center of the photograph behind the weights. Photograph courtesy of Leon Stein, Office of the State Architect, California.

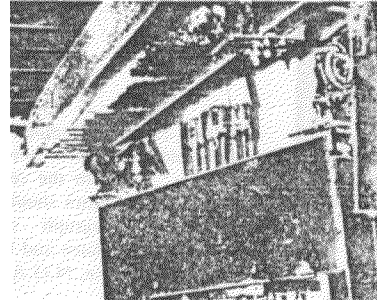
**FIGURE 3.156.** Dislodged counterweight showing where it struck the bottom of an elevator car. Photograph courtesy of Leon Stein, Office of the State Architect, California.

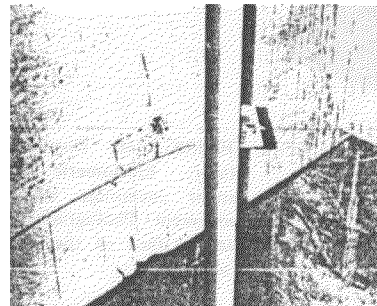
**FIGURE 3.157.** Displaced counterweight rail bracket. Note the damaged beam at lower center. Photograph courtesy of Leon Stein, Office of the State Architect, California.

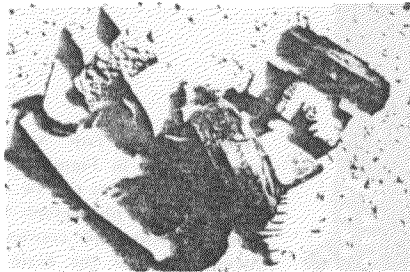
**FIGURE 3.158.** Damaged counterweight roller guide that was removed from the elevator shaft. Photograph courtesy of Richard Miller and the National Science Foundation.

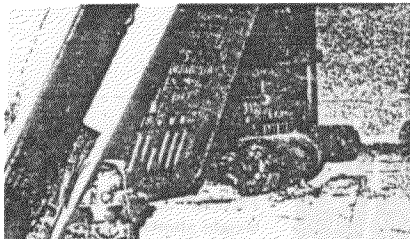
**FIGURE 3.159.** Damaged controller panels and generators thrown off their mounts. Both the control panels and motor generators should have been anchored. Photograph courtesy of Hayakawa Associates and U.S. Department of Commerce, N.O.A.A.

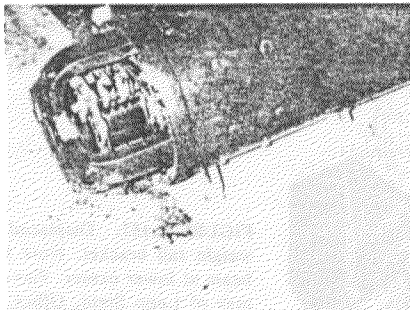
**FIGURE 3.160.** Displaced motor generator. Elastomeric feet without proper anchorage will not prevent movement. Photograph courtesy of Leon Stein, Office of the State Architect, California.

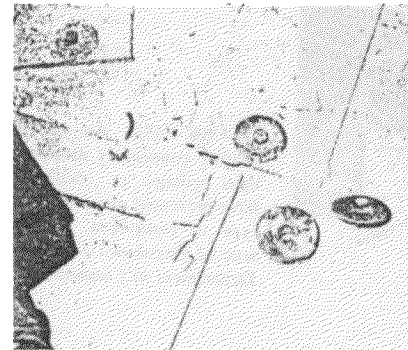
**FIGURE 3.161.** Closeup view of generator vibration isolator disassembled by earthquake. These high-frequency vibration isolators are commonly bolted to the motor generator but not the floor. Photograph courtesy of Hayakawa Associates and U.S. Department of Commerce, N.O.A.A.

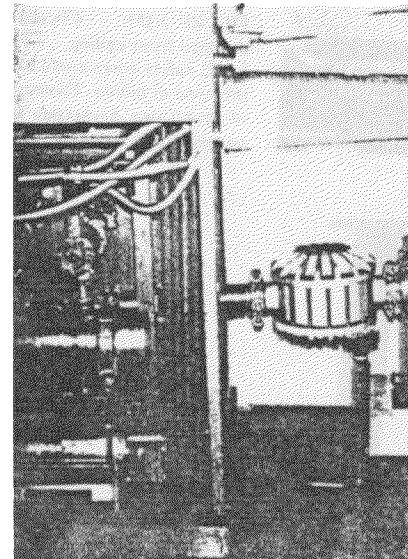
**FIGURE 3.162.** This unsecured hydraulic control unit shifted to the left here. Note the displacement with respect to the oil baffle and its support. Photograph courtesy of Leon Stein, Office of the State Architect, California.

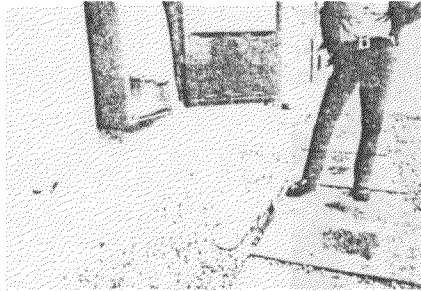
**FIGURE 3.163.** Fire extinguishers typically fall out of their cabinets unless they are provided with quick-release catches or the doors are equipped with positive latches. Safety glass or plastic should be used for viewing panes. Photograph courtesy of Richard Miller and the National Science Foundation.

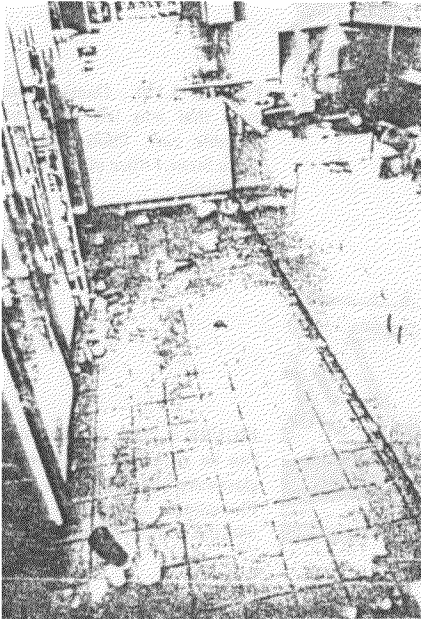
**FIGURE 3.164.** Spills such as that shown here can be expected wherever items are stored in cupboards without positive latches or on counter tops without some type of restraint. Photograph courtesy of Richard Miller and the National Science Foundation.

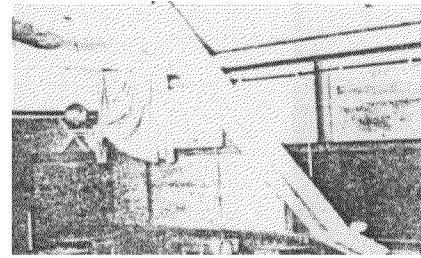
**FIGURE 3.165.** Fallen suspended fluorescent light fixture. Photograph courtesy of Leon Stein, Office of the State Architect, California.

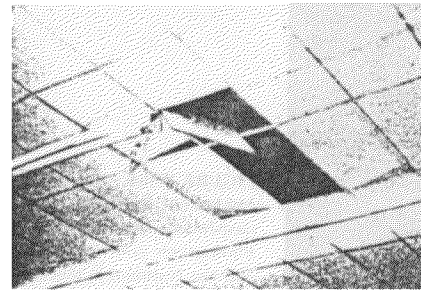
**FIGURE 3.166.** Lay-in panel failure. Note the missing linear surface-mounted fluorescent fixtures. Photograph courtesy of Leon Stein, Office of the State Architect, California.

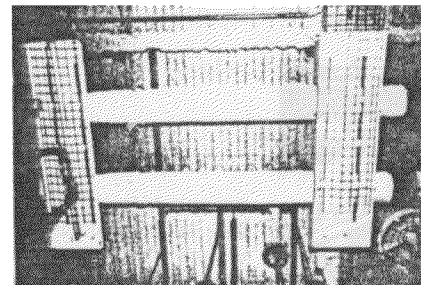
**FIGURE 3.167.** Suspended fluorescent fixtures. Note the dislodged tubes that were prevented from falling by the safety grills which slid on the light fixture. Photograph courtesy of Richard Miller and the National Science Foundation.
