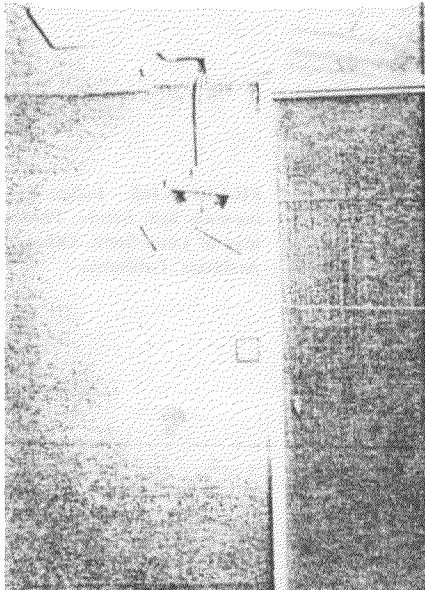
FIGURE 3.168. Surface-mounted incandescent fixture that fell and was left suspended by the electrical conduit. Photograph courtesy of Richard Miller and the National Science Foundation.

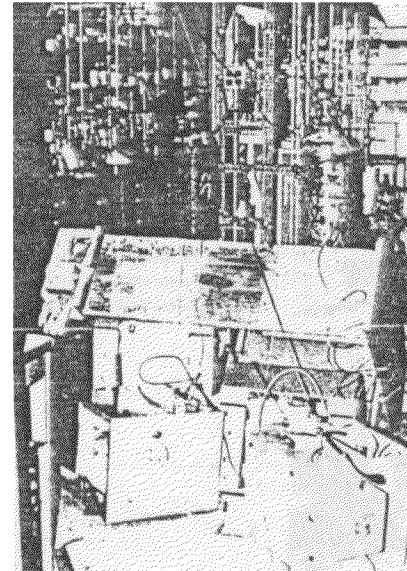
FIGURE 3.170. Damaged utility equipment that was left unrestrained on a portable cart. Photograph courtesy of Leon Stein, Office of the State Architect, California.

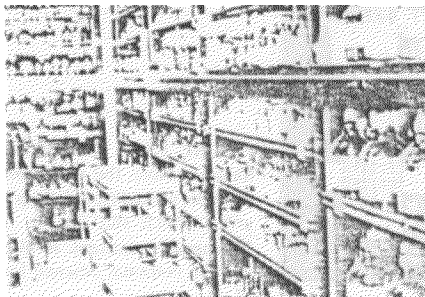
FIGURE 3.169. Shelved items that were not damaged during an earthquake because of plastic sheet parapets. Photograph courtesy of Leon Stein, Office of the State Architect, California.

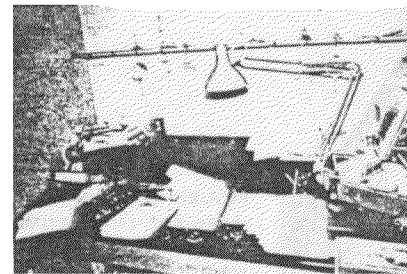
FIGURE 3.171. Typical damage that can be expected in a laboratory if the glassware and so forth is not protected. Photograph courtesy of Richard Miller and the National Science Foundation.

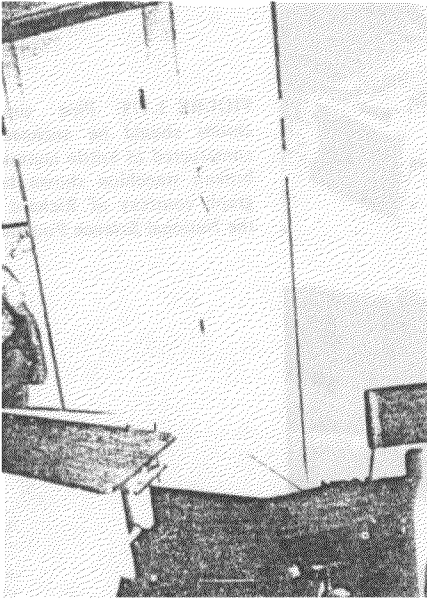
FIGURE 3.172 Wall-mounted television set that fell. Photograph courtesy of Richard Miller and the National Science Foundation

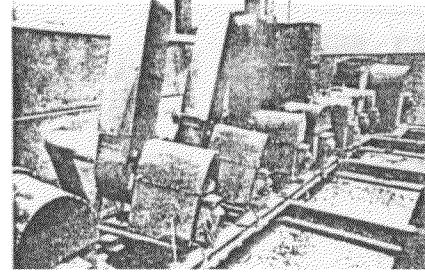
FIGURE 3.174 Fume hood fans that were supplied with vibration isolators but not motion restraints. Photograph courtesy of Richard Miller and the National Science Foundation

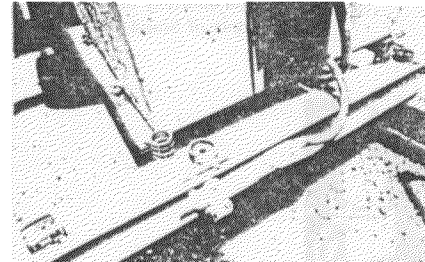
FIGURE 3.175. Detail of the failure from Figure 3.174. Photograph courtesy of Richard Miller and the National Science Foundation

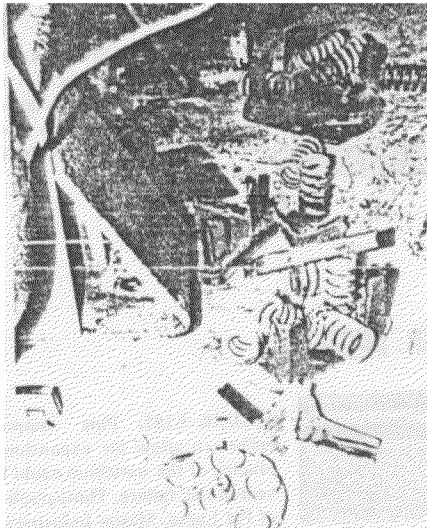
FIGURE 3.173. Collection of vibration isolators that failed as a result of not being provided with motion restraints. The vibration isolator housing should not be constructed of brittle materials. Photograph courtesy of Richard Miller and the National Science Foundation

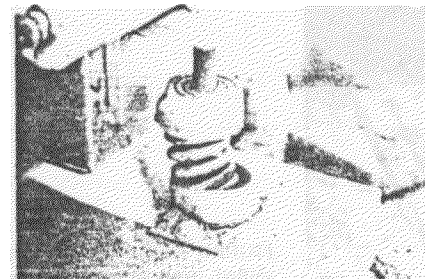
FIGURE 3.176. Small vibration isolator just at the point where the spring is ready to be dislodged. Photograph courtesy of Pat Lama, Mason Industries, Inc
