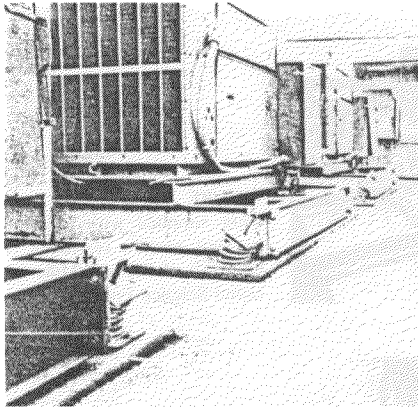
**FIGURE 3.177.** Failure of large vibration isolators at the cap screw. Photograph courtesy of J. R. Harris, National Bureau of Standards.

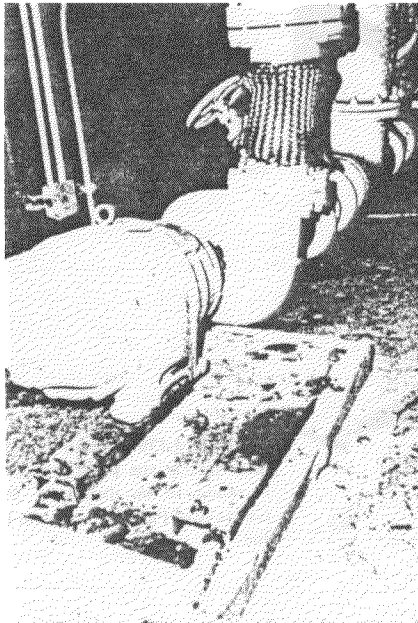
**FIGURE 3.178.** Pump motor that shifted. Note the braided pipe connector. This type of flexible coupling is not intended to resist axial loading. Photograph courtesy of Richard Miller and the National Science Foundation.

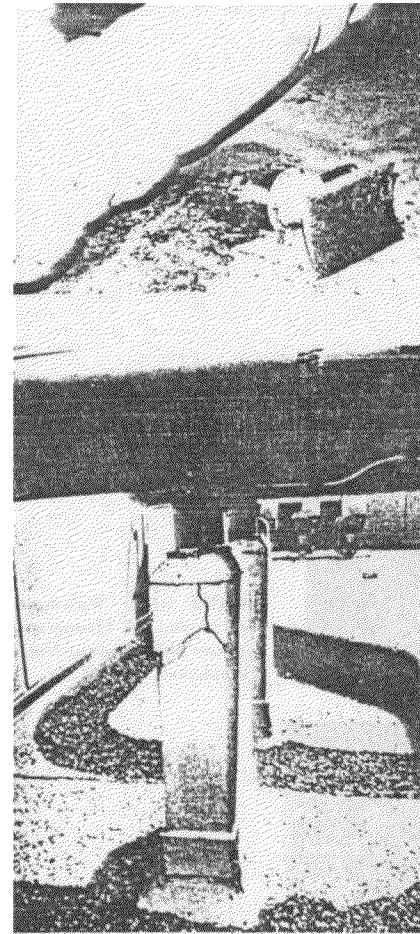
**FIGURE 3.179.** Pipe support stanchions should be anchored and not constructed of brittle material as is this broken stanchion shown here. Photograph courtesy of Richard Miller and the National Science Foundation.

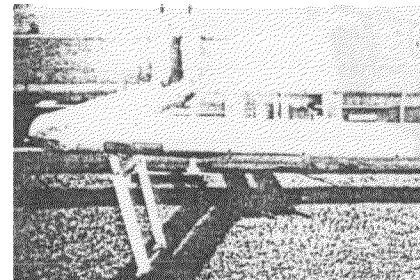
**FIGURE 3.181.** Pipe support with rollers to allow for expansion. Lateral bracing of the stanchion could have prevented this failure. Photograph courtesy of Pat Lama, Mason Industries, Inc.

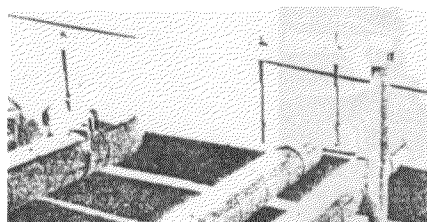
**FIGURE 3.182.** Vertical pipe hanger (without provisions for lateral bracing) failure. Photograph courtesy of Pat Lama, Mason Industries, Inc.

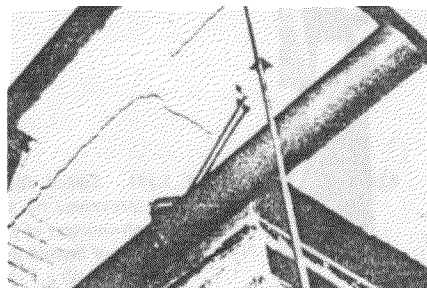
**FIGURE 3.183.** Broken C-clamp vertical pipe hanger without lateral support. Photograph courtesy of Leon Stein, Office of the State Architect, California.

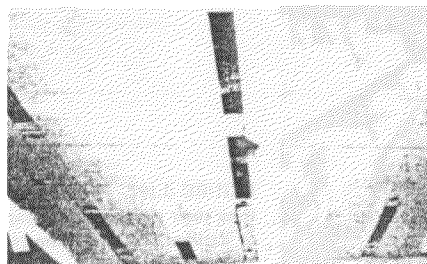
**FIGURE 3.184.** These 8 inch  $\times$  48 inch  $\times$  18 gauge  $\pm$  metal strips dislodged and fell to the seats below. Photograph courtesy of Leon Stein, Office of the State Architect, California.

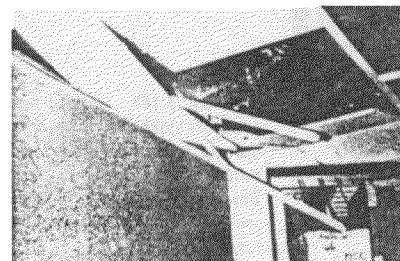
**FIGURE 3.185.** Perimeter failure of suspended ceilings is common where perimeter support is not provided. Photograph courtesy of Leon Stein, Office of the State Architect, California.

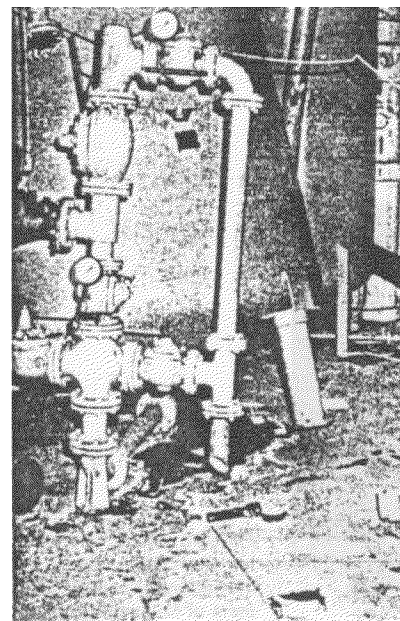
**FIGURE 3.186.** Damaged water softener. Photograph courtesy of Hayakawa Associates and U.S. Department of Commerce, N.O.A.A.

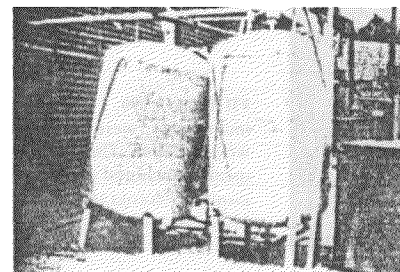
**FIGURE 3.187.** Damaged water softeners. Photograph courtesy of Hayakawa Associates and U.S. Department of Commerce, N.O.A.A.
