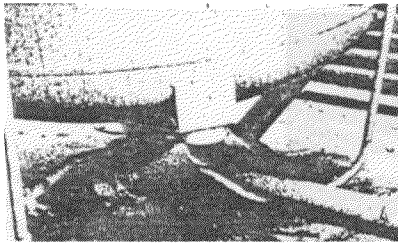
FIGURE 3.188. Bolts were sheared and nuts pulled loose on base plate supporting water softener. Pipe legs supporting tanks seldom perform well. Photograph courtesy of Hayakawa Associates and U.S. Department of Commerce, N.O.A.A.

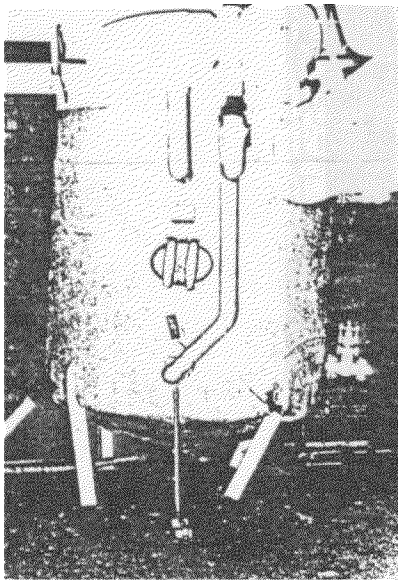
FIGURE 3.189. Damaged domestic hot water tank. Photograph courtesy of Hayakawa Associates and U.S. Department of Commerce, N.O.A.A.

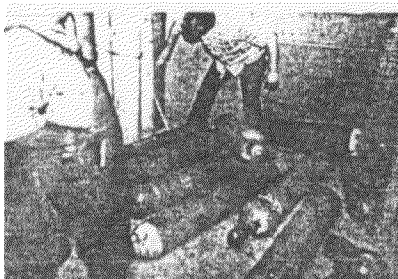
FIGURE 3.190. High-pressure gas cylinders that were supported by light-weight chains. The chains were not adequately anchored to the wall in the background. Photograph courtesy of Richard Miller and the National Science Foundation.

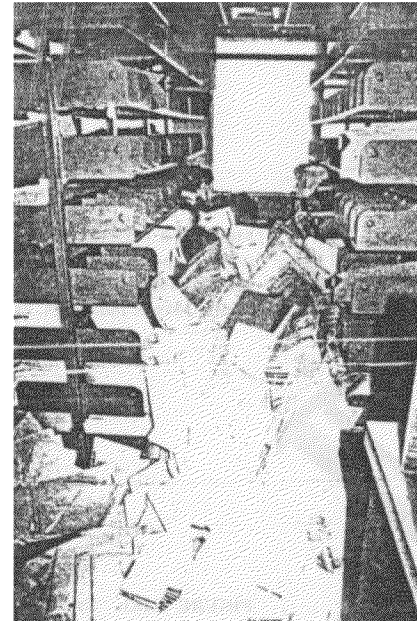
FIGURE 3.191. Spilled files such as these can be prevented by shelf retainers. Photograph courtesy of J. R. Harris, National Bureau of Standards.

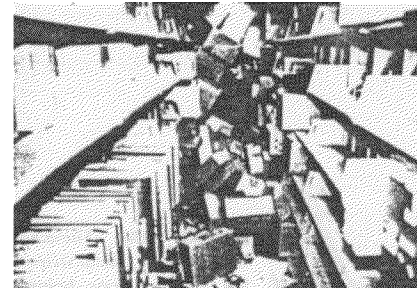
FIGURE 3.192. Boxes that spilled from their shelves. Photograph courtesy of Richard Miller and the National Science Foundation.

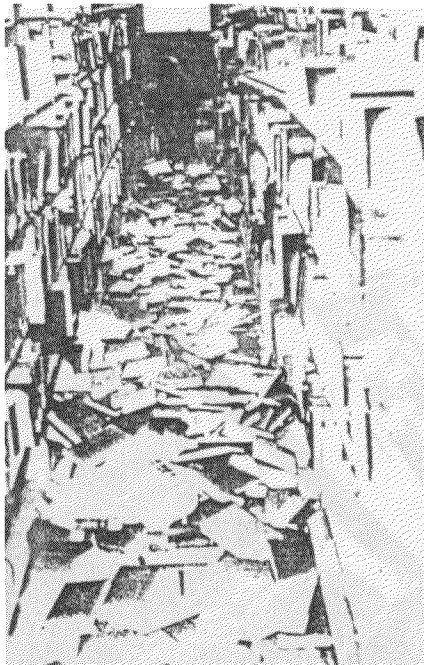
FIGURE 3.193. Typical library scene following an earthquake where shelf protection is not provided. Photograph courtesy of Richard Miller and the National Science Foundation

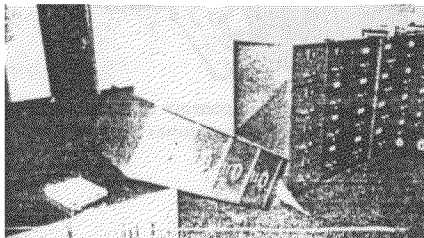
FIGURE 3.194. Without adequate protection filing cabinets can easily topple with the potential for blocking exit paths, and so forth. Photograph courtesy of J. R. Harris, National Bureau of Standards

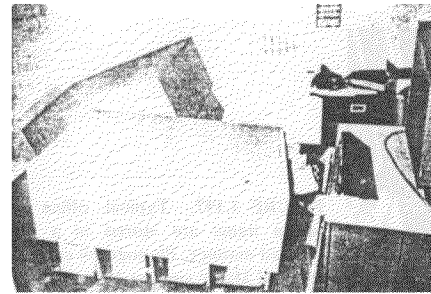
FIGURE 3.195. Top-heavy filing cabinets in the work space pose a significant hazard to personnel. Photograph courtesy of J. R. Harris, National Bureau of Standards

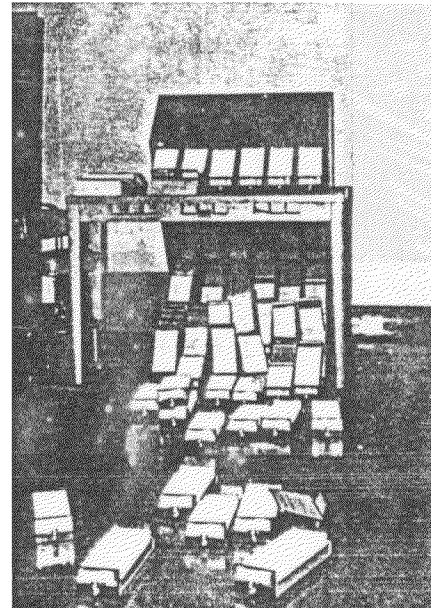
FIGURE 3.196. Even items such as library card files pose a potential threat to personnel. Photograph courtesy of Richard Miller and the National Science Foundation
