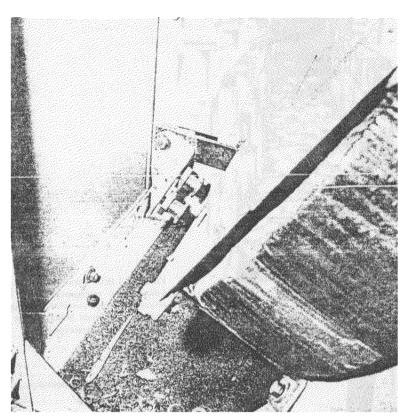
FIGURE 3.199 Failure of dynamically sensitive internal components of a control cabinet during biaxial seismic testing. Photograph courtesy of Wyle Laboratories Scientific Services and Systems Group.

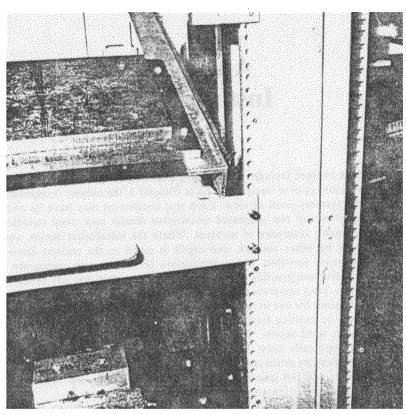
FIGURE 3.201 Fahore of equipment rack during biaxial seismic testing. Photograph courtesy of Wyle Laboratories Scientific Services and Systems Group.
