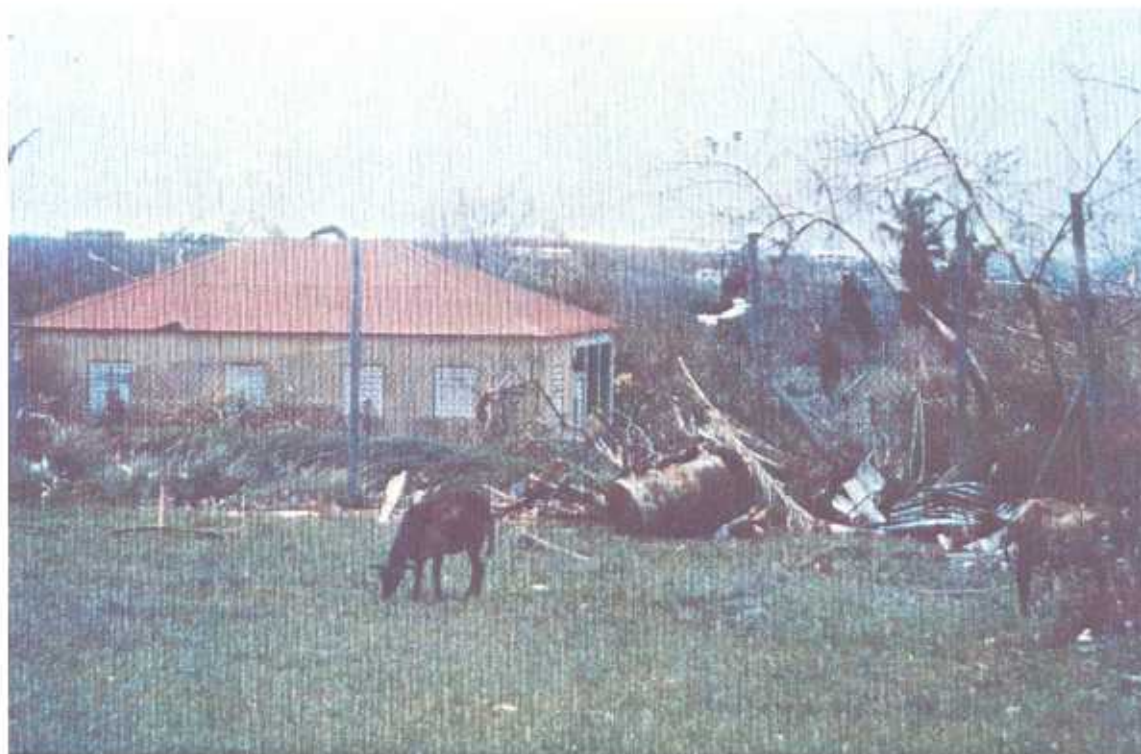
PLATE 23. Hipped roof in good condition.

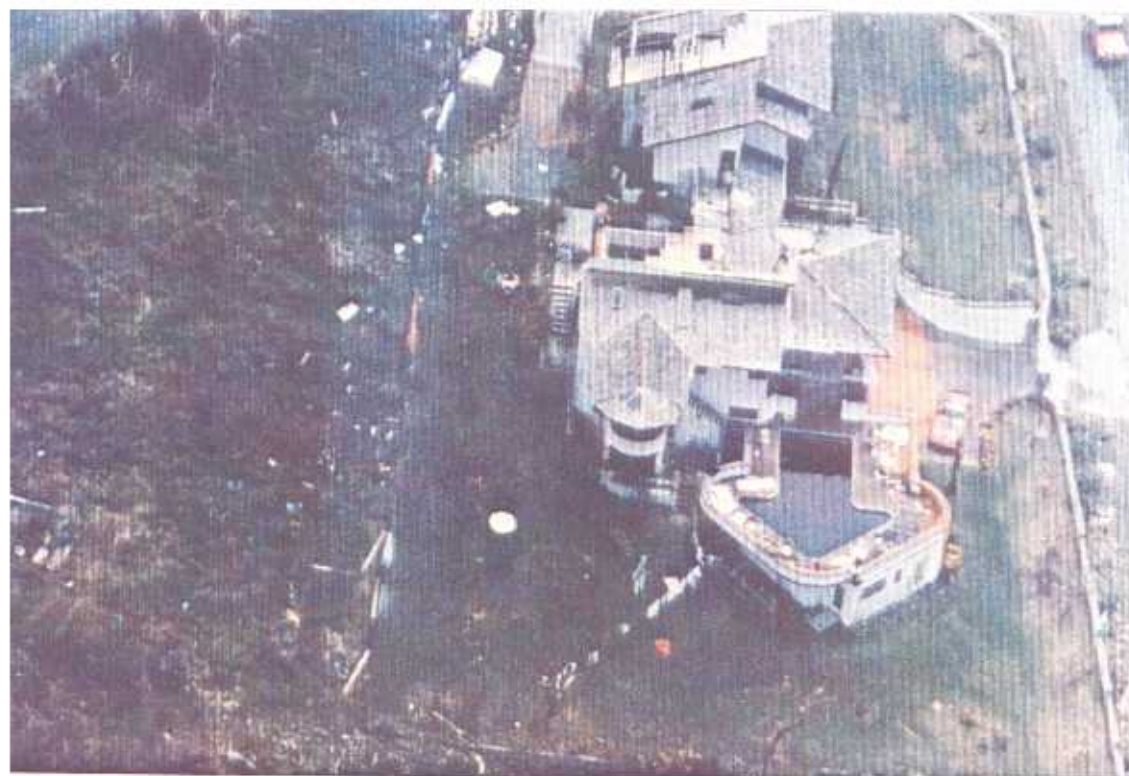
PLATE 24. Private large house with swimming pool.
Some hipped roofs are intact, but shed type roofs lost their
roof covering and some framing.

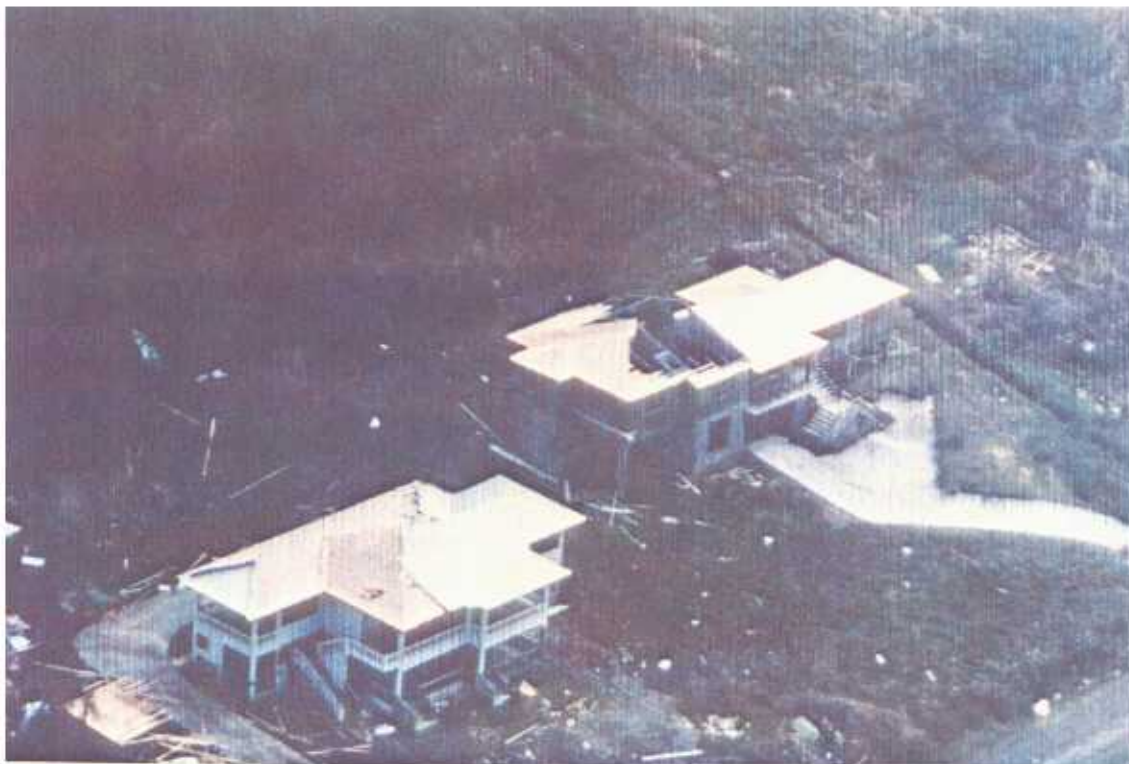
PLATE 25. Upper Income Houses. Note loss of some roof cladding to one house.

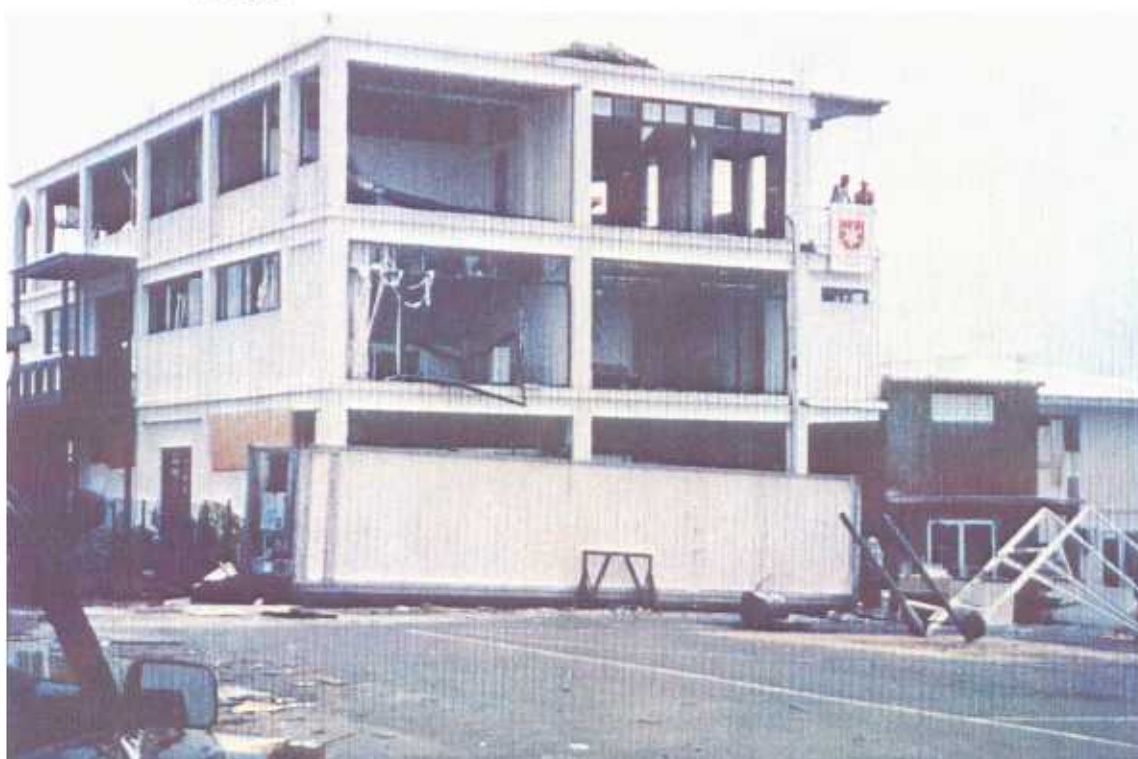
PLATE 26. Concrete roof. All windows and glass panels blown out or broken by flying objects.

Office building in Plymouth with concrete roof. The large glass windows were blown out. Such large windows are not recommended unless special provision is made to strengthen the window frames, fixings and glass. Hurricane shutters must be installed to prevent breakage from flying objects.

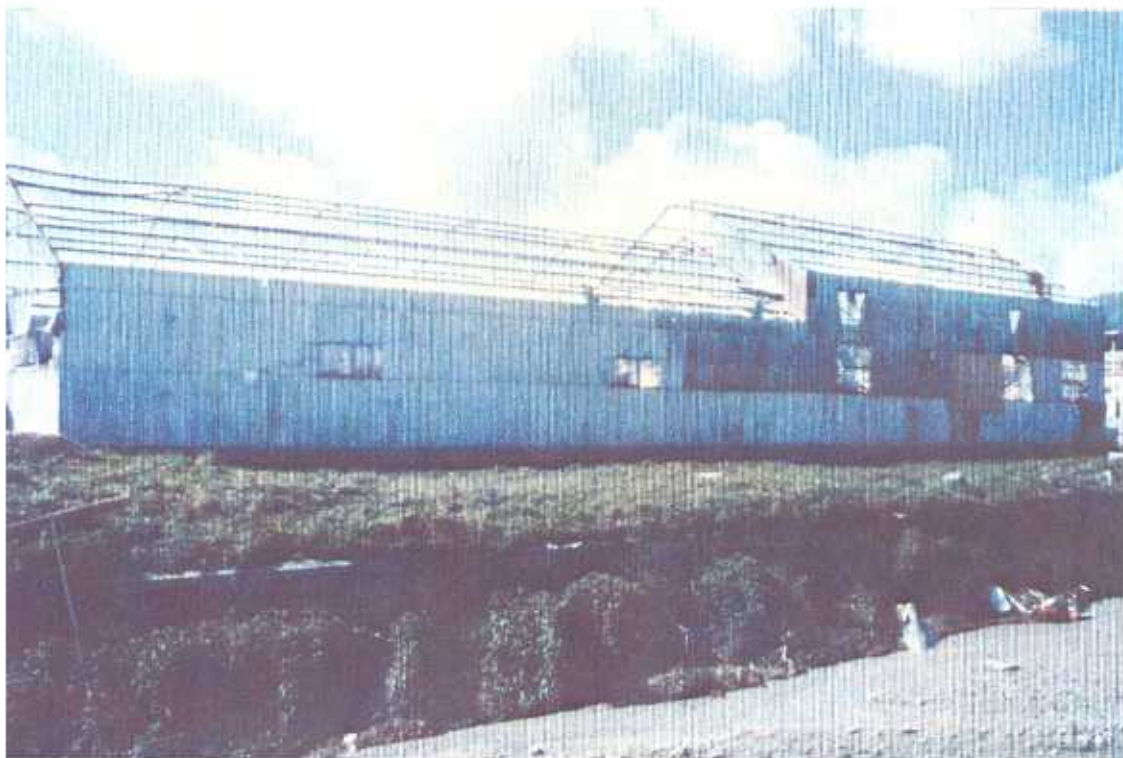
PLATE 27. Ginnery. Note total loss of corrugated roof sheeting . Steel roof frame in place but with some buckling of the purlins.

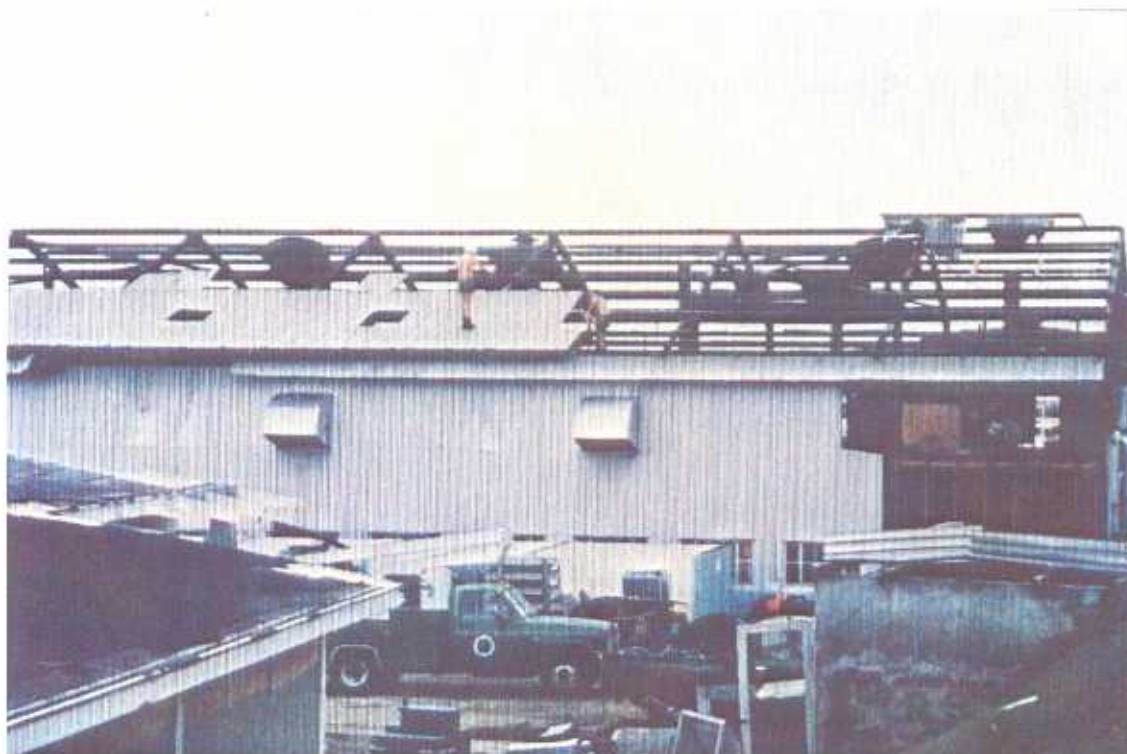
PLATE 28. Monlec Power Station. Loss of corrugated roof sheeting.
The mechanism for fixing corrugated roof sheets must be carefully detailed and installed as per the Guidelines.

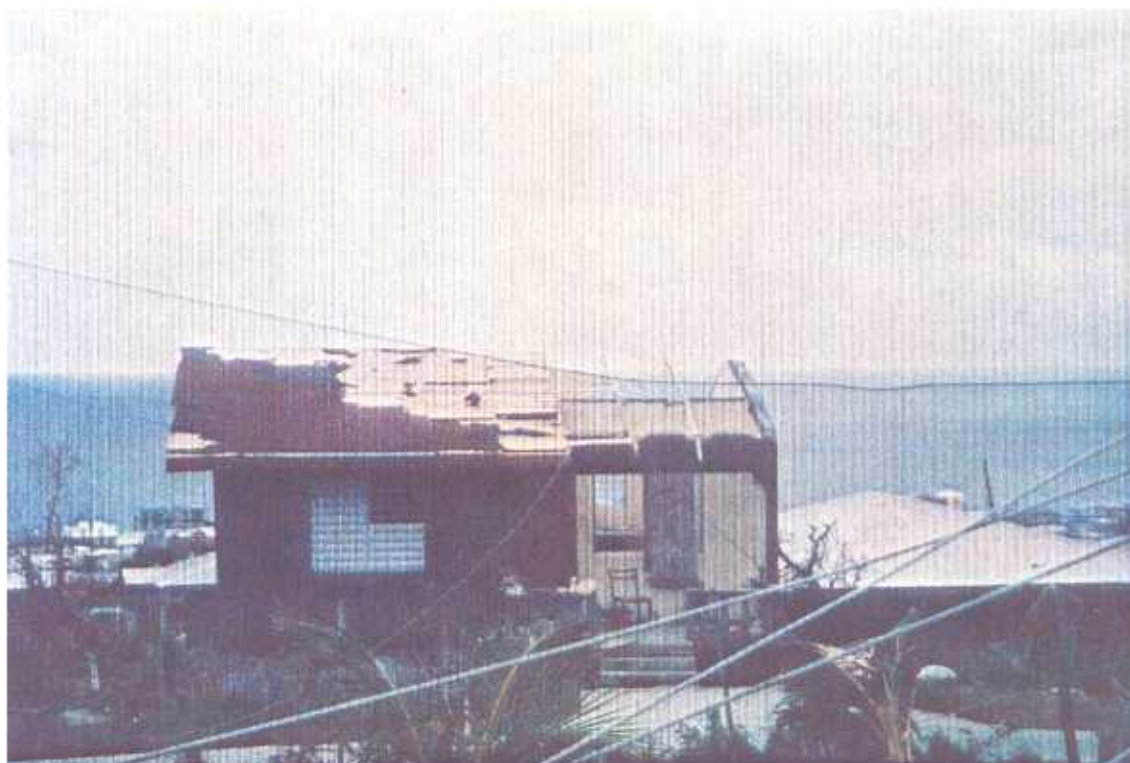
PLATE 29. Low income house at Webbs. Note failure of roof at gable and blown out wall.

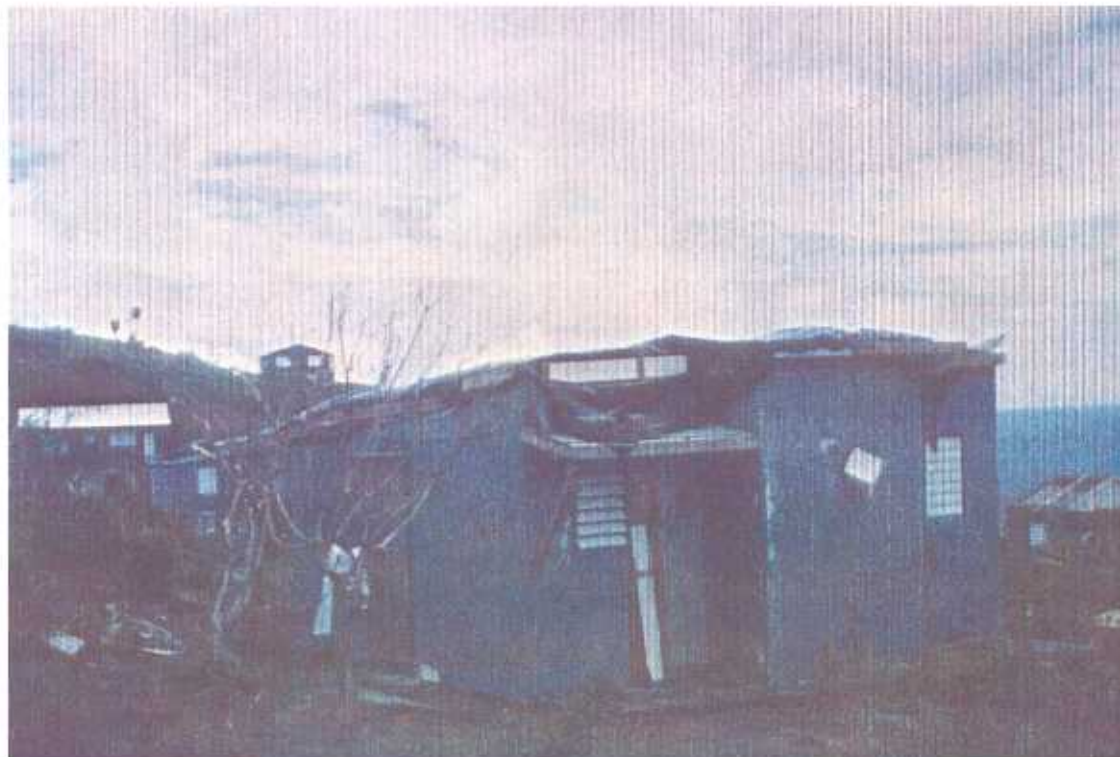
PLATE 30. Low income house at Broderick. The low pitched shed roof was lost. Such roofs are very vulnerable to high winds.

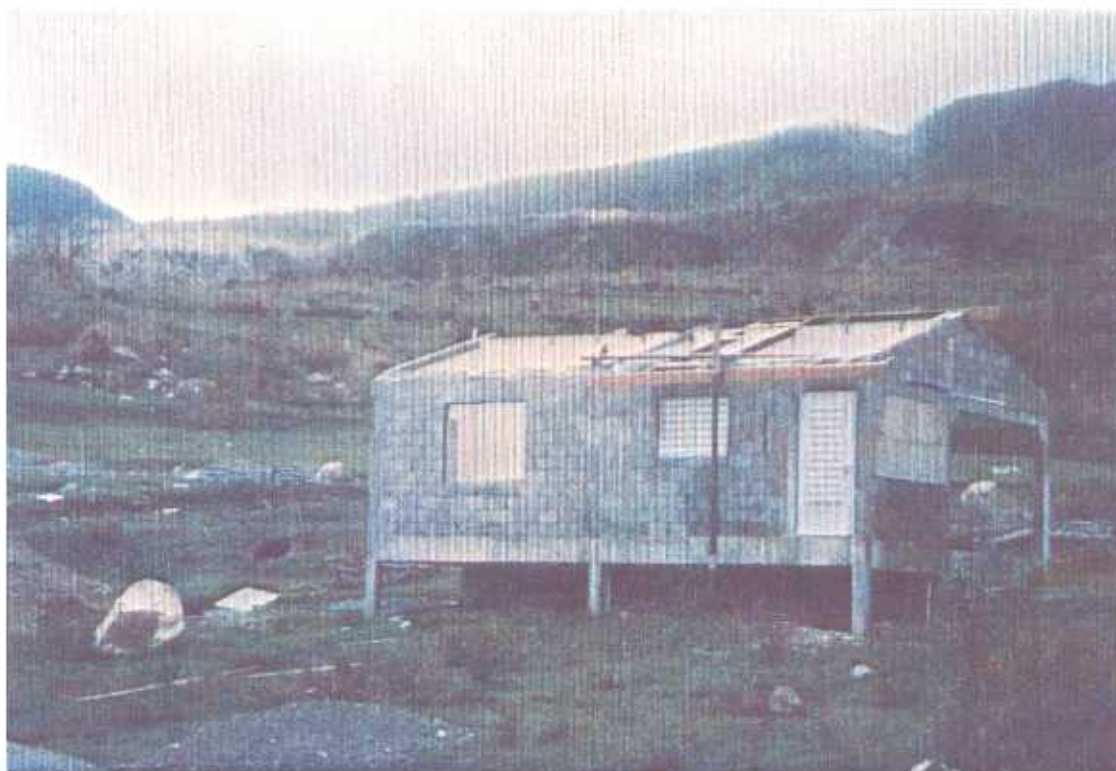
PLATE 31. Low income house on concrete posts and concrete cill-beam. The frame of the house appeared to be well constructed, but the low roof pitch on inadequate holding down details led to the loss of the roof.

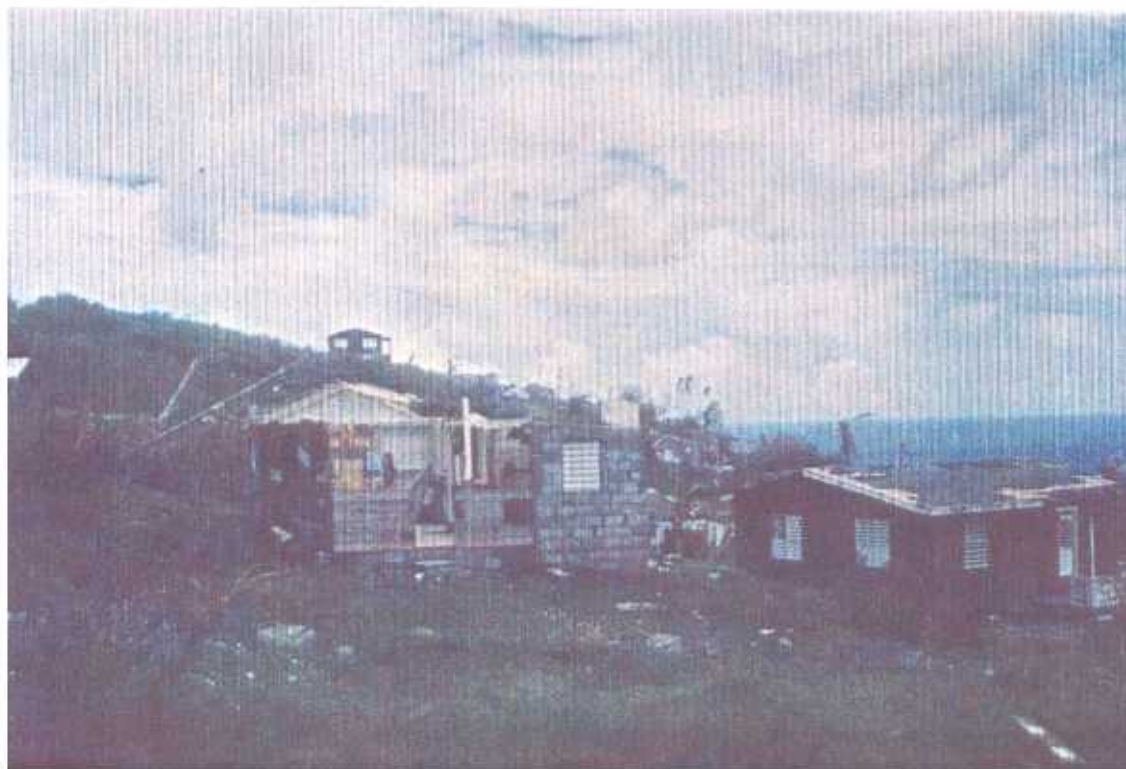
PLATE 32. Low income housing of substandard construction. However repairs would not be difficult.

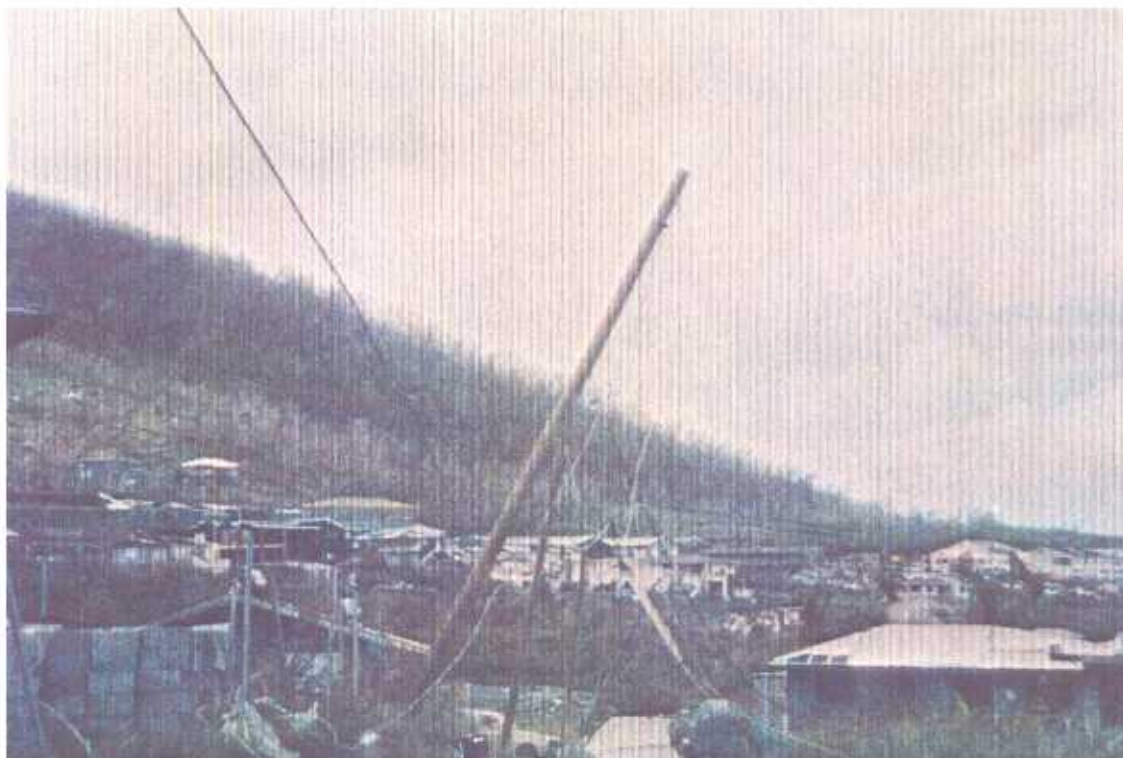
PLATE 33. Low income housing showing general failure of roofs. Note damaged utility systems.

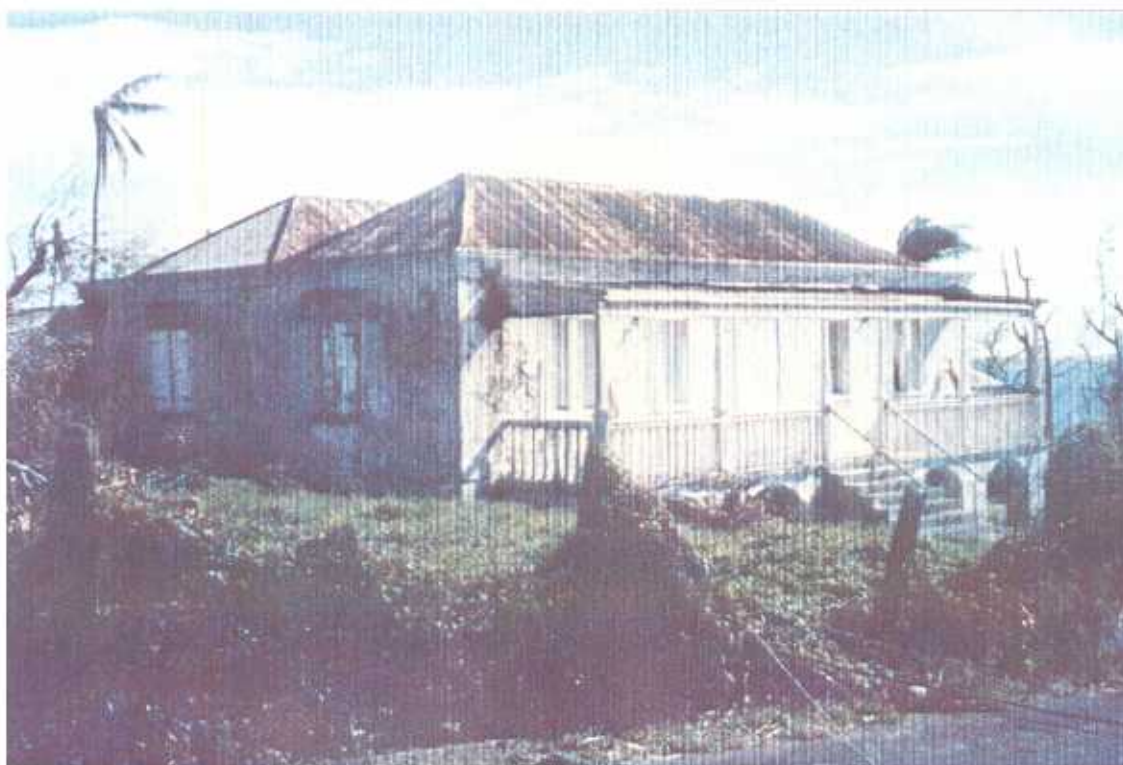
PLATE 34. Traditional middle income housing with good hurricane resistant features. Note hipped roofs of high pitch and no overhangs. Note also that the verandah to the house in Plate 21 has a separate roof. These houses have permanent timber hurricane shutters.

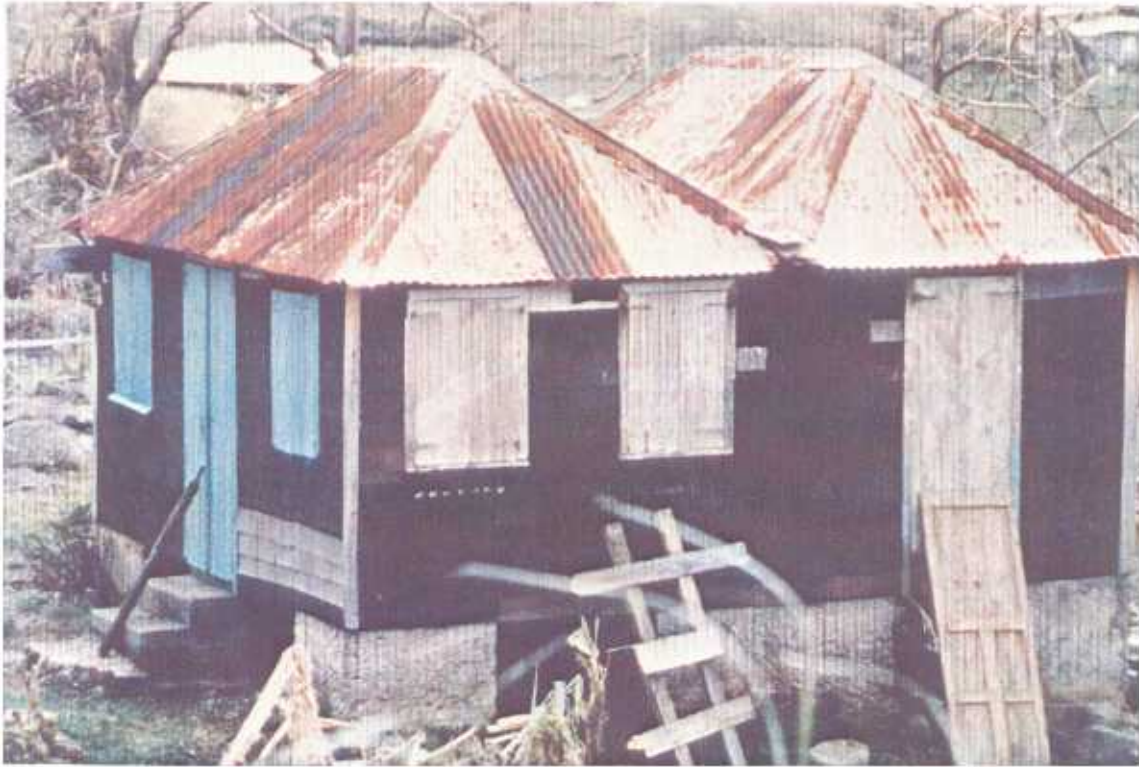
PLATE 35. Timber building - hipped roof. Shuttered windows and door.

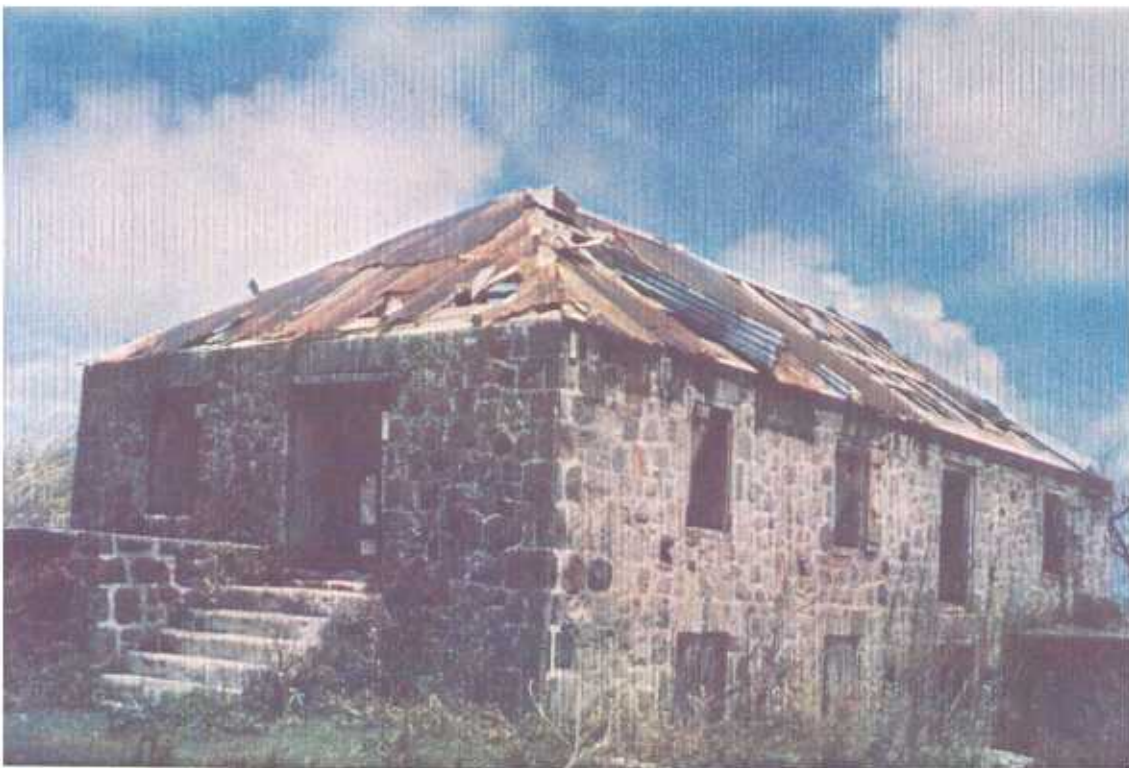
PLATE 36. Abandoned building in poor condition. Although the galvanised iron sheets are badly corroded this building might have survived damage due to the excellent shape of the roof and traditionally strong construction details.

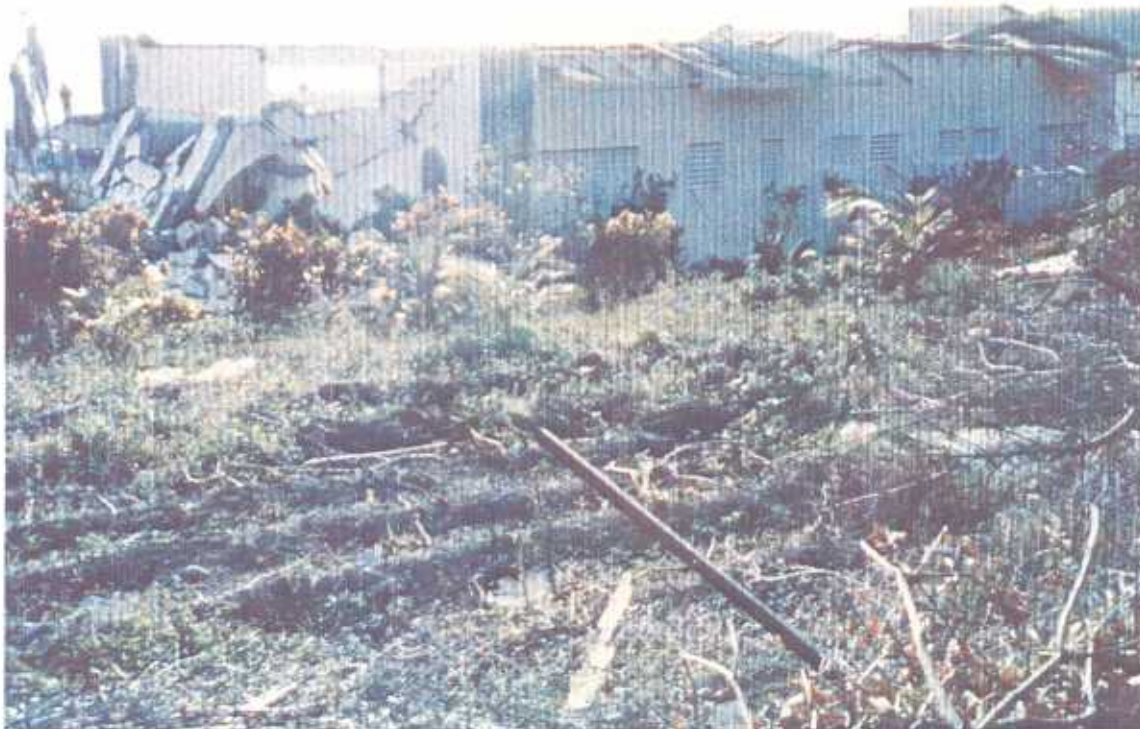
PLATE 37. Collapsed masonry walls. Loss of roof structure and cladding. Church in Plymouth allocated as a hurricane shelter. Poor construction led to complete loss of roof and collapse of the masonry walls. Buildings to be used as shelters should be designed to be hurricane and earthquake resistant and must have appropriate facilities.

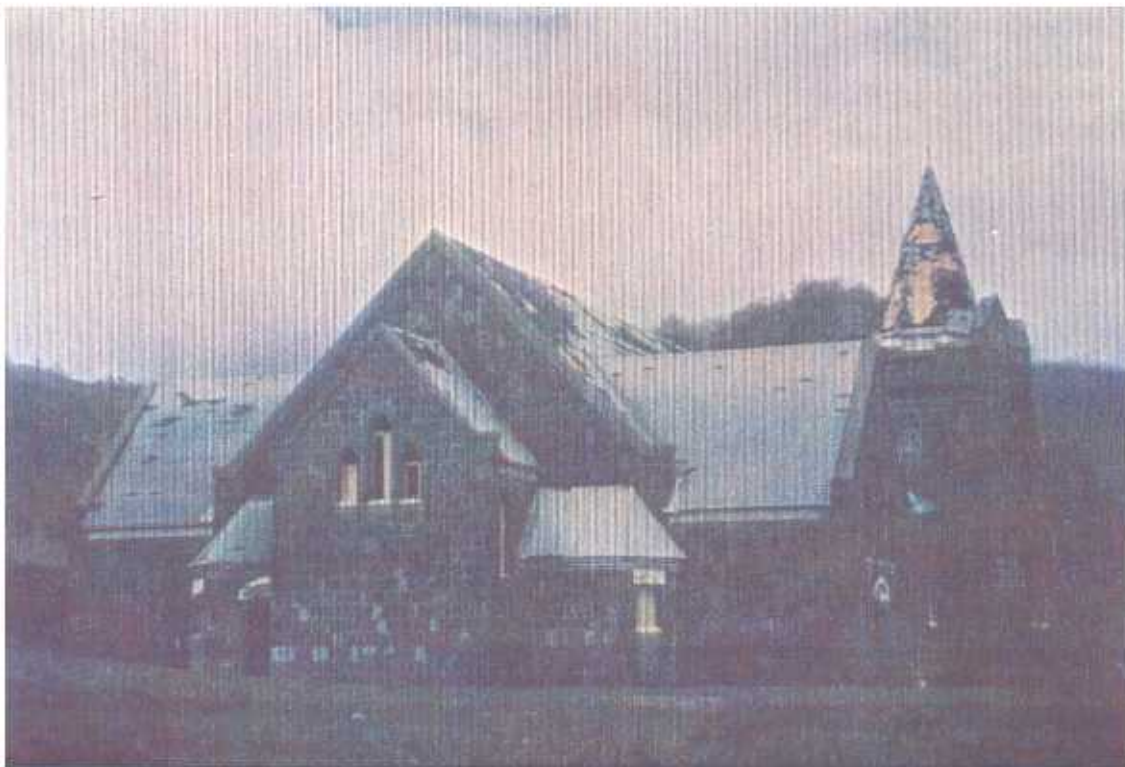
PLATE 38. Bethel Church. Church with traditional construction. Note loss of some shingles on the spire, but the church was otherwise undamaged.

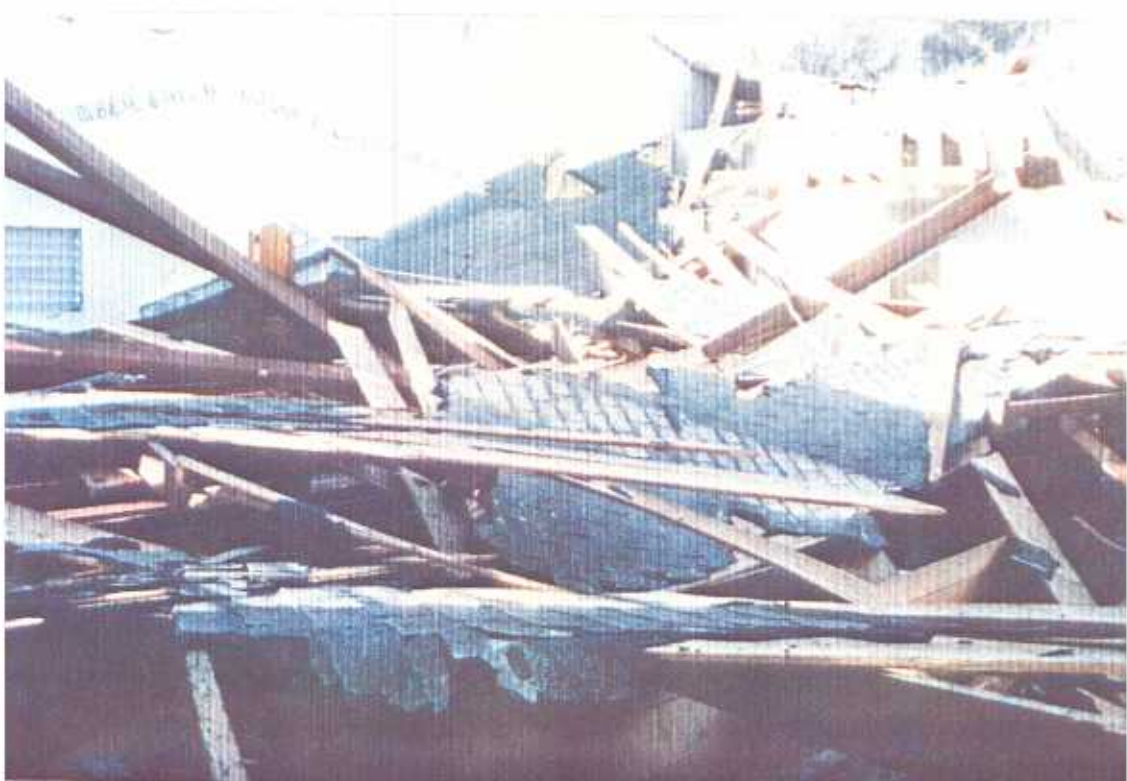
PLATE 39. Church in Plymouth. Collapse of roof structure.

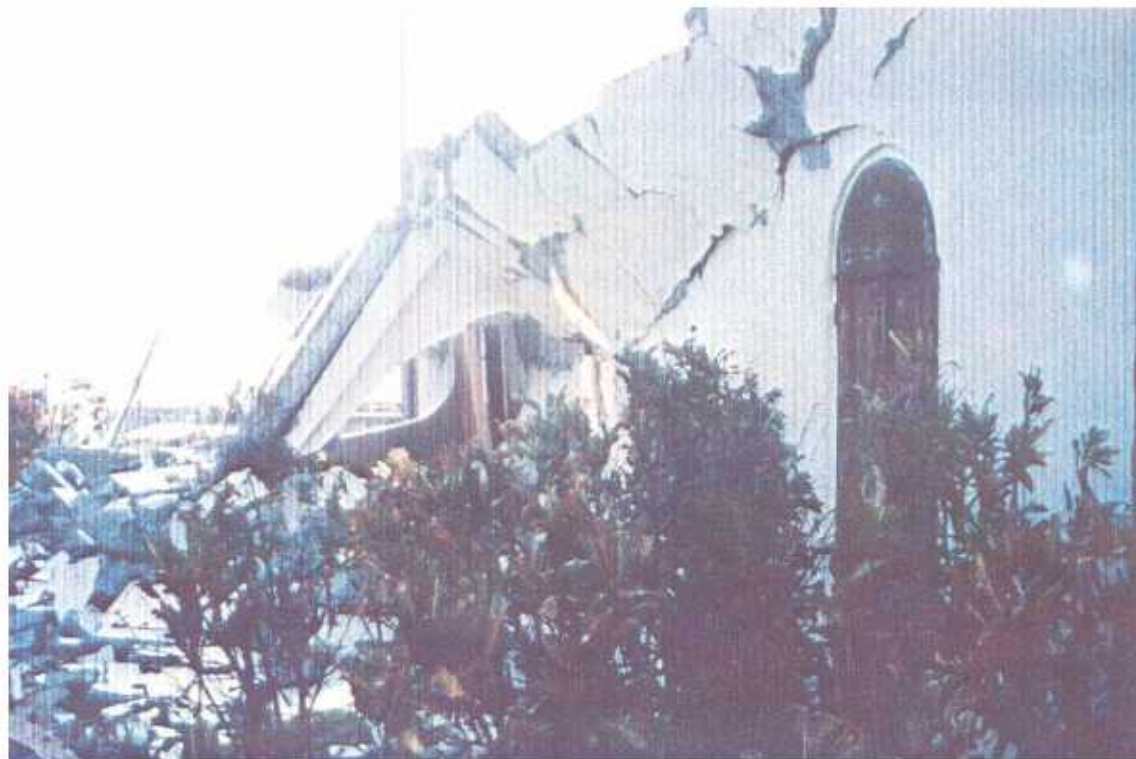
PLATE 40. Church in Plymouth. Collapse of unreinforced masonry walls.
