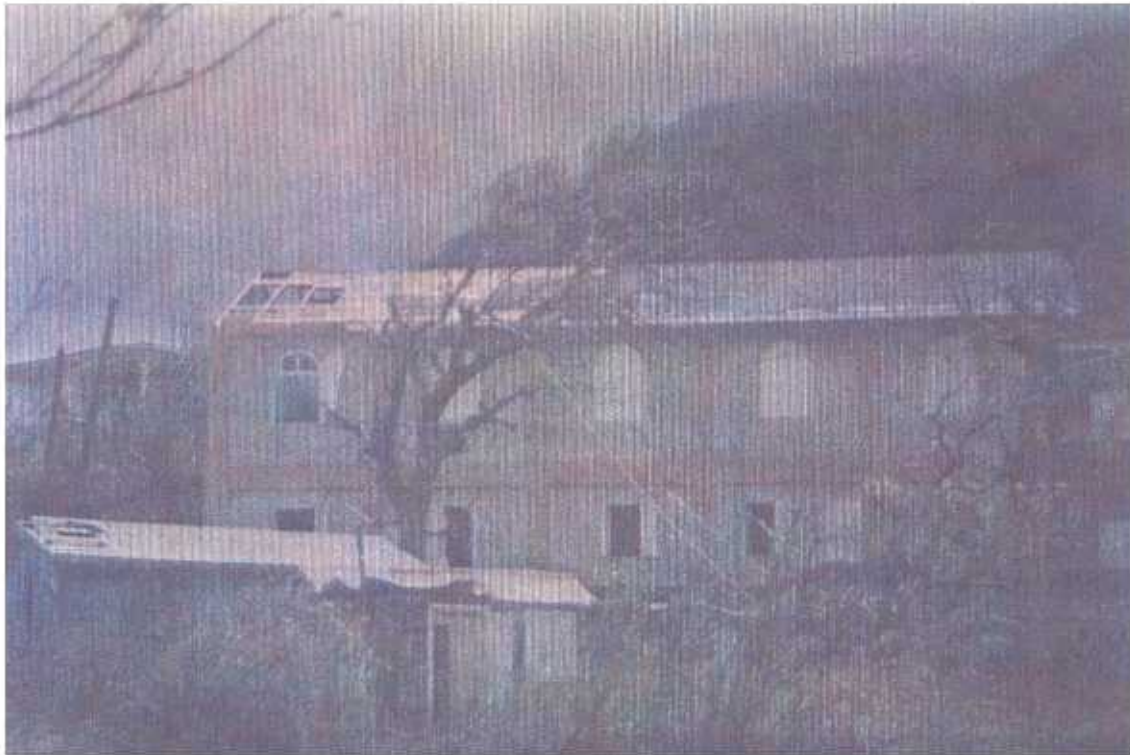
PLATE 41. Pentocostal Church - hurricane shelter. Low pitched roof, loss of sheeting at gable end.

Shuttered windows are good hurricane resistant feature, but the low pitch of the roof is "unsafe" unless specific provision is made to strengthen the roof structure.

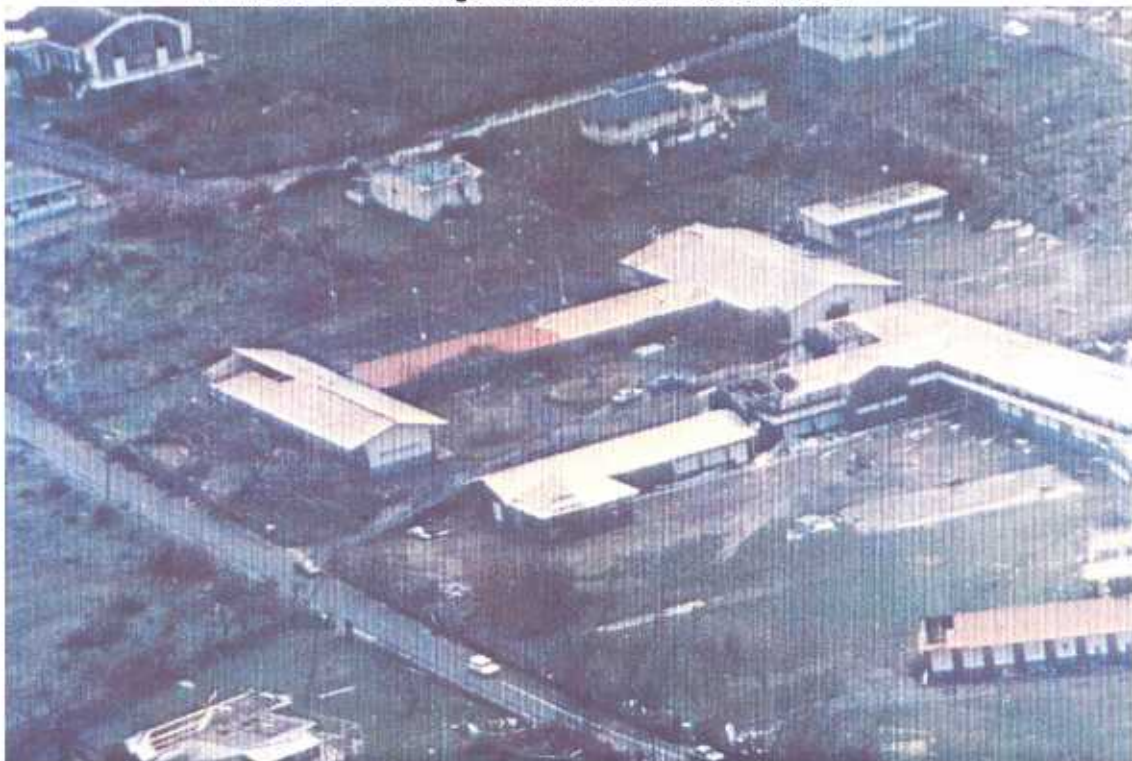
PLATE 42. Aerial view of Technical College and Secondary School. Note Typical roof failure at gable ends. Roof pitch too shallow for "normal" construction .

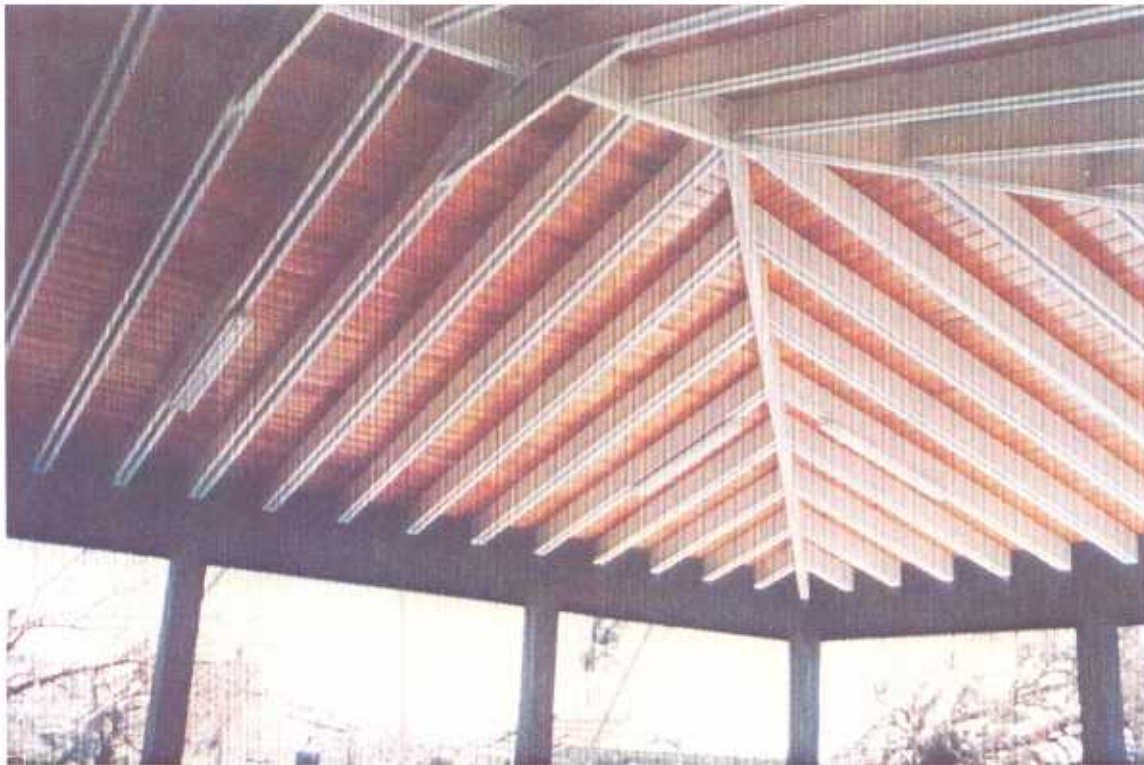
PLATE 43. Montserrat Secondary School. Well constructed hipped roof with close boarding. This roof performed satisfactorily.

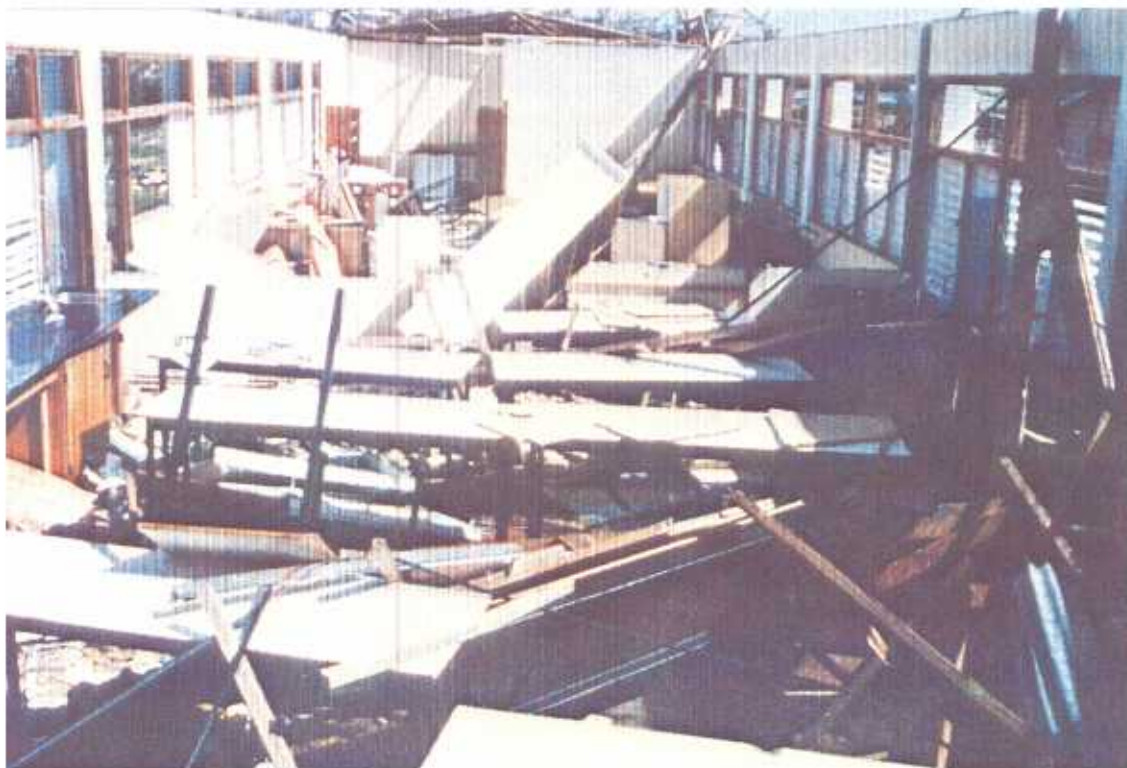
PLATE 44. The roof was completely destroyed and some windows blownout. Rebuilding to improved standards is necessary.  
(Chemistry Lab at Secondary School, Dagenham)

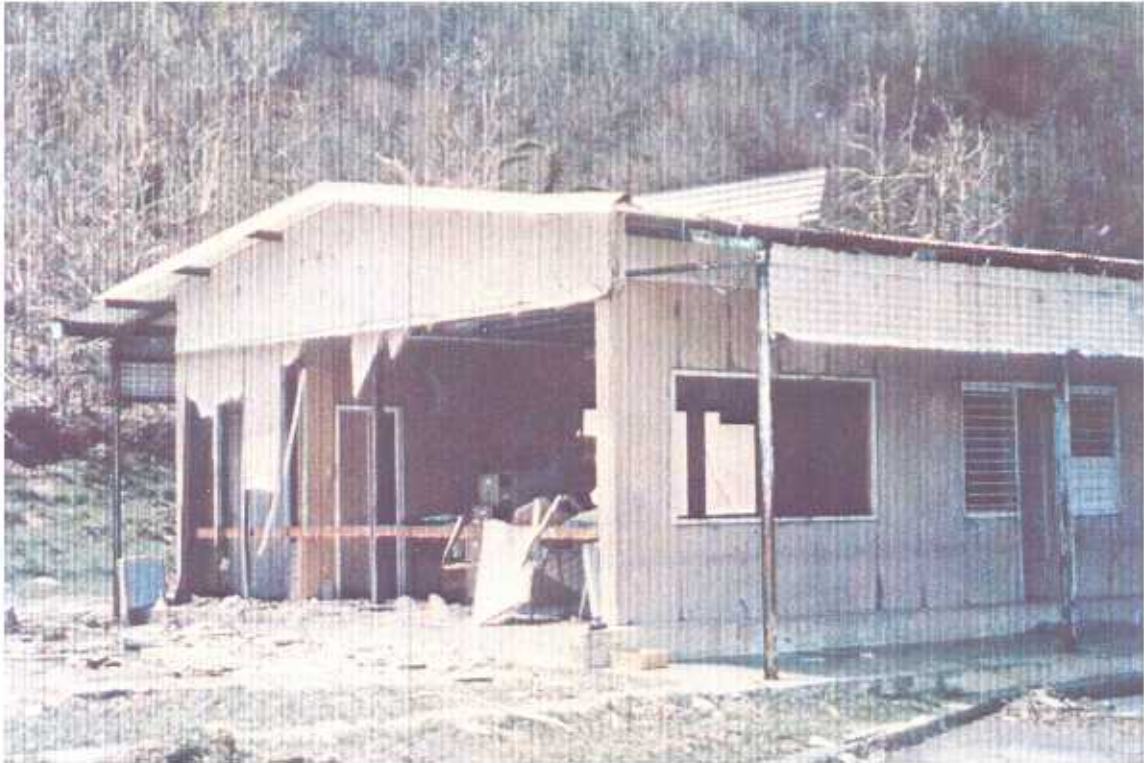
PLATE 45. Harris School. 60mm thick sandwich panel walls. Gable and walls, windows and doors blown in.

Nearby houses lost roofs - some damage may have been caused by flying debris.

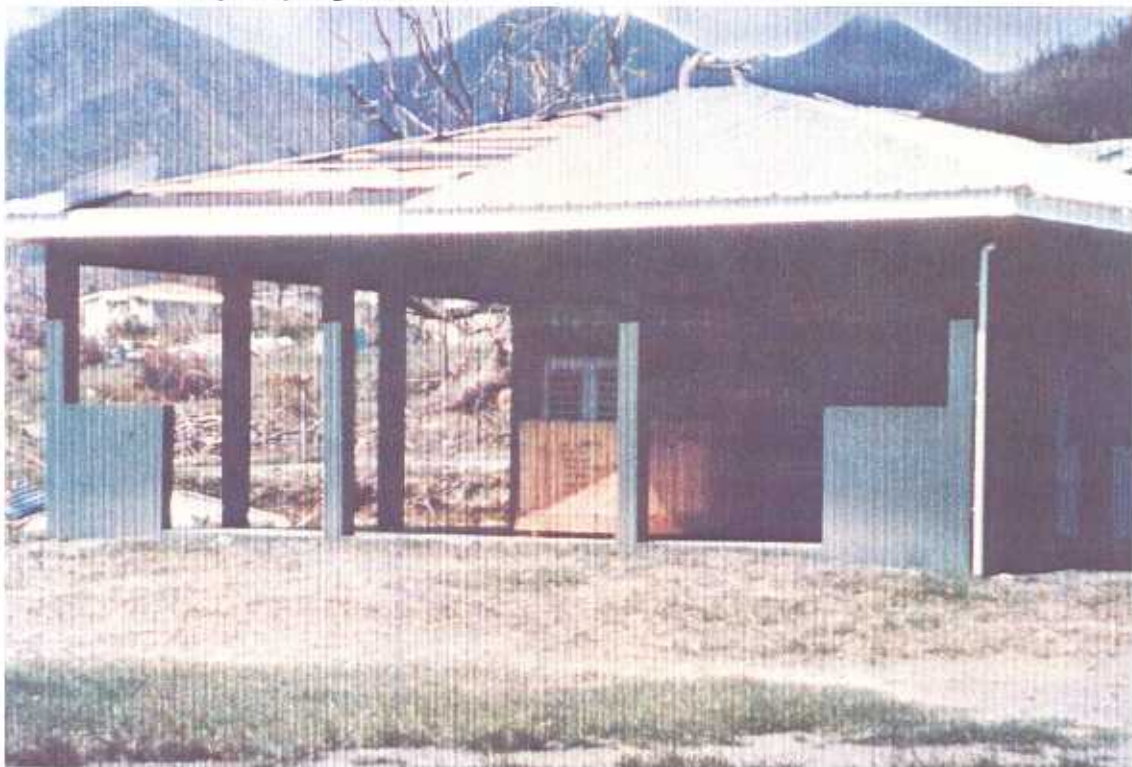
PLATE 46. Montserrat Secondary School. Loss of sheeting of hipped roof

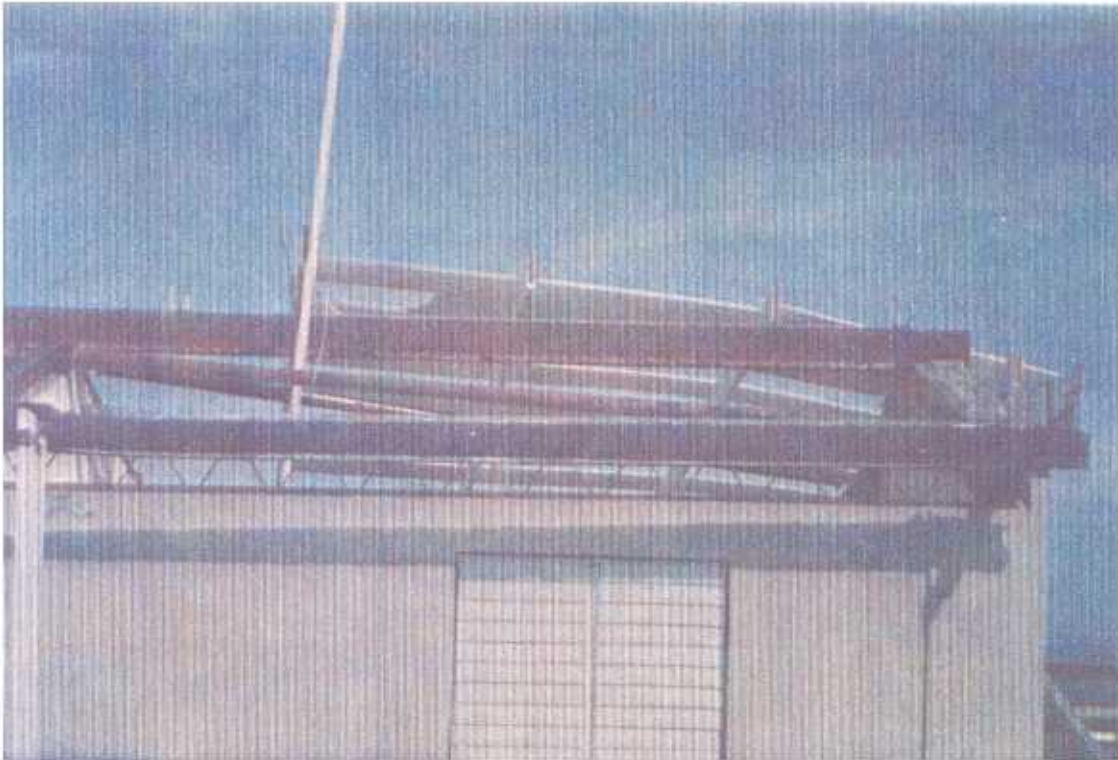
PLATE 47. Bethel School. Rafters failed at ridge joint.

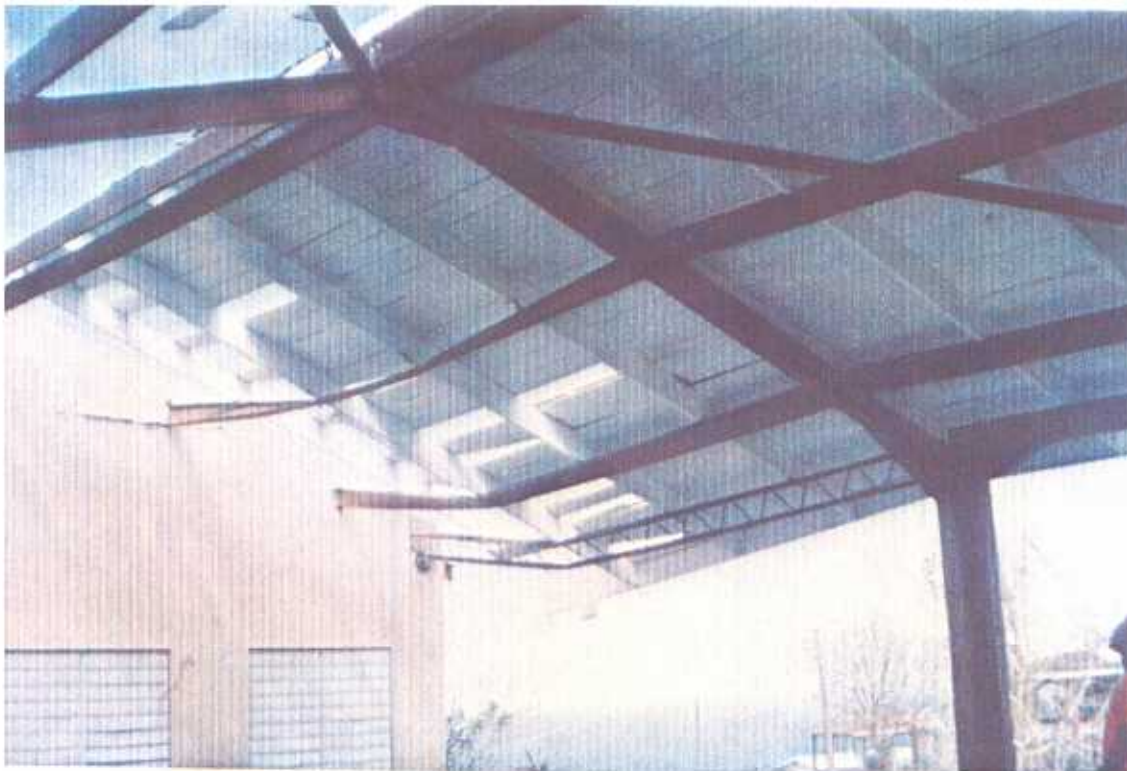
PLATE 48. Bethel School. Very inadequate roof framing contributed to the major damage.

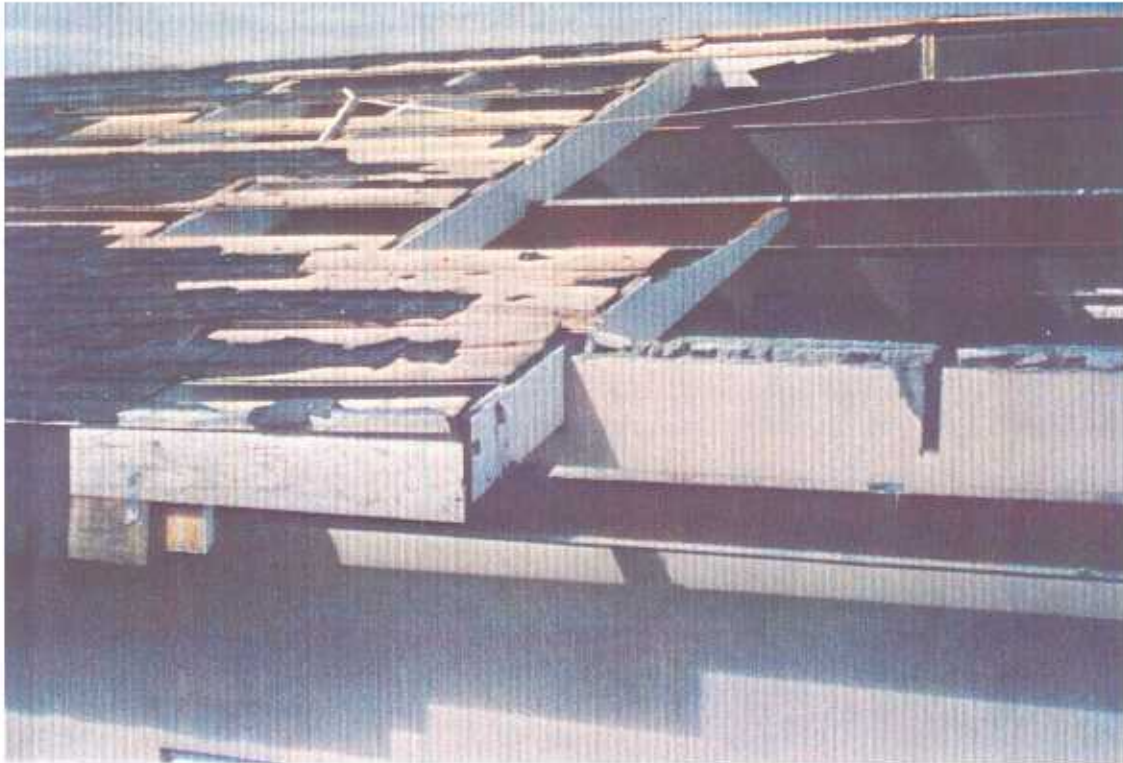
PLATE 49. Bethel School. Loss of roof cladding and rafters due to inadequate construction

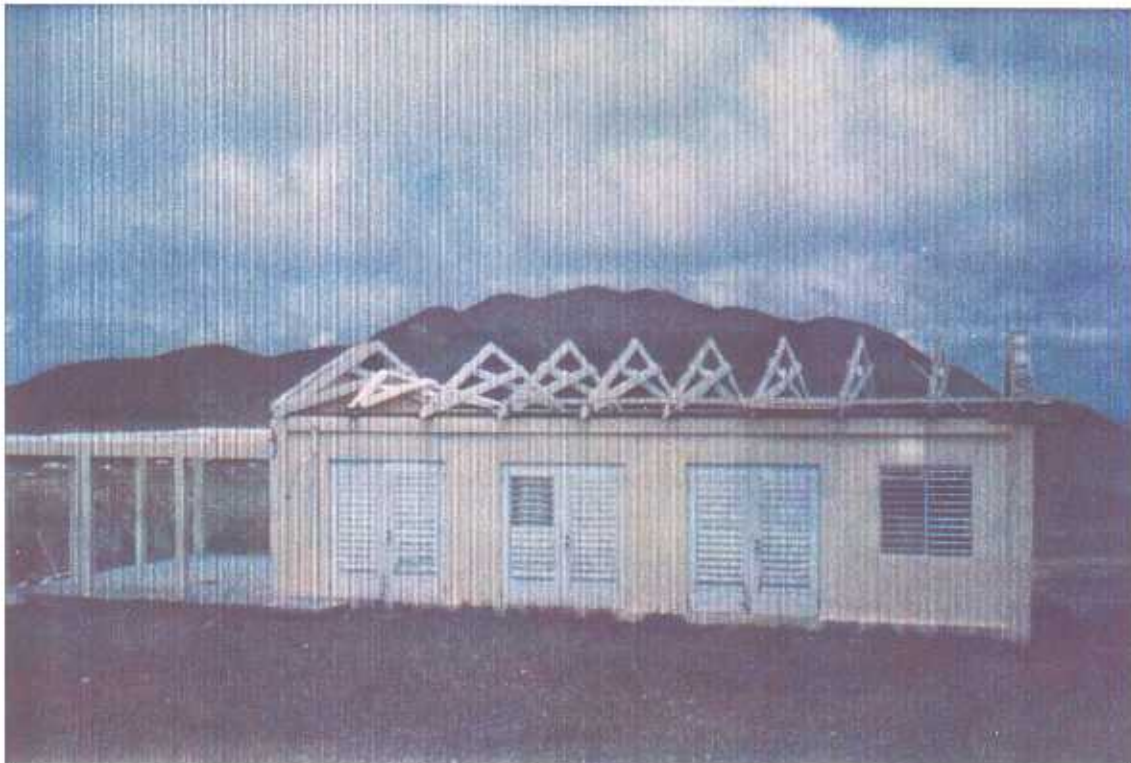
PLATE 50. St John's School. Complete loss of roof cladding from pitched roof and flat roof of open assembly area.

Roof Purlins, Closeboarding and roof covering must be securely fixed to the structure. In this case the structure survived but the roof covering and its support were sucked out.

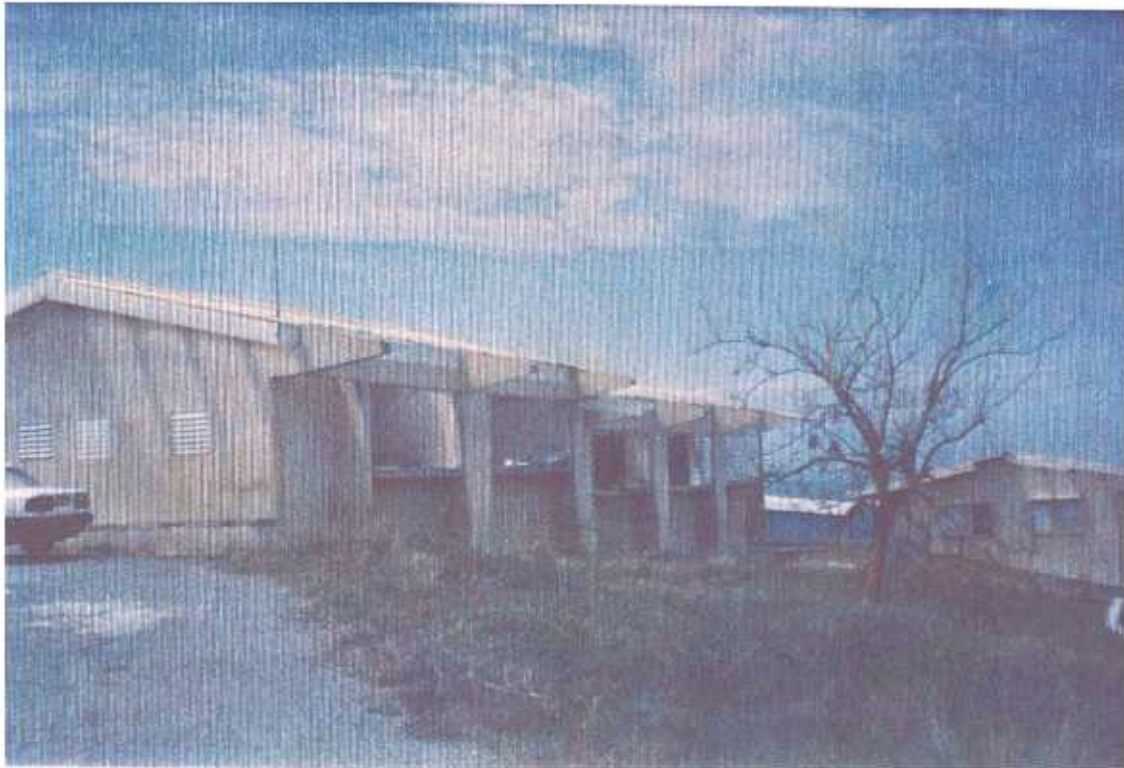
PLATE 51. Brades School. Sheeting loss from canopy roofs, windows blown out.

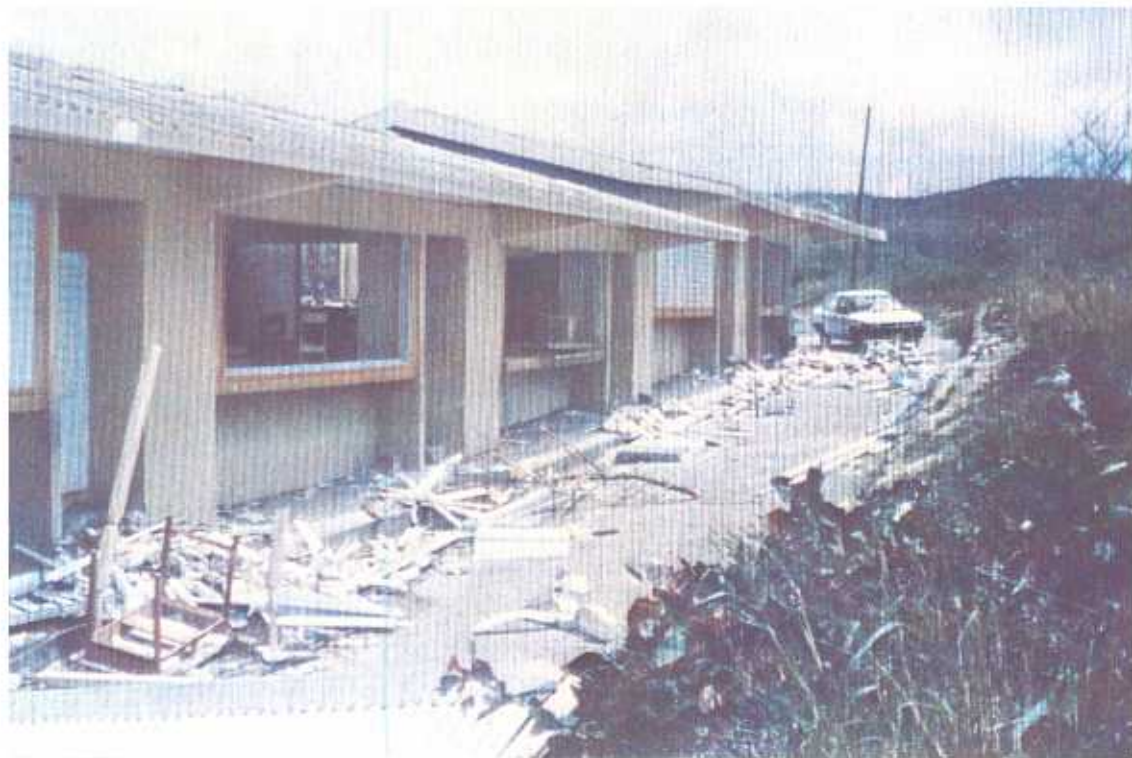
PLATE 52. Brades School. Large 12'x 5' aluminium louvre window blown out on both long elevations.

Asbestos roof sheeting blown away or punctured by flying debris. Use of Asbestos sheeting is to be discouraged as asbestos is easily broken by flying objects.

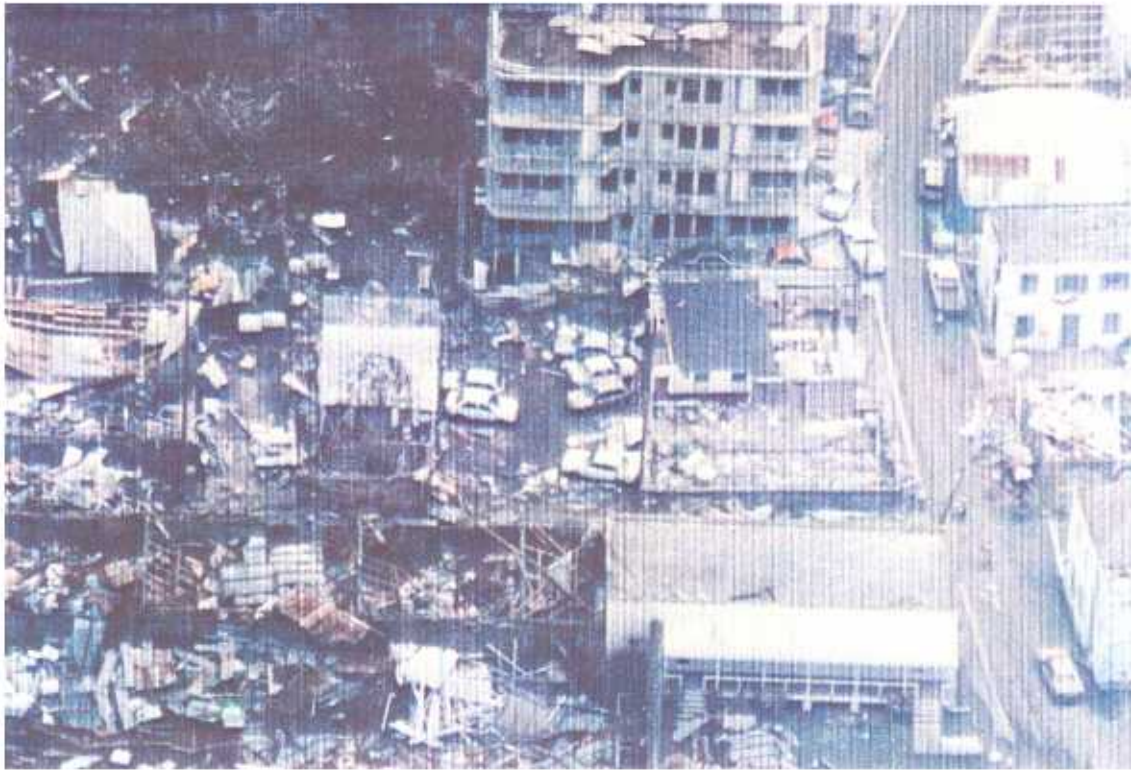
PLATE 53. Aerial view of Plymouth. This view shows the extensive destruction of roofs. However the large amount of debris provides an impression of greater destruction than was actually the case. There was significant loss of roofs and building contents, but some large buildings are still standing and can be repaired quickly.

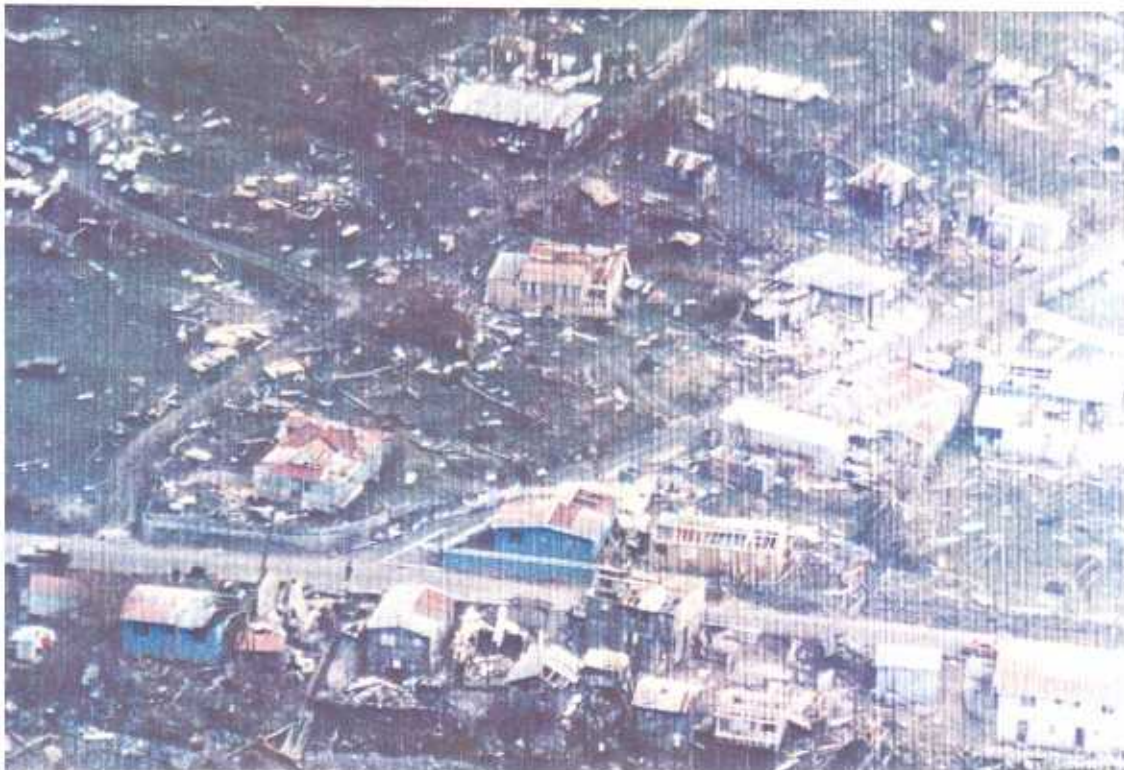
PLATE 54. General view of damage to the outskirts of Plymouth.

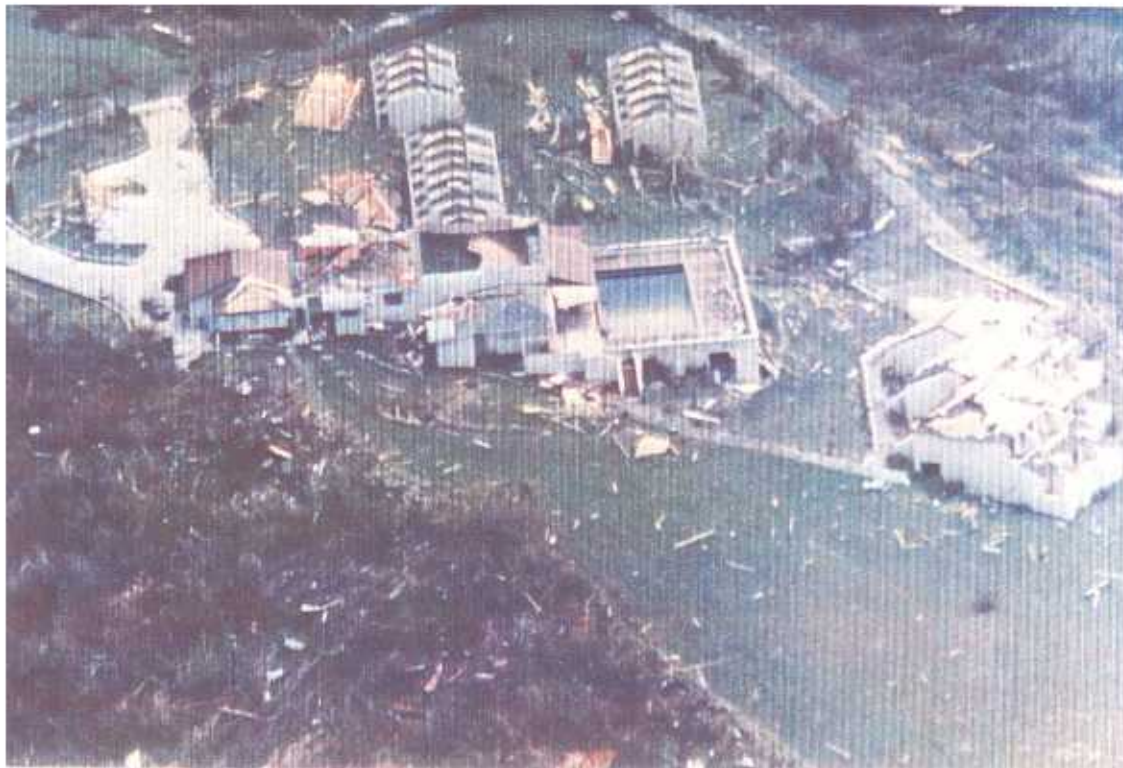
PLATE 55. Emerald Isle Hotel. General loss of roof. Note large sections of roofs on ground nearby. These gable ended roofs with shallow pitches are vulnerable.

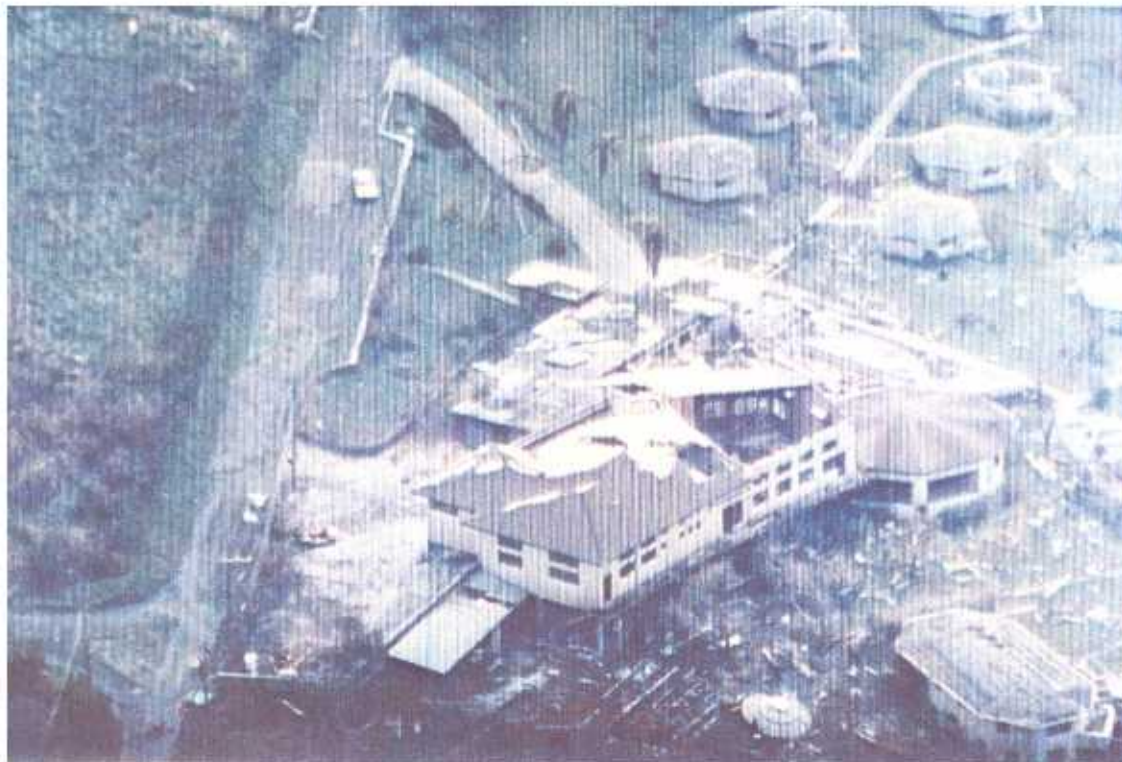
PLATE 56. View Point Hotel. Loss of roof cladding on flat pitched roof section.

Roof units of hexagonal shape with hipped roofs suffered some damage

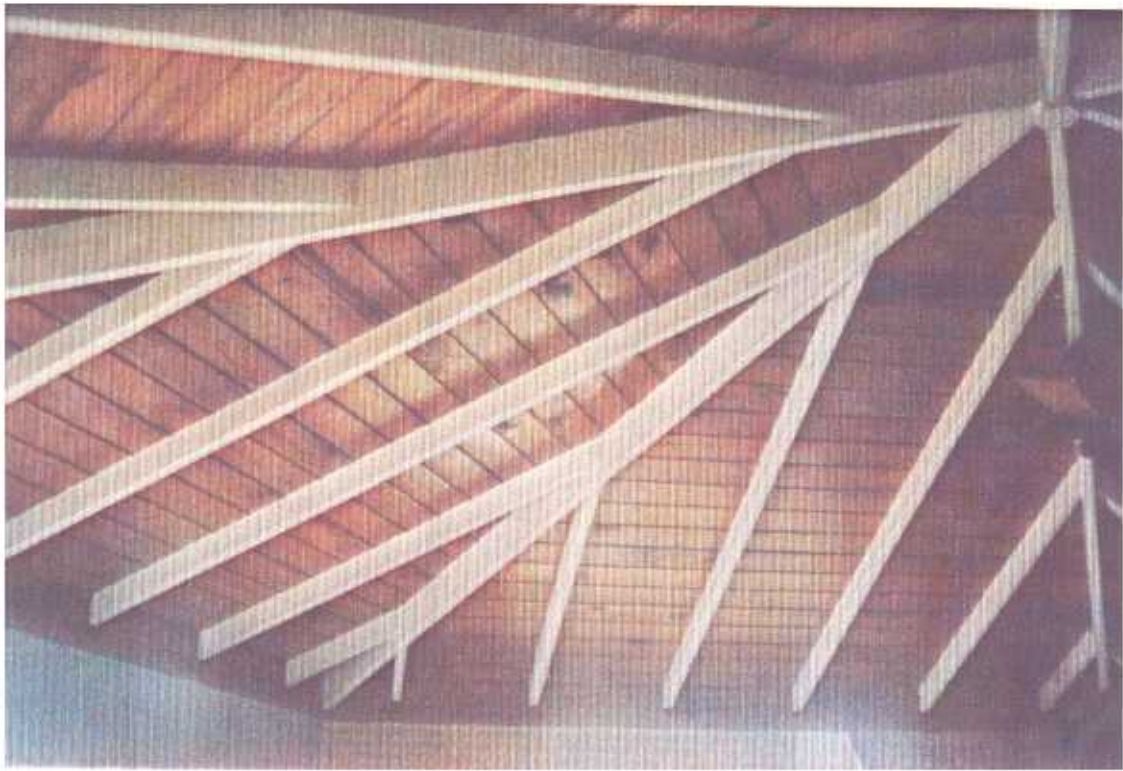
PLATE 57. View Pointe Hotel - Room Unit. An example of good roof framing. This level of construction must be maintained for all elements of the roof to ensure resistance to high winds.

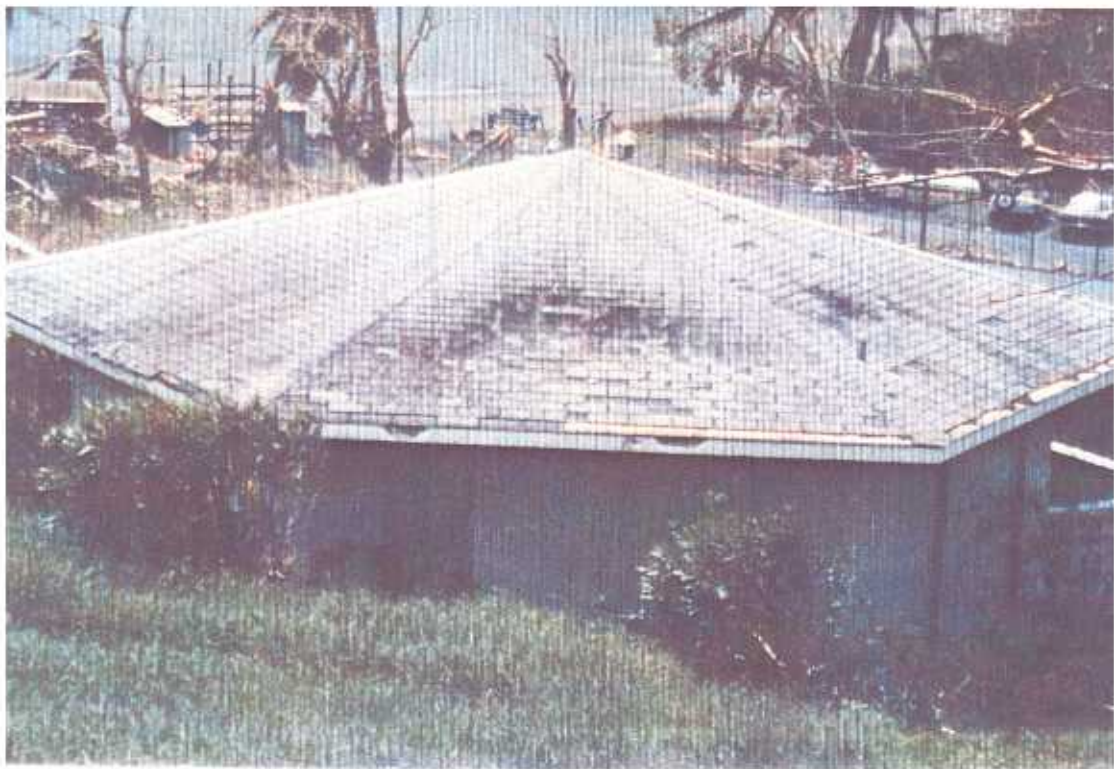
PLATE 58. View Pointe Hotel. Hipped roof performed with limited damage on hexagonal room units.

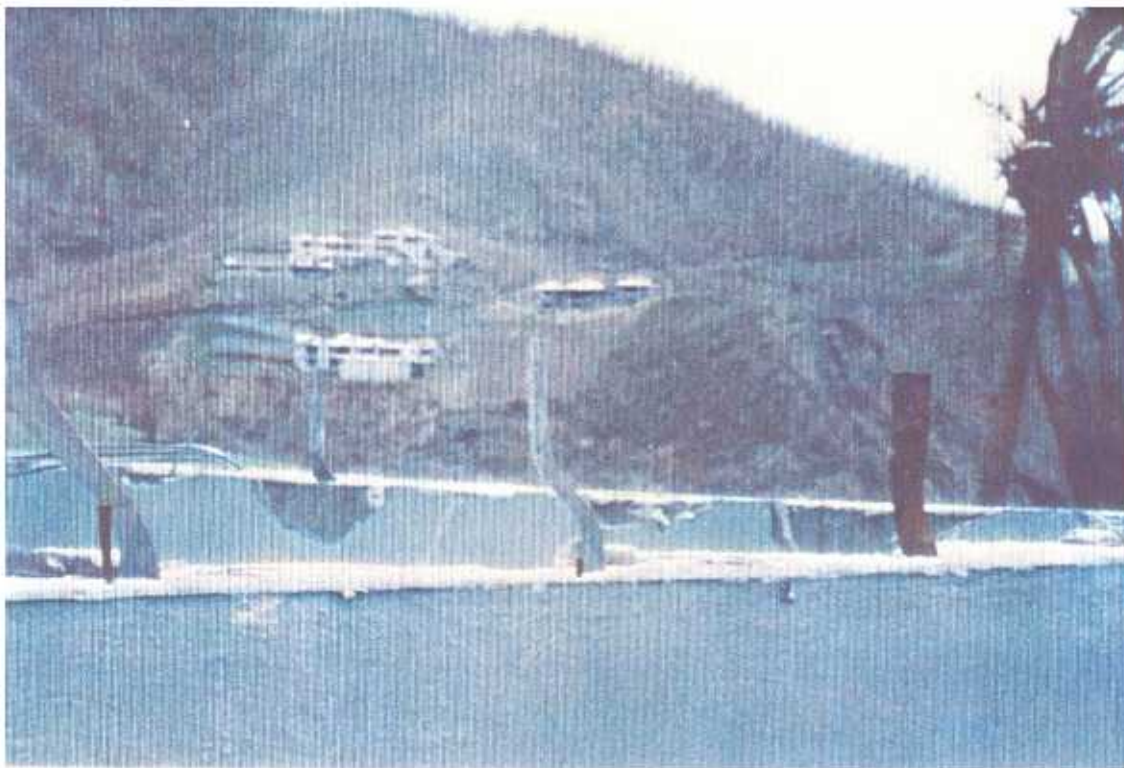
PLATE 59. View Pointe Hotel. Holding down straps, straightened out by uplift forces on unit that has lost its roof.

The construction method used appears satisfactory, but the fixing of the straps to the timber rafters may not have been positive, allowing the high wind forces to take advantage of a weak connection.

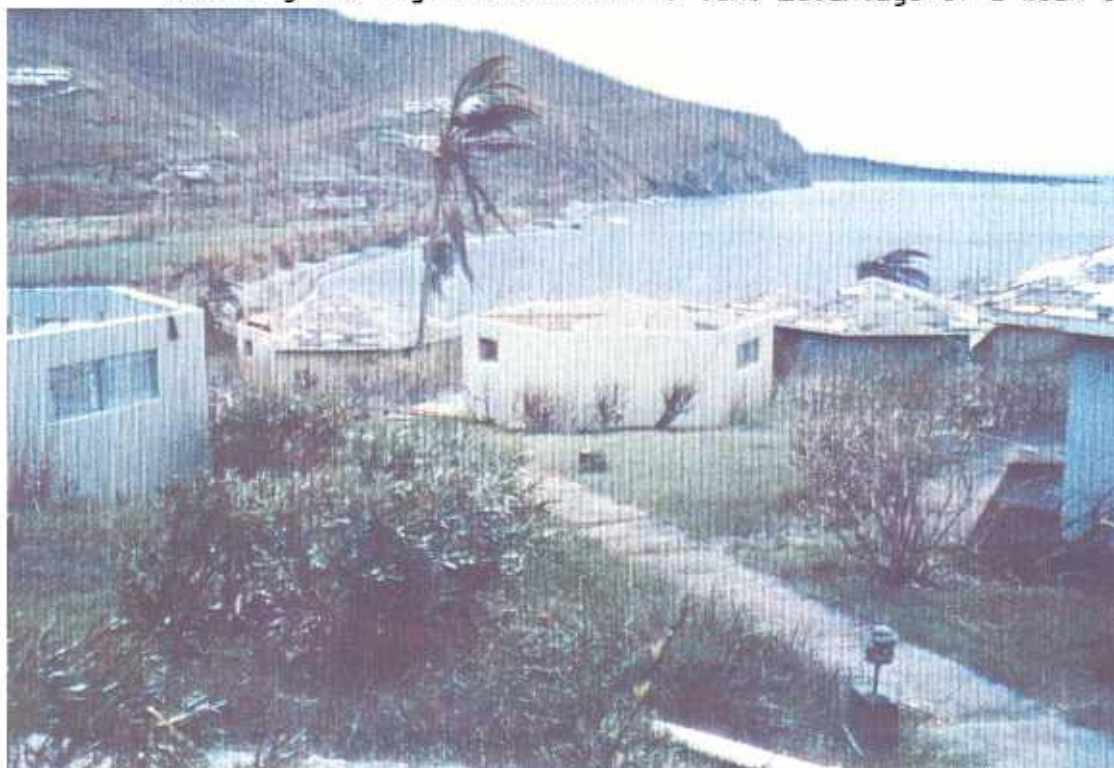
PLATE 60. View Point Hotel. Another view of the units that have their roofs and those that don't.
