# SURFACE FAULTING AND AFTERSLIP ALONG THE MOTAGUA FAULT IN GUATEMALA

R. C. Bucknam, George Plafker, R. V. Sharp<sup>1</sup>

## ABSTRACT

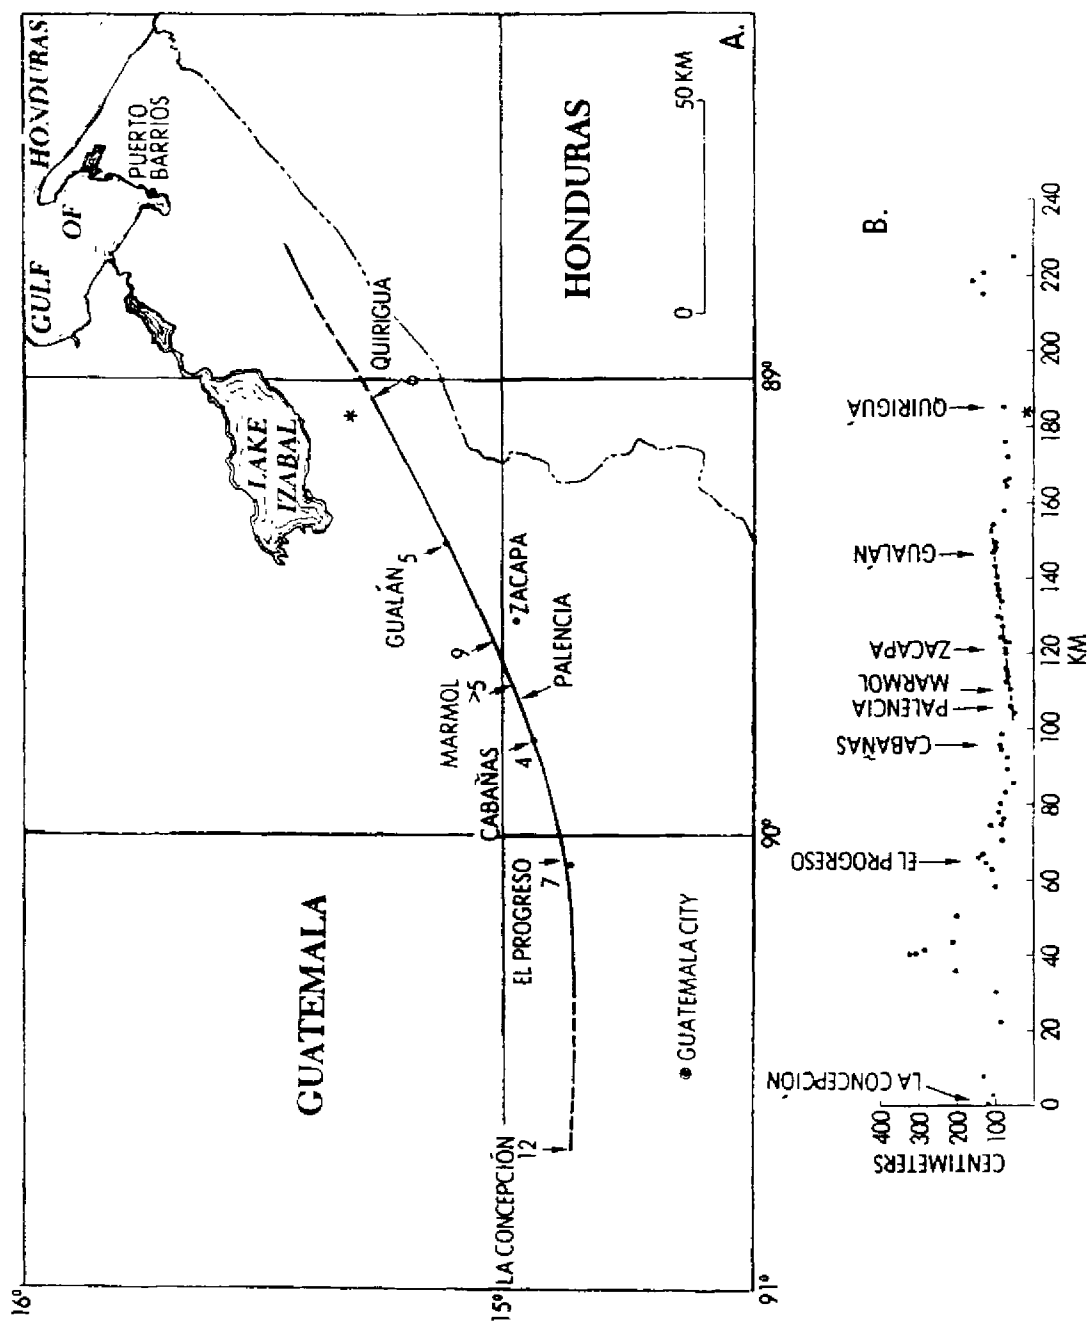
Displacements were determined by the offset of a variety of cultural features crossing the fault such as fences, roads, and building foundations, as well as by the offset of natural features such as the matching ends of broken roots and matching irregularities on opposite sides of the fractures. Left-slip along the fault, as measured in April 1976, averaged 110 cm and ranged from a maximum of 340 cm, 40 km from the west end of the fault through a minimum of 45 cm in the central portion, to 160 cm near the east end. Changes in the amount of displacement along the fault tend to be regular over distances of as much as 50 km and were terminated by short intervals of rapid variation in measured displacement (fig. 1B).

By early October 1977, we had documented afterslip at eight locations along the Motagua fault (fig. 1A); data on the variation in amount of afterslip with time are available for three of those locations (fig. 9 and table 1).

The amounts of afterslip shown on figure 1A, which range between 4 and 12 cm, represent the slip occurring between late April and late October 1976. The total afterslip occurring since first measurements of displacement produced by the earthquake were made is known to be much greater at some locations. For example, 31 cm has been measured at the Zacapa Highway site. Reference marks in the area of maximum slip near the west end of the fault were not suitable for an accurate determination of afterslip. However, measurements made there in April 1976 and October 1977 show that afterslip, if any, during that period was less than about 10 cm.

Figure 1. (A) Locations of afterslip measurements along zone of surface breakage (solid line) on the Motagua fault. Afterslip values (cm) are for the period May to October, 1976. (B) Total displacement across the fault as measured in April, 1976. Epicenter shown in (A) and (B) by asterisk.

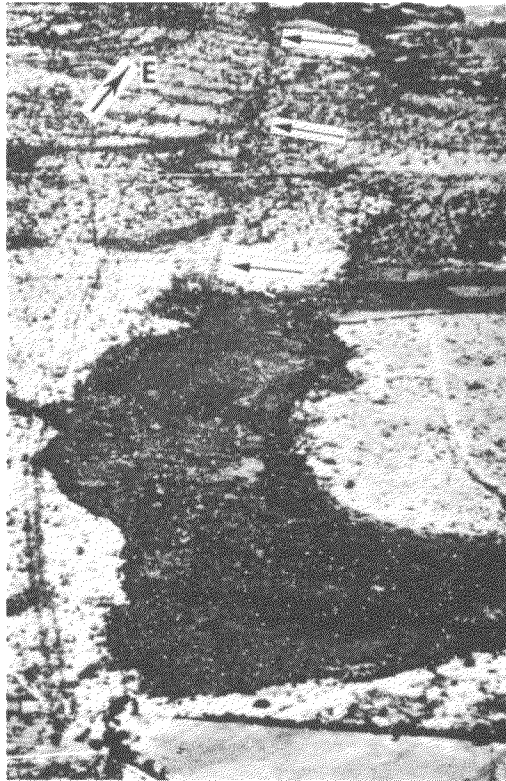
Along the Motagua fault, much of the 230-km-long surface rupture produced by the earthquake follows a zone of geomorphic features (fig. 1A) that are characteristic of major strike-slip faults. Left-lateral offsets of drainages crossing the fault trace, shutter ridges, elongate ridges and troughs, sag ponds, springs, side-hill benches, and aligned drainages are common along the rupture (fig. 2). These features are generally absent along the western 70 km of the fault, possibly indicating that it is a more recently activated strand within the Motagua fault system.

Figure 2. Sag pond (Laguneta los Yajes) along Motagua fault northwest of Zacapa. Surface ruptures of the earthquake follow the dark line of vegetation along arrows.

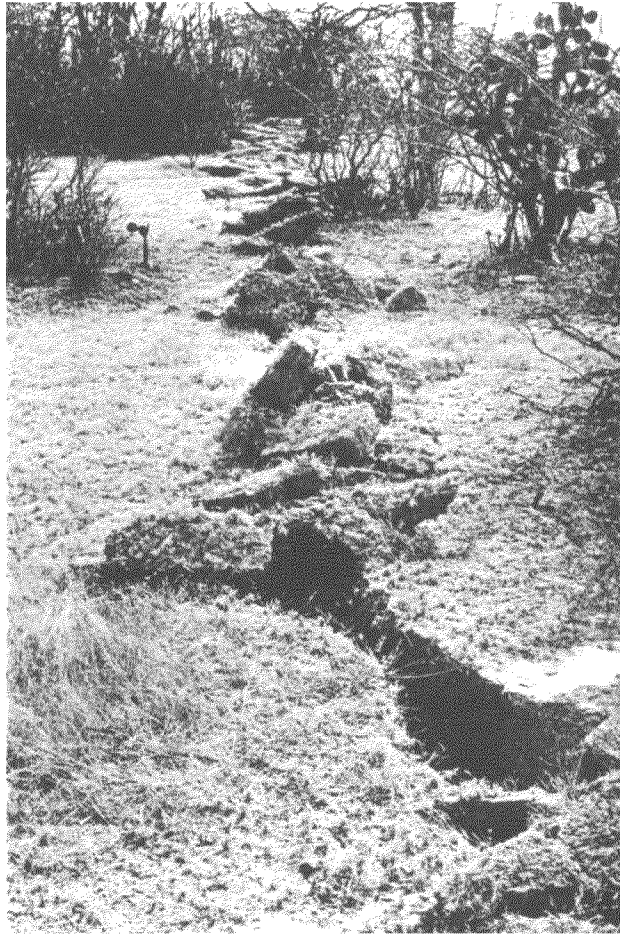
In areas of cohesive soil, displacement along the fault resulted in the development of a zone of tilted, overthrust blocks and slabs of soil or pressure ridges connected by en echelon fissures (figs. 3, 4). The fissures are at angles predominantly within the range of  $16^{\circ}$  to  $20^{\circ}$  to the overall trend of the fault zone. They are about vertical in their central portions and merge with overthrust slabs at their ends by means of a twisted surface that is inclined about  $30^{\circ}$  to the ground surface. Oppositely directed overthrust slabs of soil (fig. 5) are common in the area affected by en echelon fissuring. Numerous exposures in the bottom of the fissures showed the fault plane at depths of several meters to be a vertical, tightly closed, narrow slip surface.

Figure 3. Zone of tilted, overthrust blocks and slabs of soil along surface rupture of the Motagua fault. Left-lateral slip at this site north of Zacapa was 75 cm.
