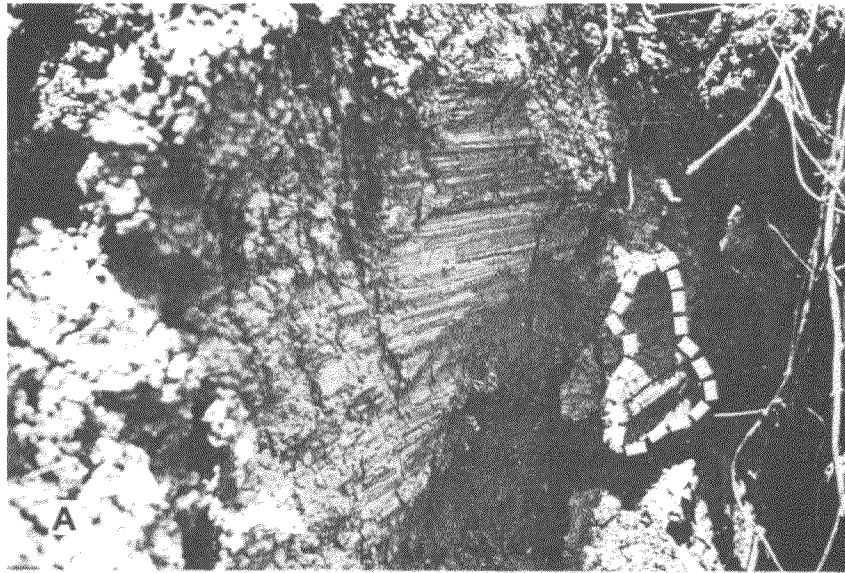
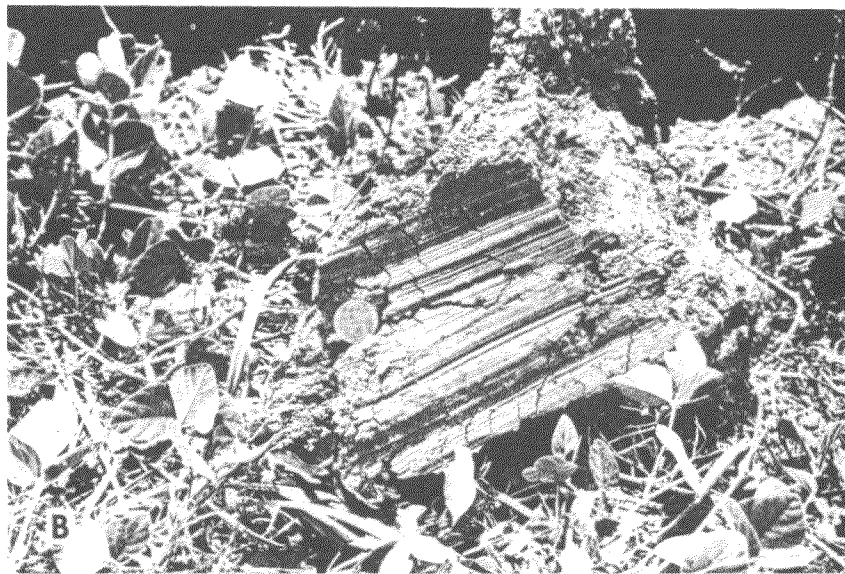
Figure 7. A. Slickensides formed in damp plastic soil along the 1976 surface rupture. Ground surface is about 10 cm above top of photograph.
 B. Detail of slickensides. Grooved block was broken from area outlined by dashed lines in A.

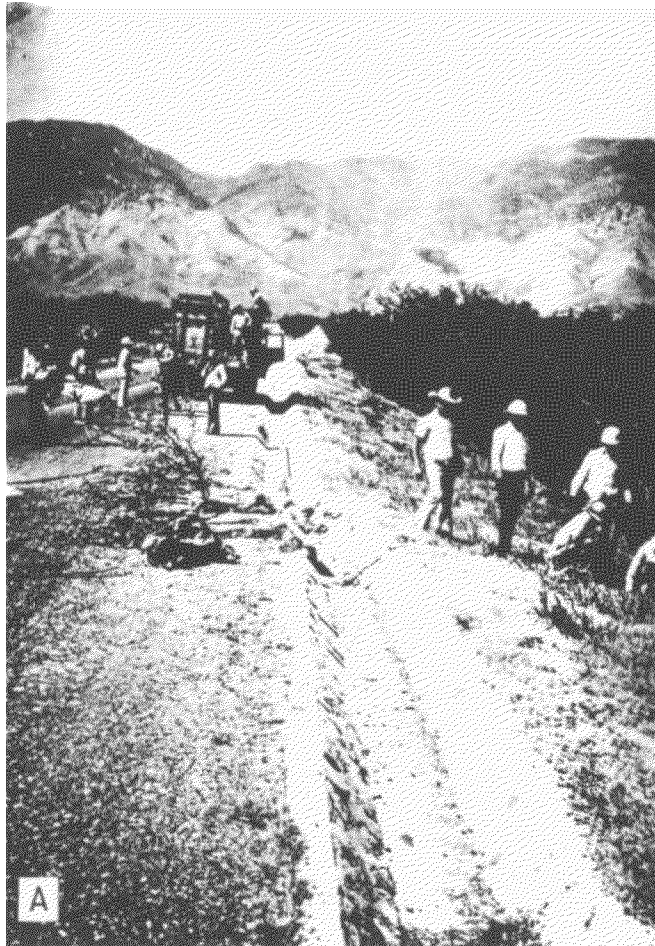
Figure 8. (A) View north along Highway CA-10 near Zacapa showing drainage ditch offset by 60-cm left-lateral and 5-cm south-side-down displacement on the Motagua fault, 8 February 1976. Black line drawn on north side of offset is alined with the upper inside edge of the section of ditch in the foreground.
