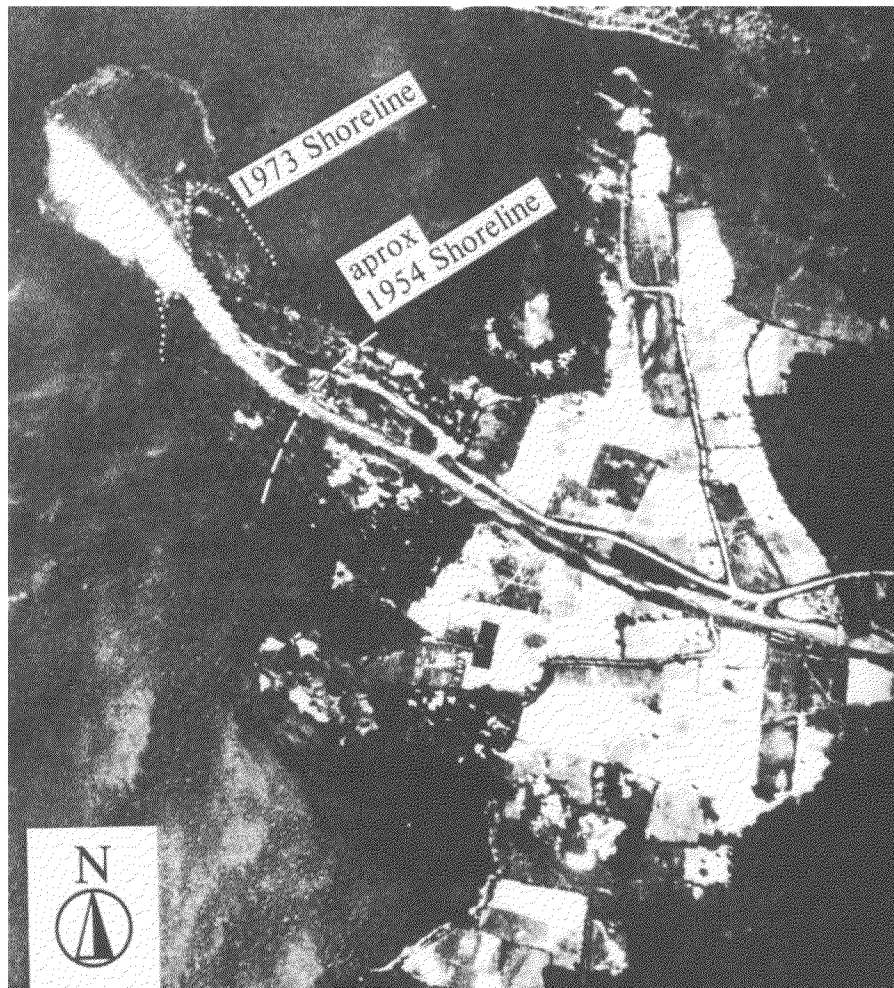
Figure 5. Aerial photograph enlarged from Fig. 4 showing the La Playa portion of the Villalobos River delta at Lake Amatitlan. Many trees are standing in the water as a consequence of subsidence. Dates of shorelines shown here are taken from older airphotos and indicate the rapid growth of this lobe of the delta. Both sand boils and lateral spreading fractures are obscured in forested areas. (Credit as on Fig. 4.)

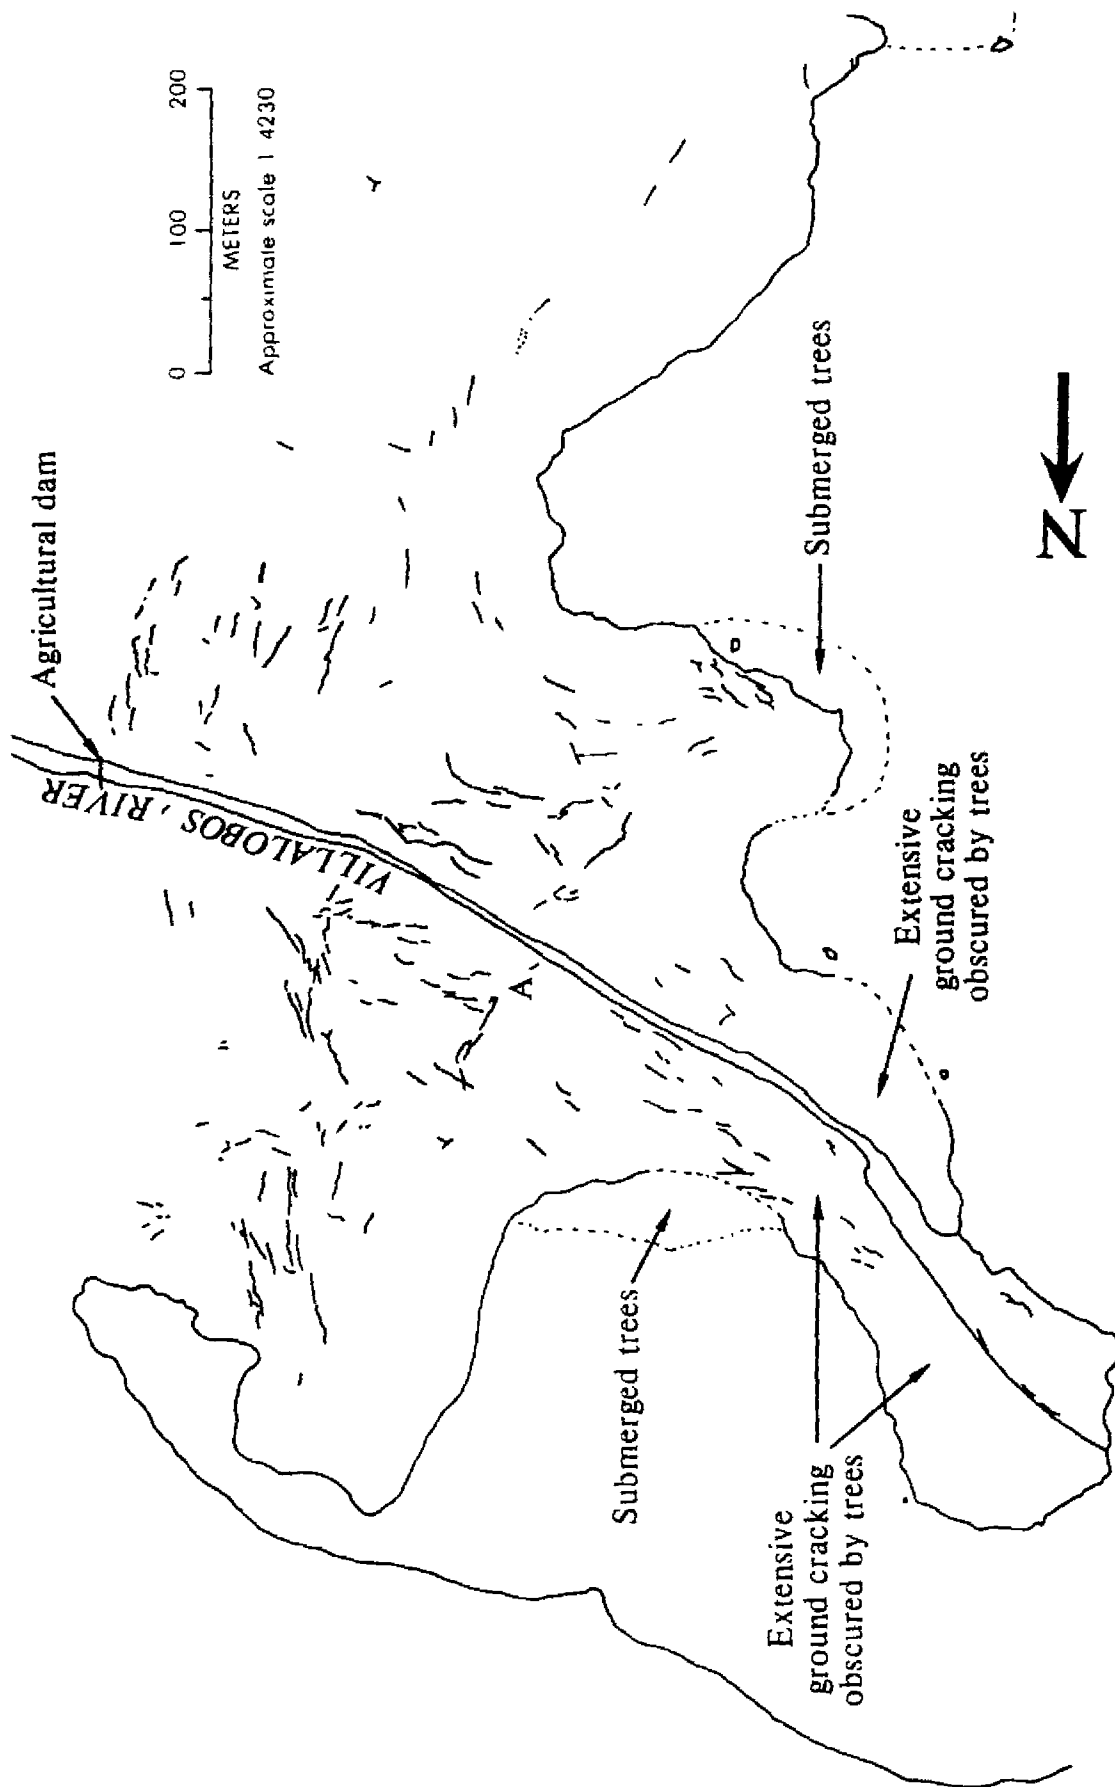
Figure 6. Prominent ground cracks due to lateral spreads identified and plotted from Figure 5 are shown on this line drawing. Some fissures on the photograph in areas of extensive sand boils obscured by glare from the discharged sand. Subsided shorelines are indicated by dashed lines. "A" is the location of a large sand boil associated with a 200 m long ground crack extending northward from that point.

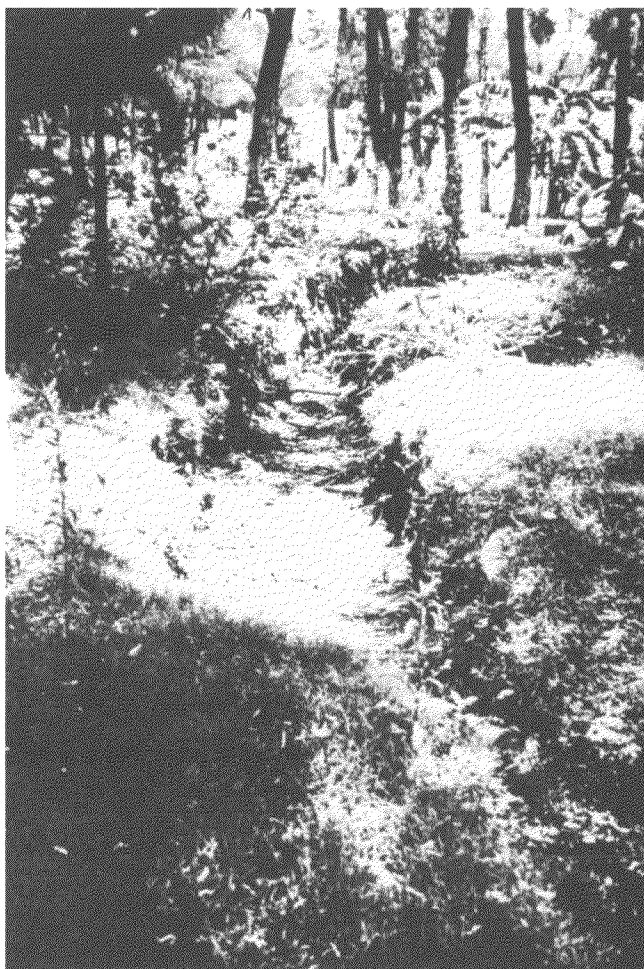
Figure 7. Typical ground crack due to lateral spreading at La Playa, illustrating vertical sides and flat sandy bottoms.
